ENGINEERING CHANGE NOTICE	DATE OF ISSUE Sep. 8, 2007	ECN DF700-286					
		FCB	None				
		SN	1/6				
Title : Release of new Microcode <DF700 Rev. 0772/D>	EQUIP. DISK ARRAY UNIT TITLE						
	EQUIP. DF700-RKM/RKS/RKXS/RKH/ MODEL No. RKHE/RKAJ/RKAJAT/ RKNAS DF600-RKA						
<u>1. Purpose</u> This ECN is to inform of the release of new Microcode <DF700 Rev. 0772/D (V7.2/D)>.							
<u>2. Supported features and functions</u>							
<u>2.1 New function</u> None.							
<u>2.2 Improvement</u>							
<u>(1) Daylight saving time changes in New Zealand.</u> New Zealanders will have three weeks more daylight saving from 30 September this year following the decision by the Labour-led Government to extend the period to 27 weeks. Daylight saving in New Zealand for 2007-2008 will start at 2am on 30 September 2007 and end at 3am on 6 April 2008.							
<u>(2) HDU reliability improvement by changing Online Verify process</u> The microcode changes Online Verify period to activate the IDLE SEEK(self-diagnosis function) of the following HDDs when these HDDs are installed. FC HDD: HGST HUS151414VLF400 (Model: DF-F700-AGH146(H), Firmware: K0) HGST HUS151473VLF400 (Model: DF-F700-AGH72(H), Firmware: K0)

3

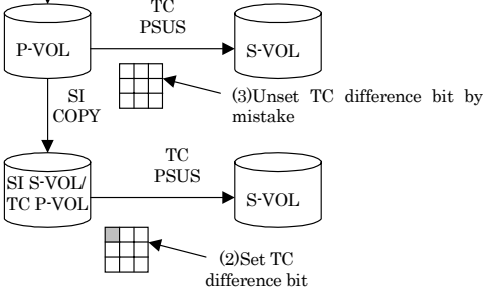
Title	System down by the Write Command on ShadowImage and TrueCopy cascade configuration.
<1>	Phenomena	When the host issue Write command to CTL0 of DF , CTL0 is blockaded. When the host issue Write command to CTL1 of DF for retry, CTL1 also is blockaded and system down.
<2>	Severity	A: Critical High (Subsystem Outage /Data Disagreement) B: Critical Middle C: Critical Low
<3>		<p>This phenomenon occurs when all of the following conditions are met: (a) Microcode version is 0772/A or later. (b) There are TrueCopy cascades for both P-VOL and S-VOL of ShadowImage (c) The pair status of ShadowImage and TrueCopy are the following case1 and case2. (d) The host issue Write command to P-VOL of ShadowImage.</p>

<p>This phenomenon occurs when all of the following conditions are met: (i) Pair status of ShadowImage COPY or PAIR or RCOPY(restore) (ii) Pair status of TrueCopy (P-VOL side of ShadowImage) PSUS or PSUE (iii) Pair status of TrueCopy (S-VOL side of ShadowImage) PSUS or PSUE</p>

<5>	Affected Products/Version	Version : 0772/A
<6>	Fixed Product/Version	Version : 0772/D
<7>	Special direction to applying the modified code.	
	(1) Restriction of micro-program exchange	None
	(2) others	None
<8>	Category	ShadowImage and TrueCopy cascade configuration
<9>	Changed Part	MICRO-Disk
<10>	Problem ID	DF700-0208
<11>	Site	customer
<12>	ESC/CTSC LOG#	DF700-19750
<13>	Early Notice#	DF700-M034(Rev.0)

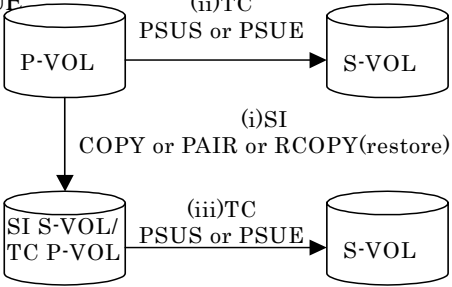
<p>This phenomenon occurs when all of the following conditions are met:</p> <ul style="list-style-type: none">(i) Pair status of ShadowImage COPY or PAIR or RCOPY(restore)(ii) Pair status of TrueCopy (P-VOL side of ShadowImage) PSUS(iii) Pair status of TrueCopy (S-VOL side of ShadowImage) PSUS or PSUE

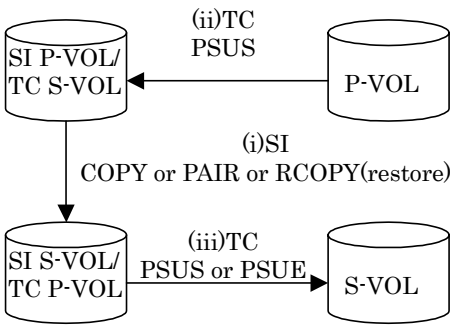
<4>	Cause	<p>Microprogram 0772/A was supported TrueCopy cascades for both P-VOL and S-VOL of ShadowImage. When Write command to P-VOL of ShadowImage is received, there is a case of unsetting TC difference bit of TrueCopy (P-VOL side of ShadowImage) by mistake.</p> <p>CTL is blockaded, because TrueCopy difference bit unset is detected just before the status transfer of Write command. (Check logic)</p>

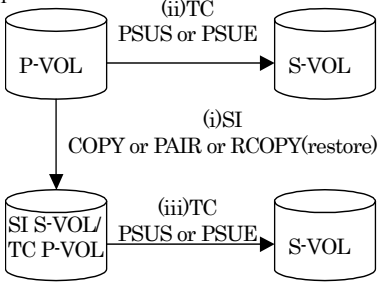
6	C	A	DF700-19750	DF700-0208	<p>System down by the Write Command on ShadowImage and TrueCopy cascade configuration.</p>	<p>[Phenomenon] When the host issue Write command to CTL0 of DF , CTL0 is blockaded. When the host issue Write command to CTL1 of DF for retry, CTL1 also is blockaded and system down.</p> <p>[Conditions of occurrence] This phenomenon occurs when all of the following conditions are met: (a) Microcode version is 0772/A or later. (b) There are TrueCopy cascades for both P-VOL and S-VOL of ShadowImage (c) The pair status of ShadowImage and TrueCopy are the following case1 and case2. (d) The host issue Write command to P-VOL of ShadowImage.</p> <p>Case1</p>

<p>This phenomenon occurs when all of the following conditions are met:</p> <ul style="list-style-type: none"> (i) Pair status of ShadowImage COPY or PAIR or RCOPY(restore) (ii) Pair status of TrueCopy (P-VOL side of ShadowImage) PSUS or PSUE (iii) Pair status of TrueCopy (S-VOL side of ShadowImage) PSUS or PSUE <p>Case2</p> <pre> graph TD SI_PVOL_TC_SVOL[SI P-VOL / TC S-VOL] -- "(i)SI COPY or PAIR or RCOPY(restore)" --> SI_SVOL_TC_PVOL[SI S-VOL / TC P-VOL] SI_SVOL_TC_PVOL -- "(iii)TC PSUS or PSUE" --> S_VOL[S-VOL] P_VOL[P-VOL] -- "(ii)TC PSUS" --> SI_PVOL_TC_SVOL </pre> <p>This phenomenon occurs when all of the following conditions are met:</p> <ul style="list-style-type: none"> (i) Pair status of ShadowImage COPY or PAIR or RCOPY(restore) (ii) Pair status of TrueCopy (P-VOL side of ShadowImage) PSUS (iii) Pair status of TrueCopy (S-VOL side of ShadowImage) PSUS or PSUE <p>[Cause] Microprogram 0772/A was supported TrueCopy cascades for both P-VOL and S-VOL of ShadowImage. When Write command to P-VOL of ShadowImage is received, there is a case of unsetting TC difference bit of TrueCopy (P-VOL side of ShadowImage) by mistake. CTL is blockaded, because TrueCopy difference bit unset is detected just before the status transfer of Write command. (Check logic)</p>
