## Motorola Solutions Technical Notification (MTN)

**TITLE:** MoMs registered in UEM NBI cease to process forwarded data after upgrading/patching UEM

**TECHNOLOGY:** ASTRO 25

DOCUMENT NUMBER: MTN-0001-22-NA

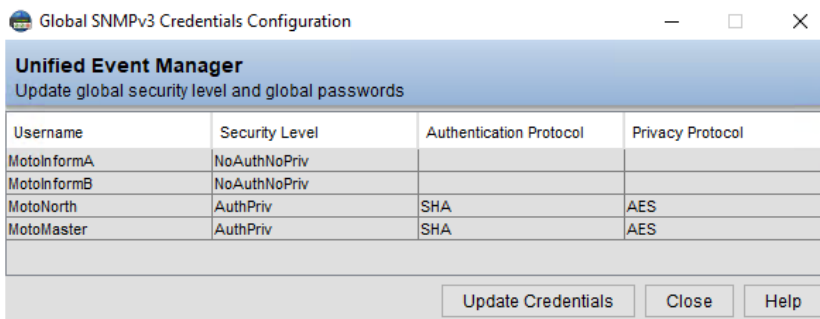
The SNMPv3 credential configuration before the upgrade/patching:

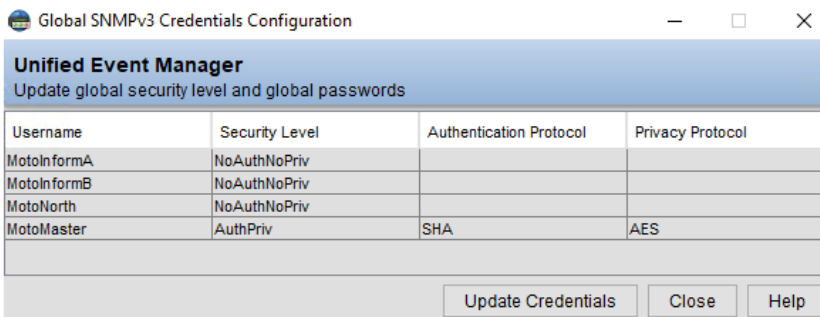
When a UEM server is upgraded/patched, the security level configured for *MotoNorth* and *MotoNorthMotorola* users is reset to *NoAuthNoPriv* (see the pictures below), causing that all MoMs registered in UEM NBI cease to process forwarded data due to a credential mismatch.

The SNMPv3 credential configuration after the upgrade/patching:

The NBI engine ID reset mechanism works improperly.

**Workaround:** If the problem occurs, there is a need to configure the security settings for *MotoNorth* and *MotoNorthMotorola* users back to the values before the upgrade. The workaround will be effective until the next upgrade to a version not containing the fix - to avoid further resets, there is a need to perform the corrective actions below.

**Corrective actions:** Install/upgrade to the software version containing the fix (see the *Parts Required (Hardware/Software)* section).
