## Motorola Solutions Technical Notification (MTN)

**TITLE:** InfoVista does not show port / interface related statistics.

**TECHNOLOGY:** ASTRO 25

DOCUMENT NUMBER: MTN-0016-22-NA

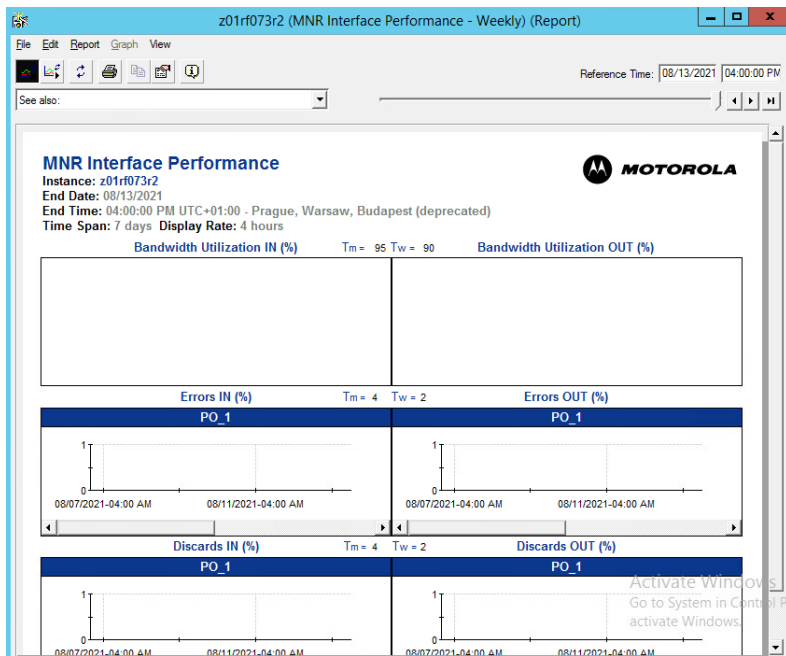
When reviewing Port / Interface related reports in the IVReport application, no data is shown on the reports (see the Screenshot below). It affects all types of network devices (HP switches, MNR routers, Juniper Gateways). This issue occurs on fresh Astro A2019.2 installs or on Astro systems upgraded to A2019.2 or A2020.1.

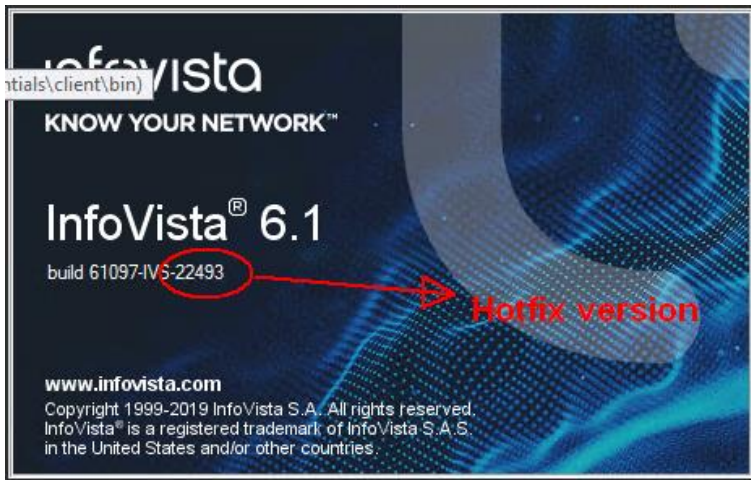
- a) Log in to InfoVista Server
- b) Press Windows button and type: ivreport.exe <enter>
- c) Check the build version on IVReport starting screen as shown below:

- d) If the build number is 61097-IVS-20966, the newer build should be applied as a remediation.

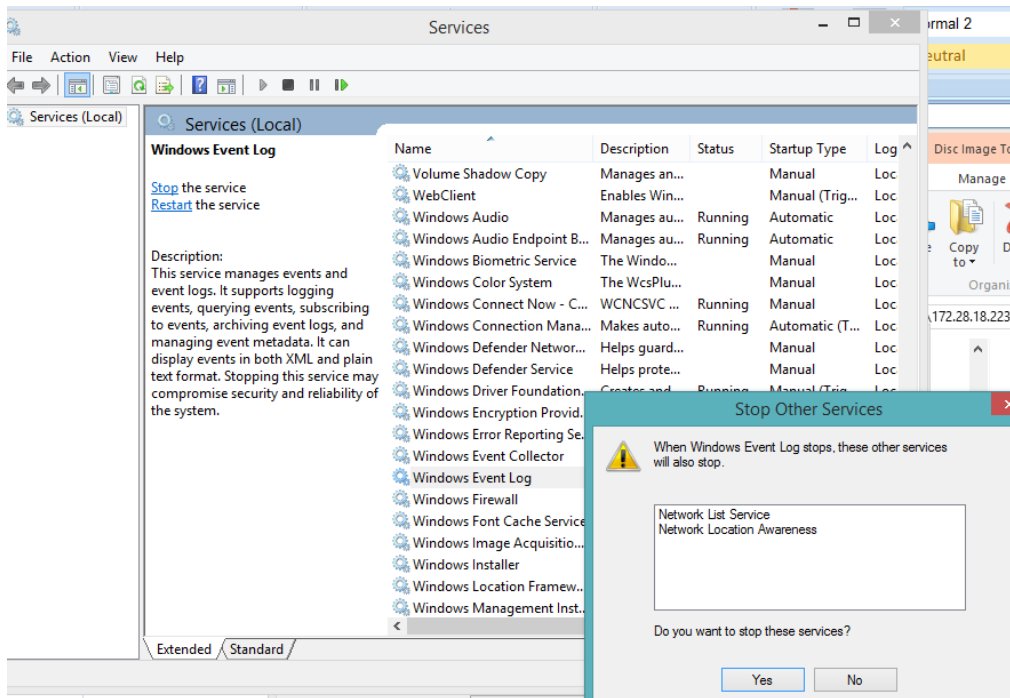
7. Additional steps in case installation fails due to mysqld.exe being used by another process:
  - a) Start "Services" (click on Windows menu and type "services").
  - b) Scroll down to "Windows Event Log", right click and choose to Stop this service. In case the "Stop Other Services" window pops up, click on the "yes" button (see the picture below).

After hotfix installation (step 6. ) is complete, right click on the Windows Event Log service and select “Start”.
