## Motorola Solutions Technical Notification (MTN)

**TITLE:** "NAND" flash devices may not initialize or mount properly, which may cause a variety of symptoms on HP DL3x0 Servers

**TECHNOLOGY:** All ASTRO releases in the RNI and CEN using HPE DL380 Gen8 and Gen9 servers

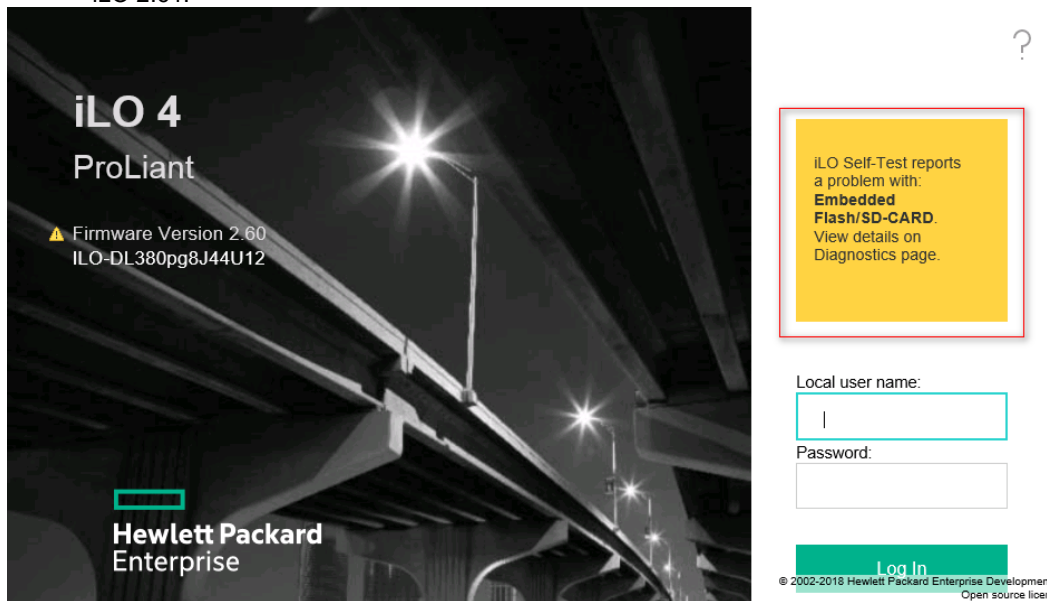
- f. "Embedded Media initialization failed due to media write-verify test failure"
6. Intelligent Provisioning will not execute when selecting F10.
7. A yellow splash window appears on the iLO interface. The example is from iLO 2.60, but is essentially the same for iLO 2.61.

HPE has confirmed that the problem is a hardware level issue, where the system board contains a non-replaceable memory chip, which reaches a read/write cycle limit after multiple reads and writes.

1. Shut down virtual machines
2. Shut down server (completely power off the server)
3. Unplug power cords
4. Wait around 5 minutes
5. Plug in the power cords
6. Power up the server

- If **WORKAROUNDS AND CORRECTIVE ACTIONS** section does not resolve the issue and the server will not boot, upgrade using HPE Firmware DVD from PARTS REQUIRED Section.
- If after applying the HPE Firmware DVD and the issues / symptoms still persist contact SSC at 1-800-221-7144 .
