Motorola Solutions Technical Notification (MTN)

TITLE: Audio lost on (Gen1) GTR8000 channels during long calls

TECHNOLOGY: ASTRO 25 Trunking/Conventional

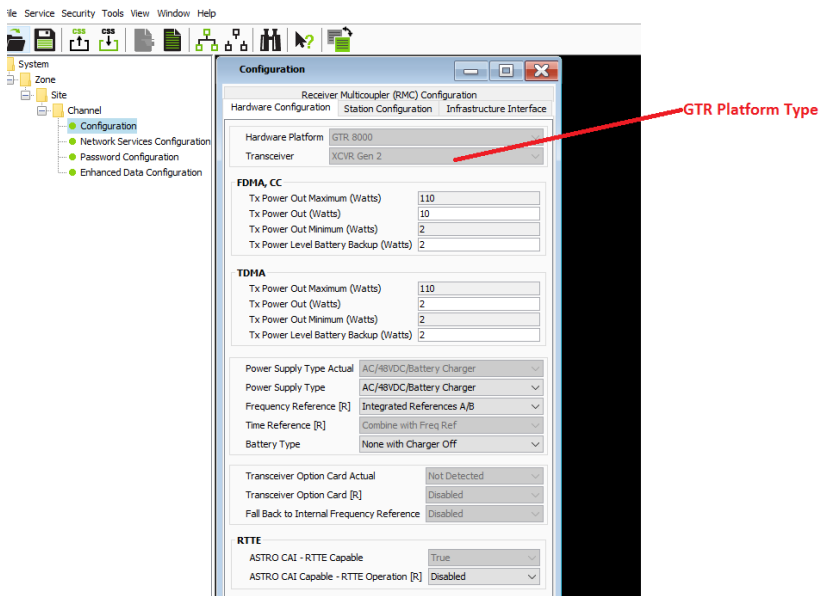
[192.168.1.1] CSS - ASTRO®25 Repeater Site Base Radio

Identifying hardware type form CSS:

After reading the device with CSS, click on Configuration in the left navigation pane. In the Configuration window which appears, click on the Hardware Configuration tab. The second field ("Transceiver") will have the value "XCVR Gen 1" for GTR 8000 Gen1 equipment. See Figure below.
