DOCUMENT NUMBER:	MTN-0055-25
ISSUE DATE:	2025-04

Motorola Solutions Technical Notification (MTN)

Antenna connector on **DVR-LX Vehicle Mount Cross-Band, DVR-LX Vehicle Mount In-Band and VRX1000 In-Band** may be threaded improperly

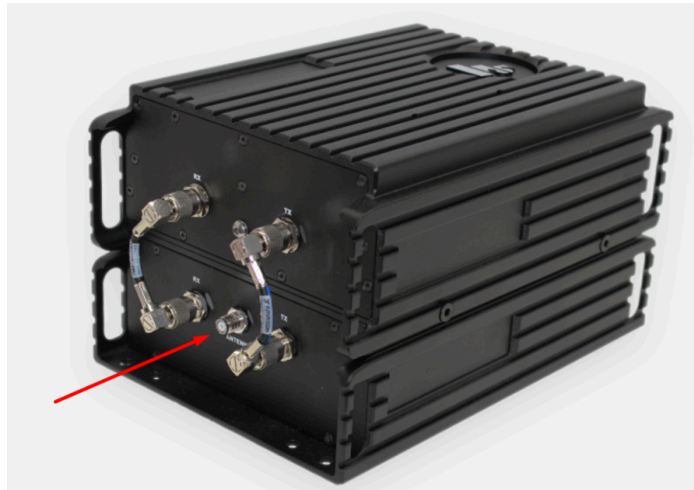
This connector connects the duplexer of the DVR-LX or VRX with the antenna. The thread on the bad connector is not threaded deep enough. As a result, the male connector (on the antenna) cannot fully thread onto the defective female connector (on the duplexer) and the connection is not tightly mated.

During install, a good connector allows the technician to thread the collar all the way in but a bad connector only allows for approximately 3 or less partial turns. One way to identify the collar is not fully seated is to push and pull the coax cable. A good collar will not allow the coaxial cable to move away from the faulty female connector.

1. If the technician notices any concerns while connecting the antenna to the duplexer during install, please call 1-800-MSI-HELP and asking for TSO ASTRO Devices technical support to raise a RMA
