Motorola Solutions Technical Notification (MTN)

TITLE: MOTOTRBO R7 having Error 679 after modifying configuration from firmware upgrade via Wifi

TECHNOLOGY: MOTOTRBO™ R7

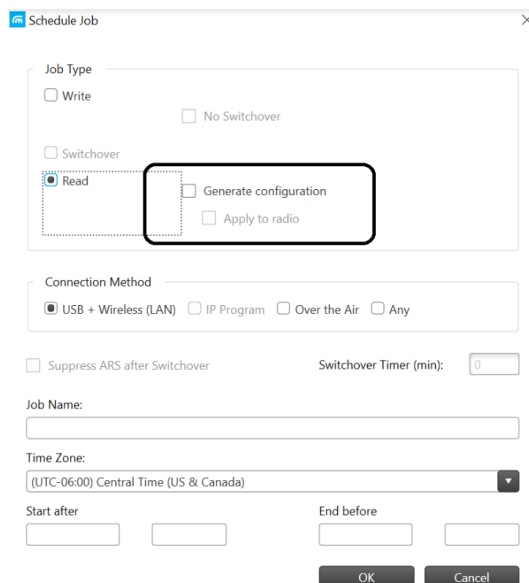
When using Radio Management (RM) tool to write a configuration to an R7 radio which has previously been upgraded via Wifi programming method, the job will fail and RM will prompt “Error #679 Failed to Write to the device. The device may have been modified outside of the managed database. Please schedule a read operation.” message.

This is due to the discrepancy of the Software Update Management (SUM) date between the value stored in RM and the device software.

Perform and schedule a READ job without the generation of the configuration as shown in the snapshot below:

After performing the READ job, reassign the original configuration and perform WRITE job to the impacted radio.
