KS-20472 BELLCELL* BATTERY VISUAL INSPECTION PROCEDURE

SECTION 157-629-702

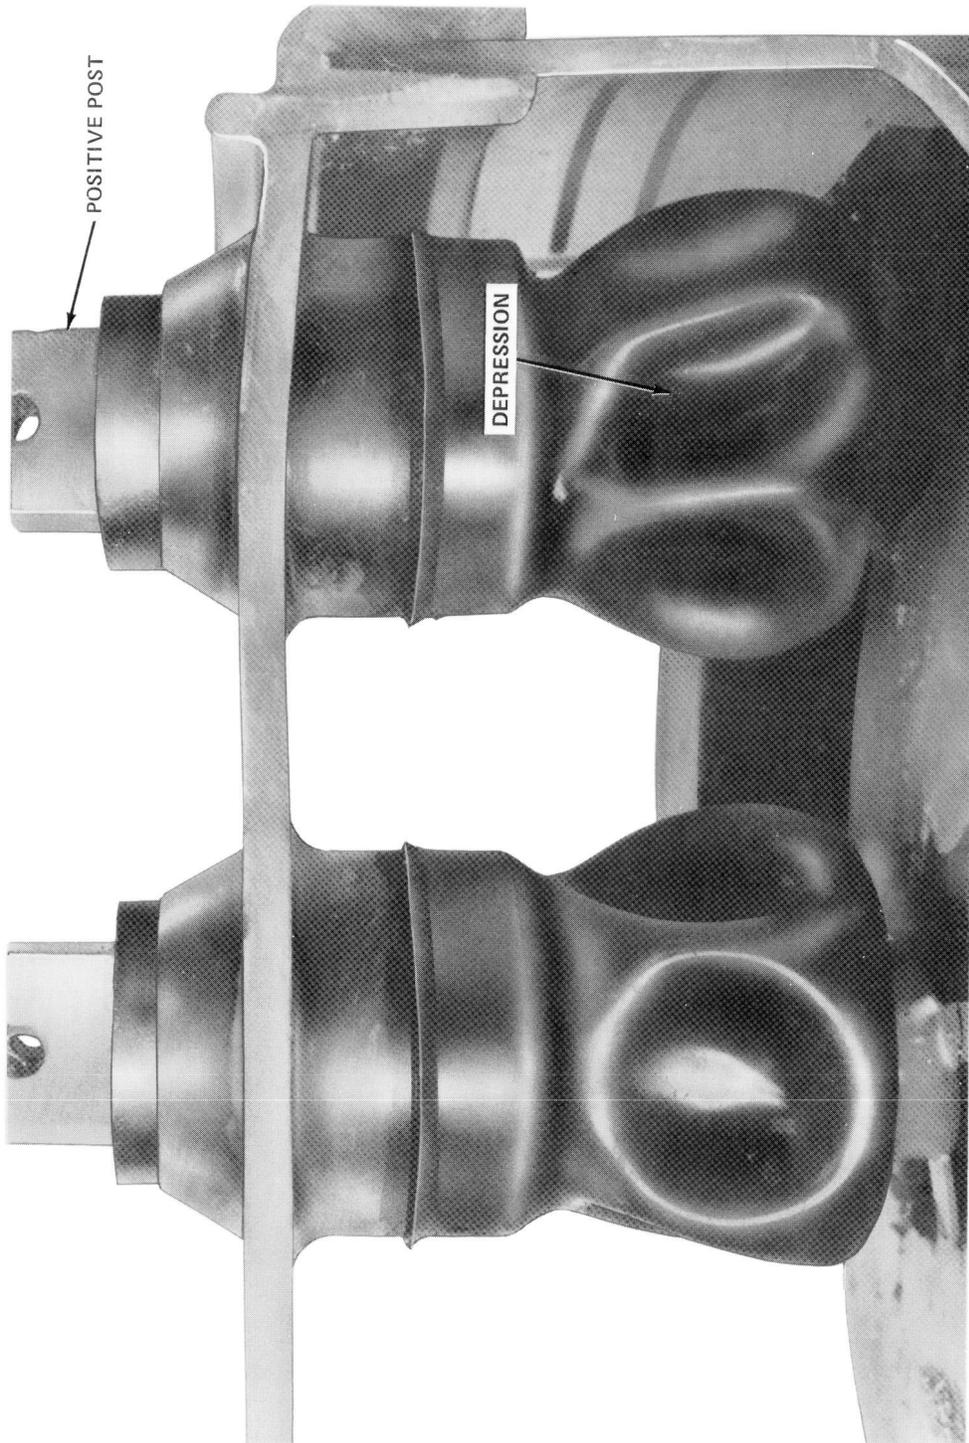
4.03 As the corrosion increases, broken particles and powder can start to fill up the boot. Techniques for assembling the post seals in manufacture are such that the boot section of the rubber sleeve will usually have depressions in it. These depressions are shown in Fig. 6. On positive posts, with severely defective seals, the accumulation of corrosion product expands the rubber boot such that the depressions disappear. This is shown in Fig. 7 where no depressions exist in the boot of the positive post seal. Depressions still exist in the negative post boot since corrosion does not occur on the negative post. Sometimes the boot section is inflated because of air pressure inside the boot. Accordingly, it is necessary to probe the boot with the tip of the hook in order to differentiate between corrosion and air. If air fills the boot, it will be flexible. If corrosion fills the boot, it will be hard and should not be lifted.

Fig. 6—Cell Post Boots Showing Normal Depression

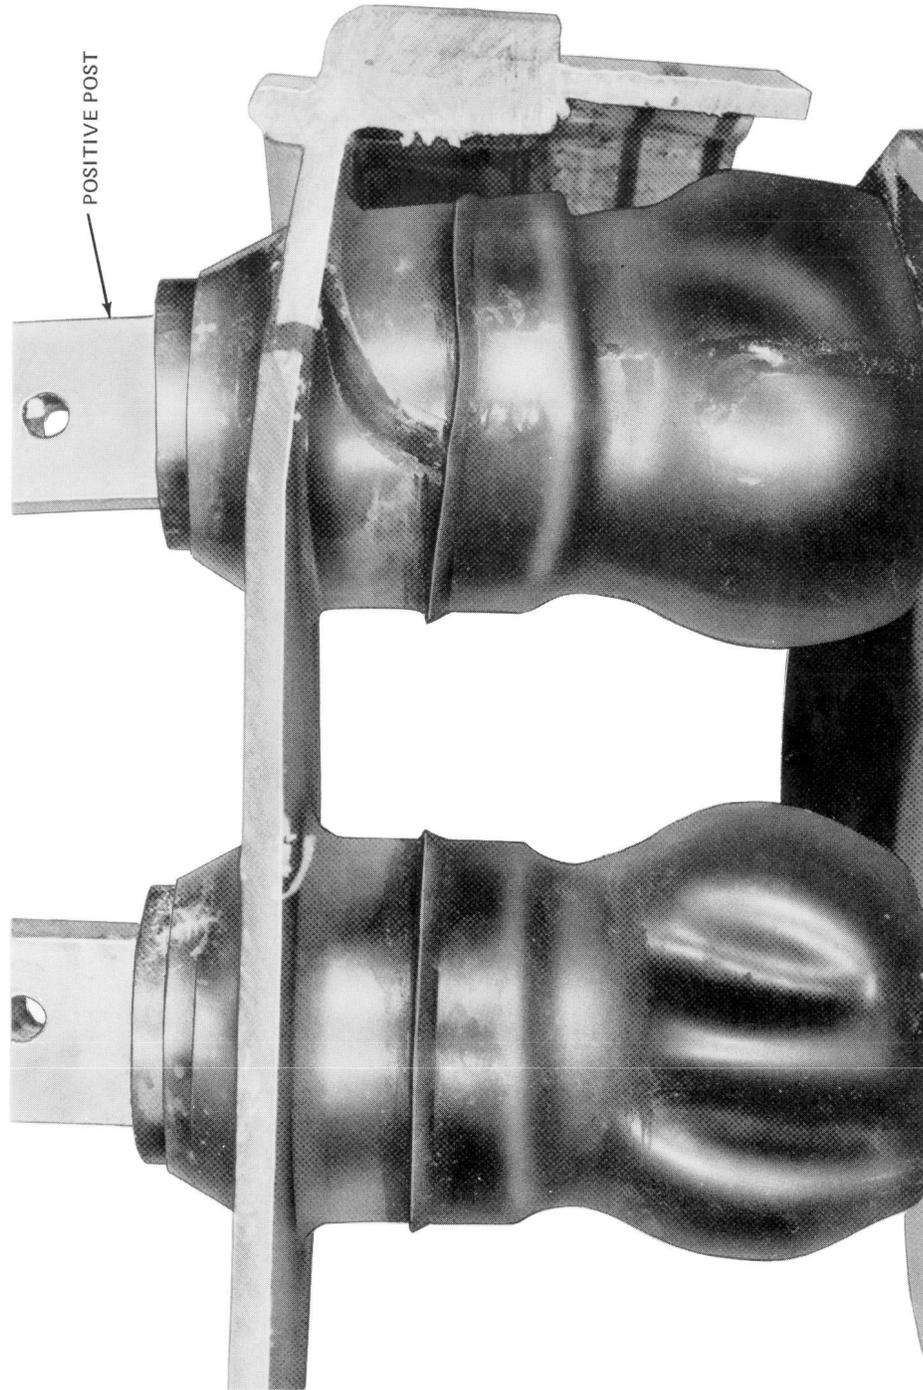
has reason to believe that a higher rating exists. Swollen boot or heavy debris under the post would justify a 4 or 5 rating.

Fig. 7 —Cell Posts Showing Swollen Boot Due to Post Corrosion

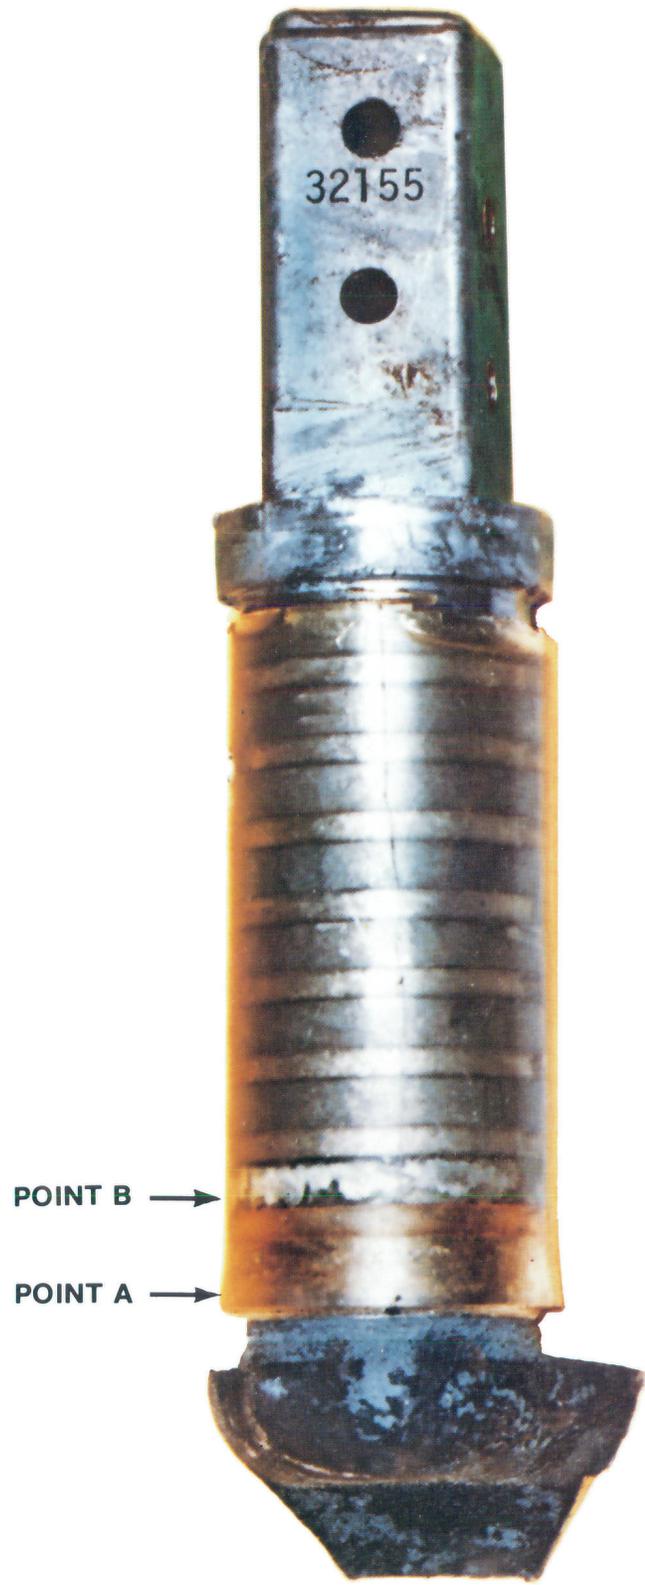
| RATING | DESCRIPTION (SEE NOTE) | EXAMPLES |
|---|---|---|
| 1 | No visible corrosion | Fig. 8 Fig. 9, Point E |

8.06 The amber color of the epoxy shown in Fig. 8, Point A, and Fig. 9, above Point D is normal for this type of epoxy.

8.07 The white and black areas under the epoxy shown in Fig. 8, Point B; and Fig. 10; Fig. 12, Point B; and Fig. 15, below Point C are the result of acid creepage up the epoxy/lead interface and are not indications of post corrosion.

Fig. 8—Rating 1—Normal Post (No Corrosion)

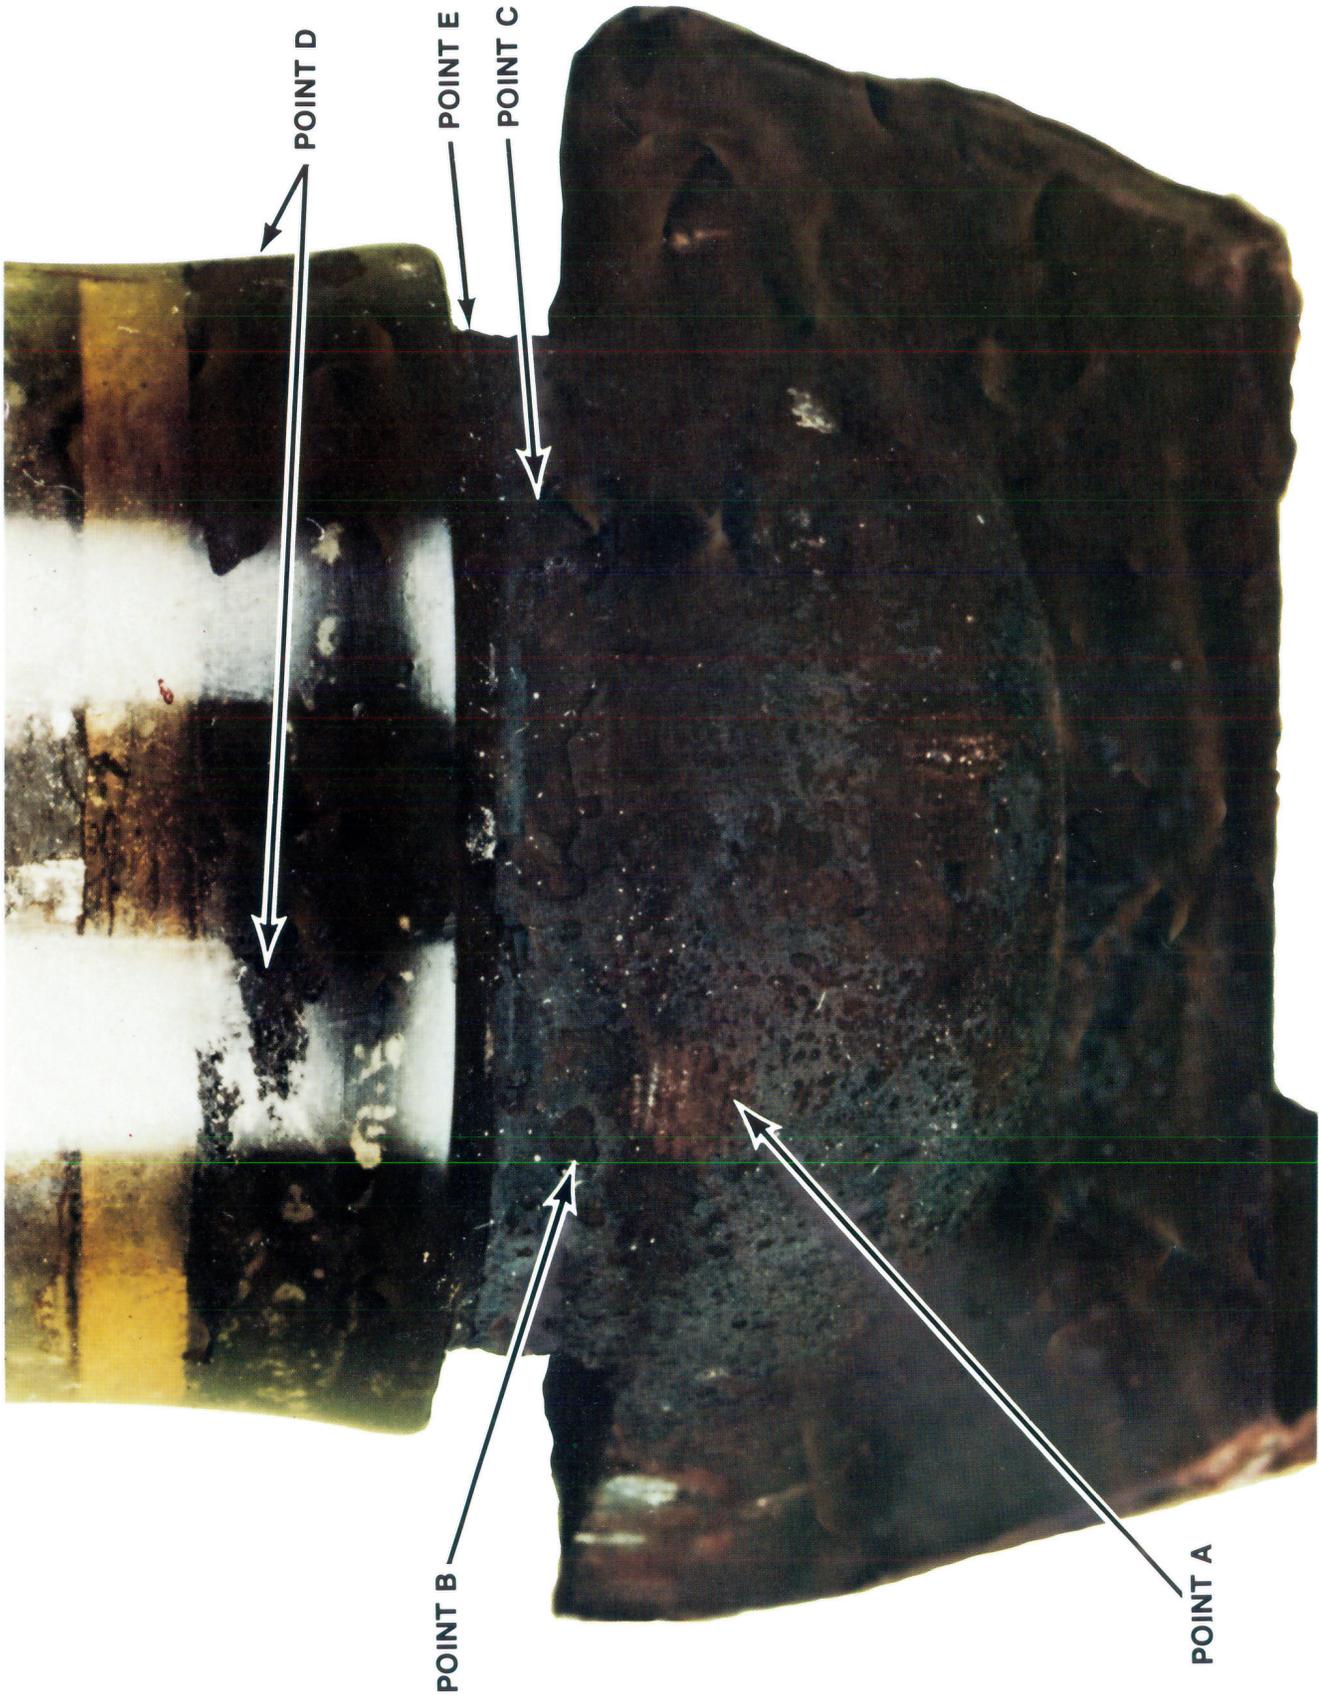
8.02 Unless otherwise stated, all references to the lead or lead post refer to the epoxy/lead interface on the positive post. See Fig. 9, Point E.

8.04 On some cells, the lead post will have craters or an irregular surface (Fig. 9, Points A, B, and C) which is the result of the post flaking. These

surface conditions should not be mistaken for corrosion. Cells which have these surface conditions will have brown debris (not powder) on top of the white cap under the post. Do not confuse this debris with the powder debris described under corrosion rating 3.

8.05 Some cells examined will have a black butyl adhesive material on the lead post, and on or under the epoxy (Fig. 9, Point D; Fig. 10, Point A; and Fig. 11, Point B). This butyl material should not be confused with post corrosion.

Fig. 9—Rating 1—Typical Close-Up

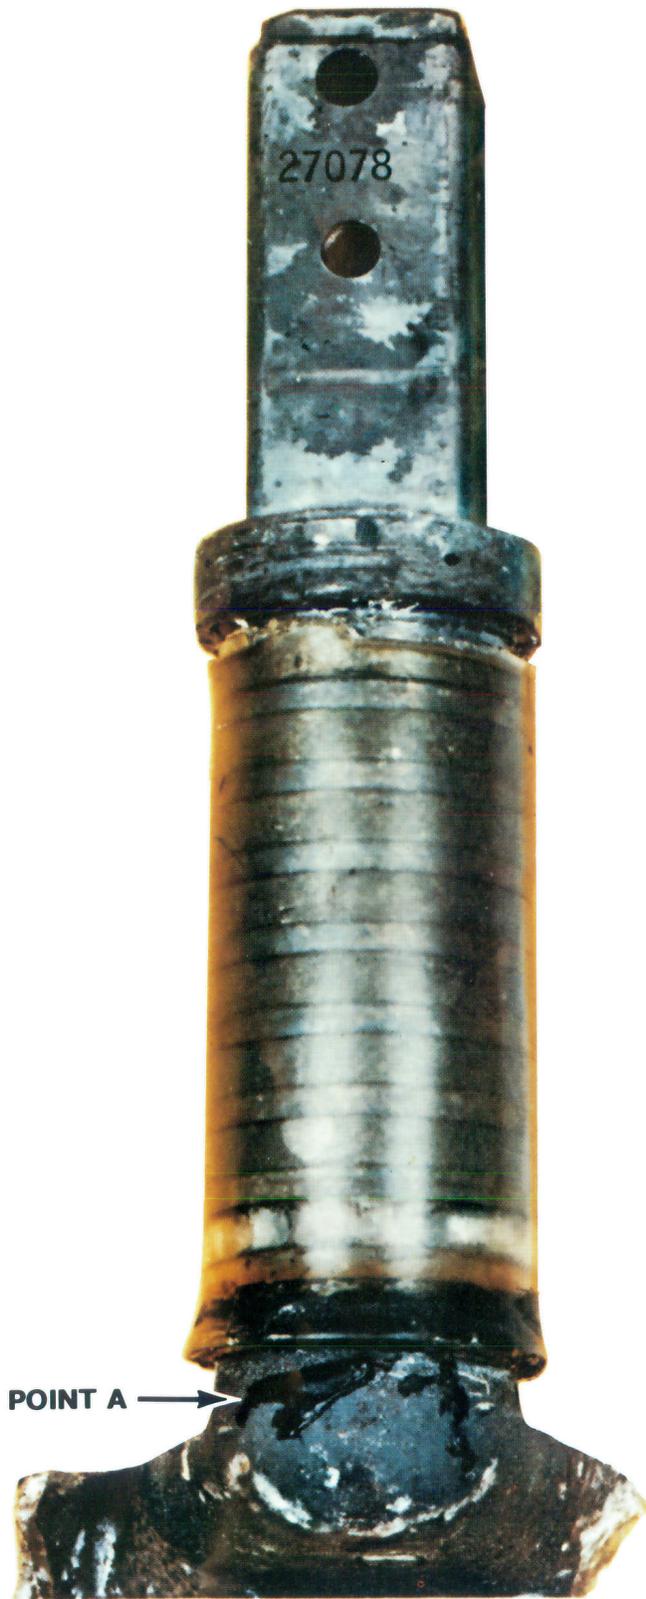
Fig. 10—Rating 1—With Butyl Adhesive

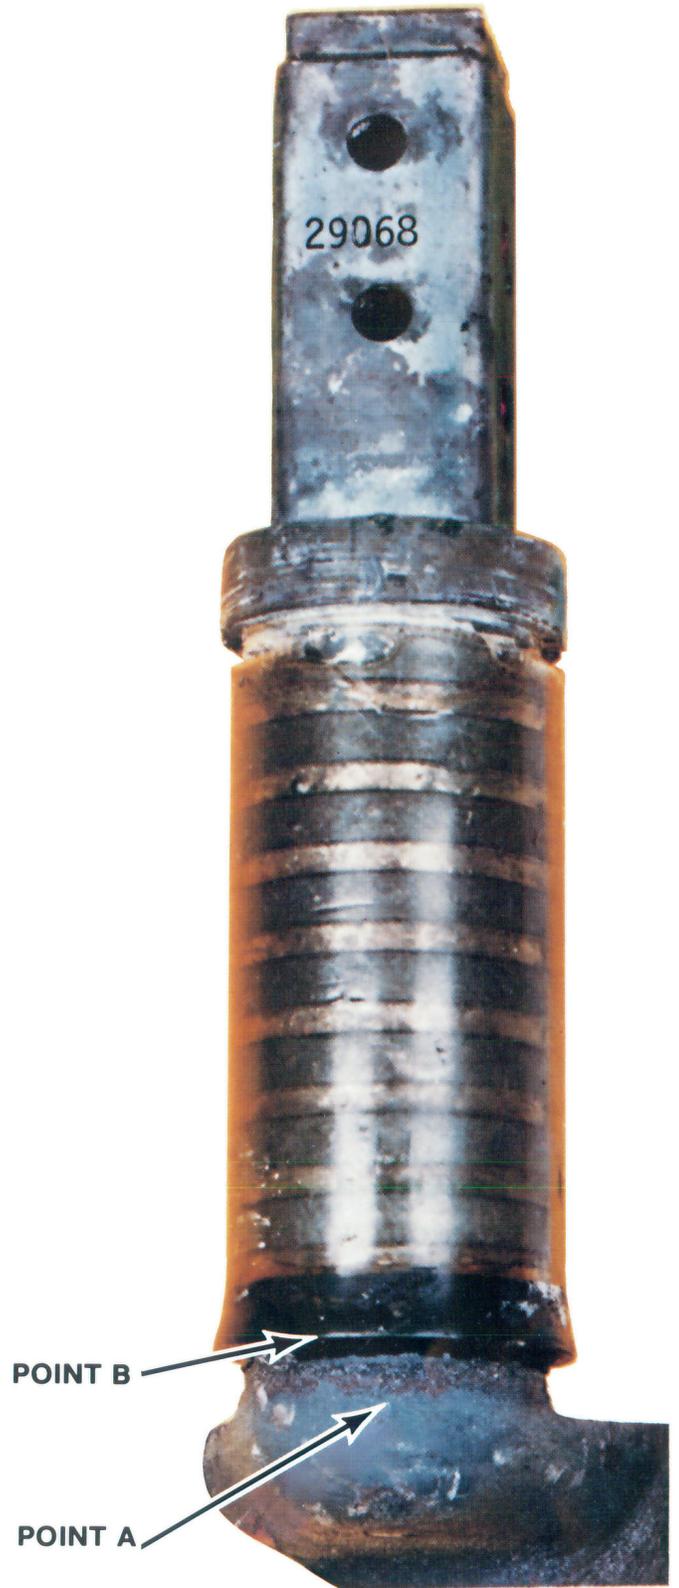
8.08 The irregularity on the lead post (Fig. 11, Point A) and on the lower edge of the epoxy (Fig. 12, Point A) should not be confused with post corrosion.

Fig. 11—Rating 1—With Butyl Adhesive Under Epoxy

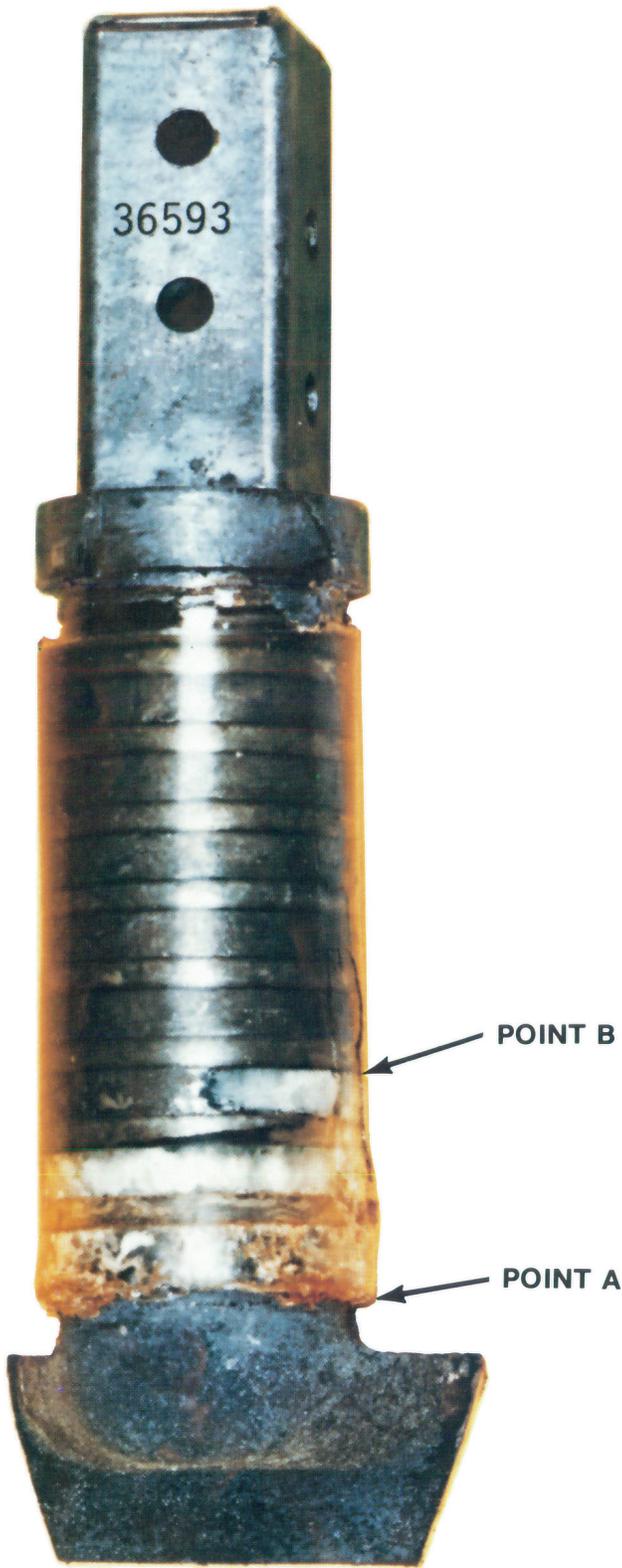
Fig. 12—Rating 1—With Distorted Epoxy

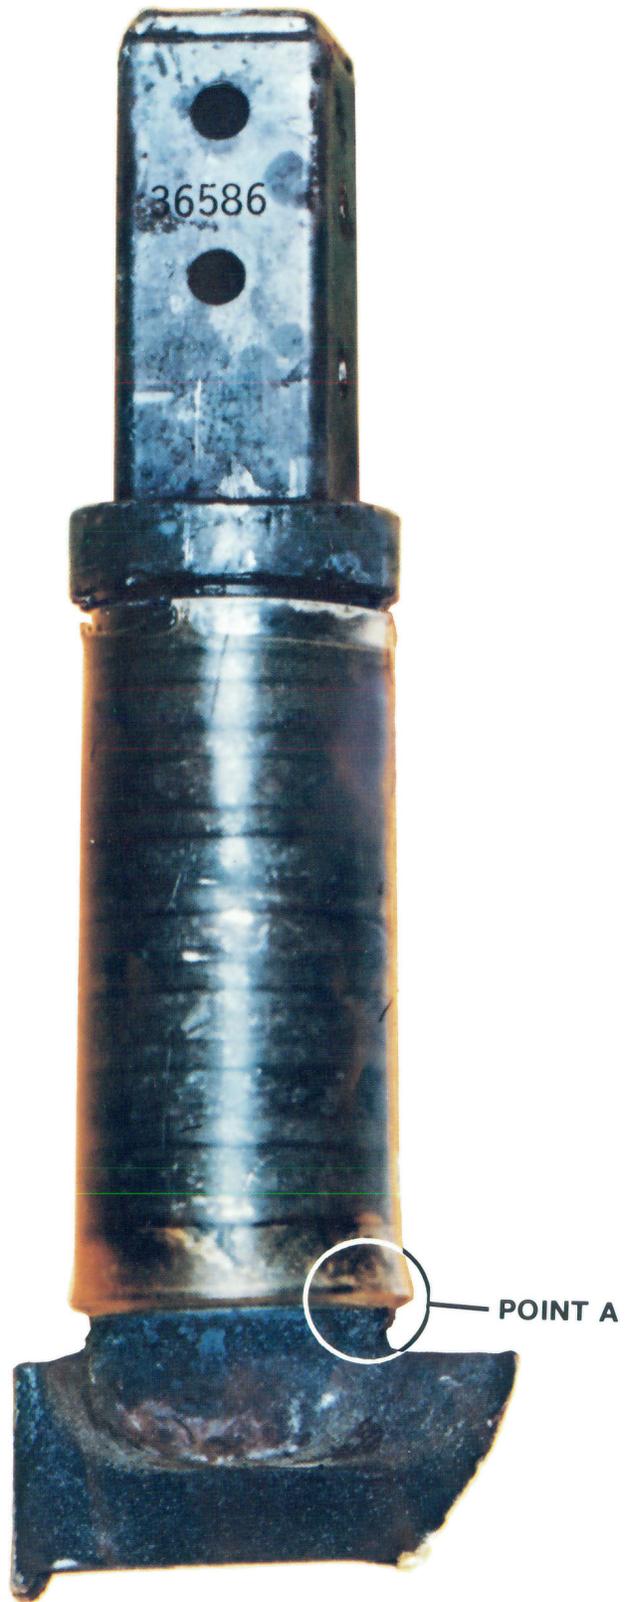
| RATING | DESCRIPTION (SEE NOTE) | EXAMPLES |
|---|---|---|
| | (f) Swelling centered at edge of epoxy (approximately 1/8-inch high, 1/2-inch diameter) | Fig. 13, Point A |

Fig. 13—Rating 3—Swelling at Edge of Epoxy

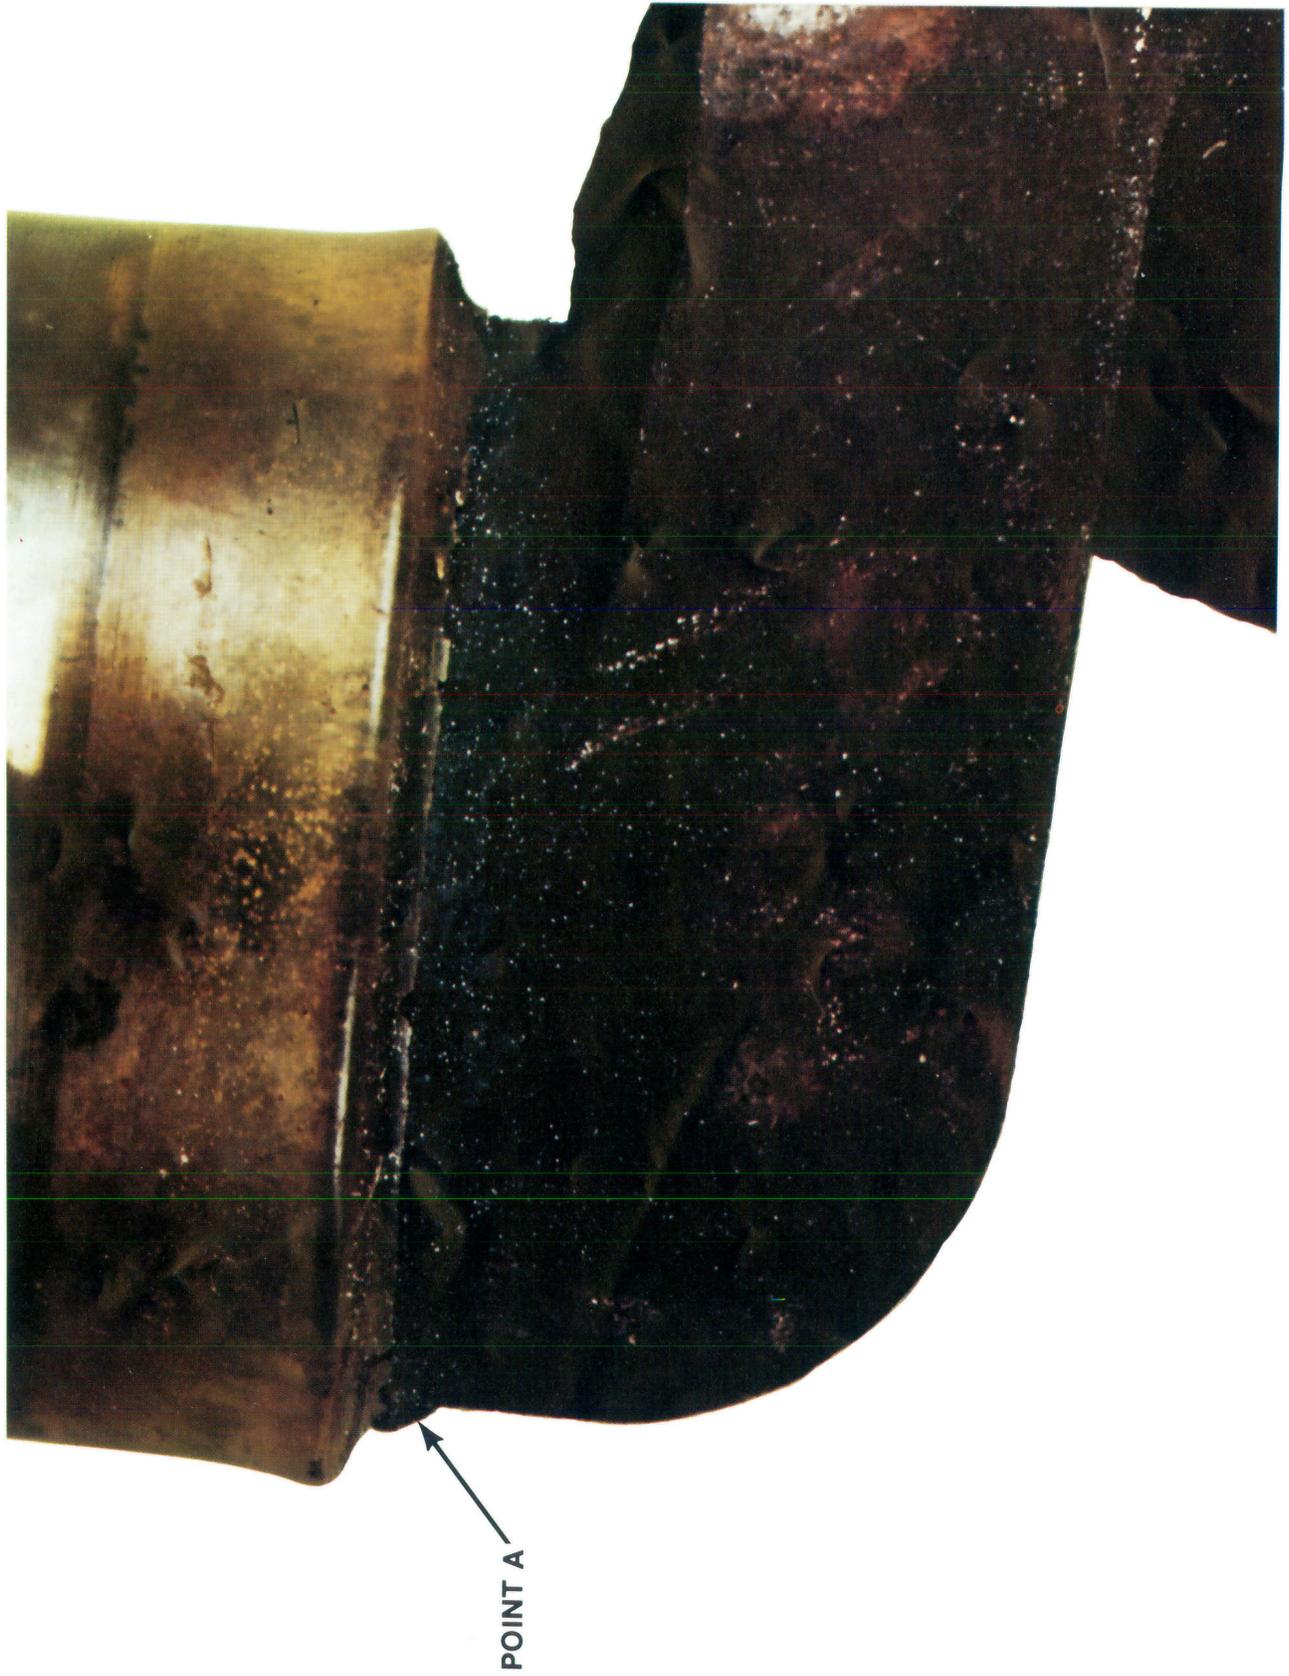
| RATING | DESCRIPTION (SEE NOTE) | EXAMPLES |
|---|---|---|
| 2 | (a) Slight blisters or swelling visible on lead (less than 1/8-inch diameter) | Fig. 14, Point A |

Fig. 14—Rating 2—Close-Up

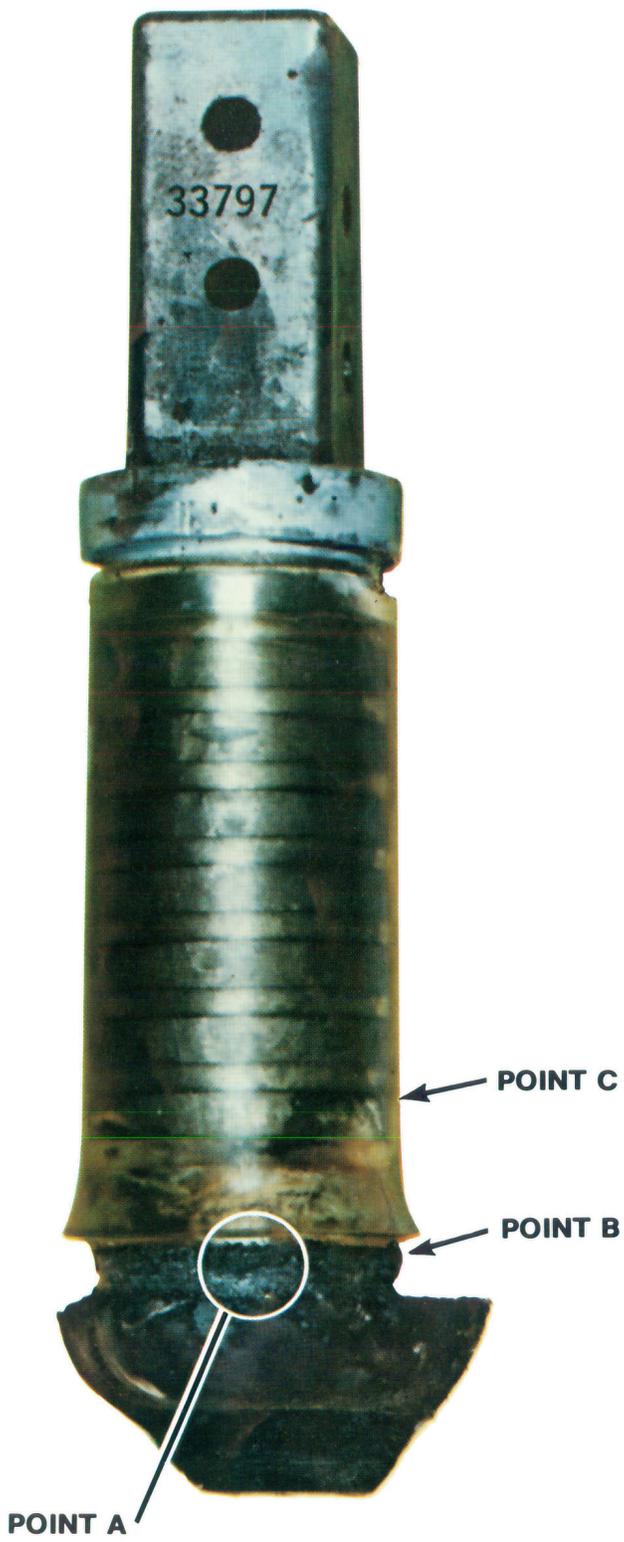
| RATING | DESCRIPTION (SEE NOTE) | EXAMPLES |
|---|---|---|
| 3 | (a) Blisters or swelling visible on lead (greater than 1/8-inch diameter) | Fig. 15, Point B |
| | (b) Small to medium size eruptions on lead | Fig. 15, Point A Fig. 18, Points A and C |

Fig. 15—Rating 3—With Two Corrosion Sites

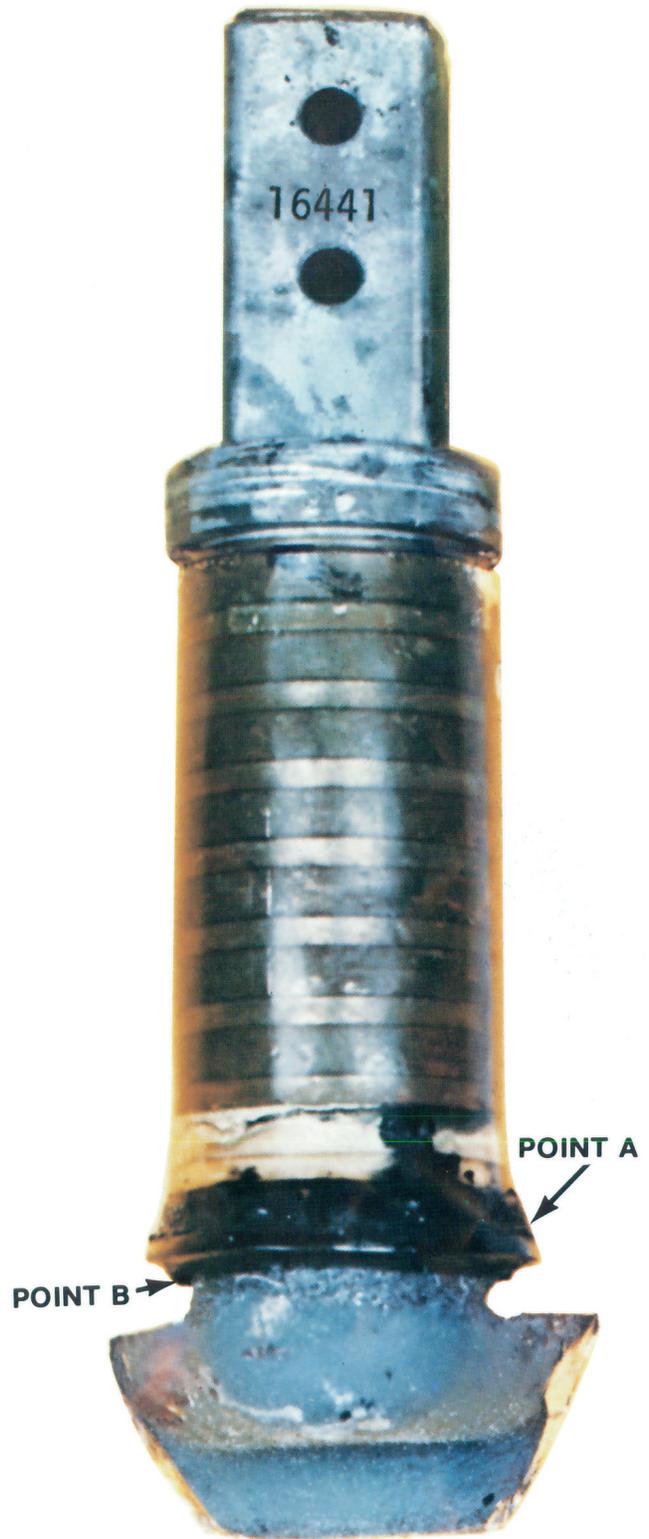
| RATING | DESCRIPTION (SEE NOTE) | EXAMPLES |
|---|---|---|
| | (d) Medium degree of flaring or pullaway of epoxy at the bottom edge of the epoxy column | Fig. 16, Points A and B |

Fig. 16—Rating 3—With Epoxy Flare

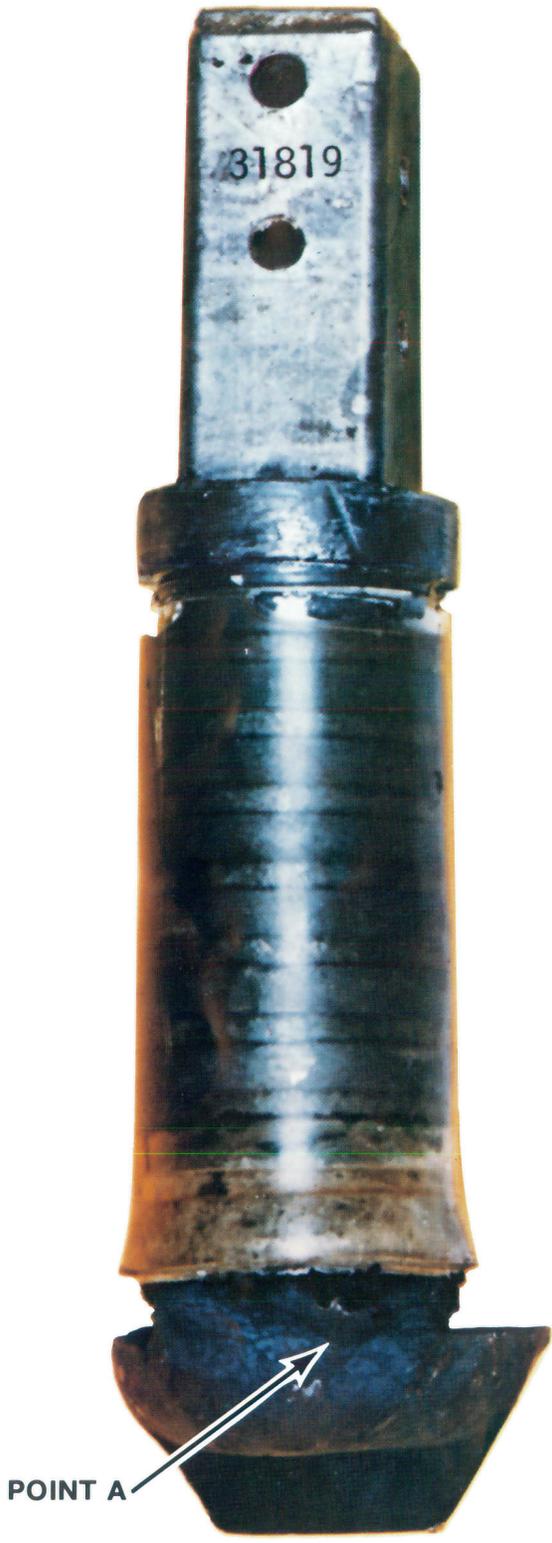
| RATING | DESCRIPTION (SEE NOTE) | EXAMPLES |
|---|---|---|
| | (c) Worst case of Class 3 type eruption | Fig. 17, Point A |

Fig. 17—Rating 3—Worst Case

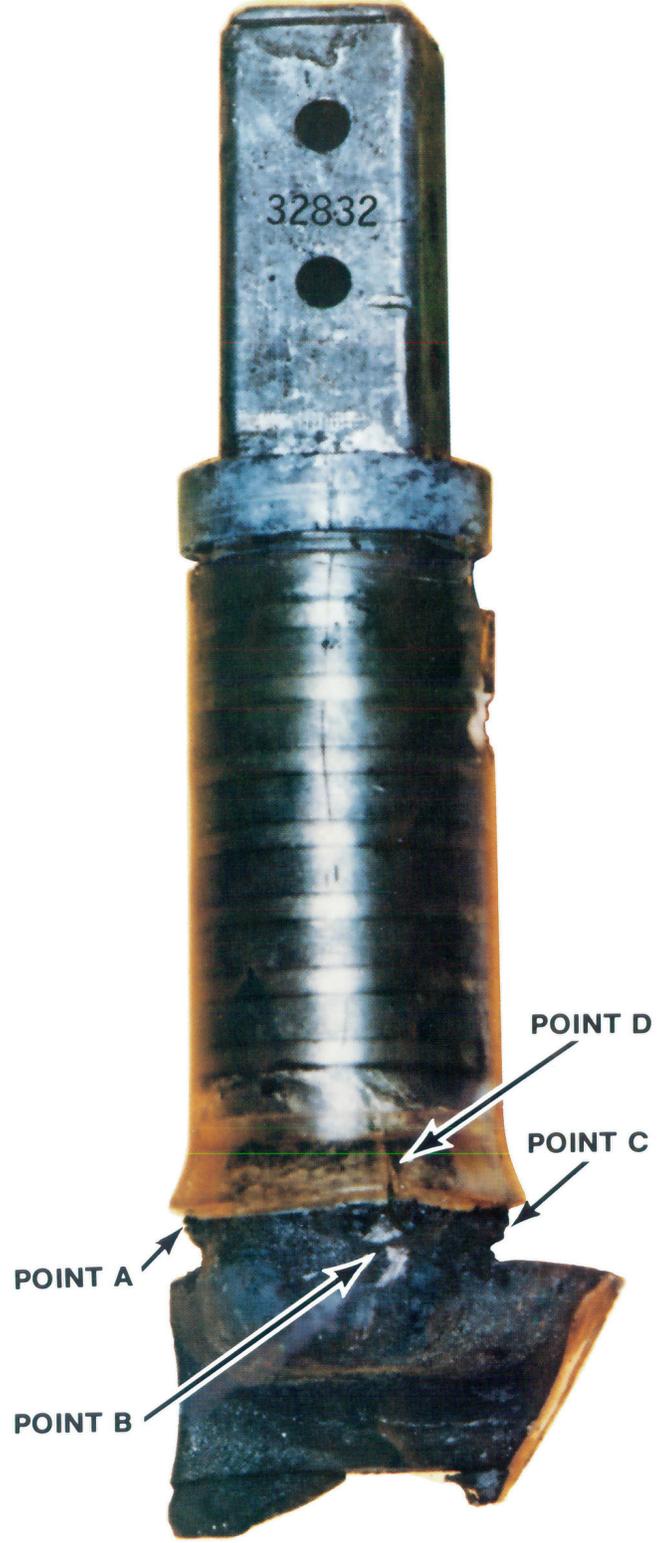
| RATING | DESCRIPTION (SEE NOTE) | EXAMPLES |
|---|---|---|
| 4 | (a) Epoxy cracked, caused by corrosion at Point B on Fig. 18 and 20 | Fig. 18, Point D Fig. 20, Point A |

Fig. 18—Rating 4—Typical

6.01 Place a defective cell label on all defective Class 4 and 5 cells (see Fig. 3). An Engineering Complaint should be filed to obtain replacement of all Class 4 and 5 cells. Copies of the replacement Visual Inspection Report Form should be attached to the Engineering Complaint.

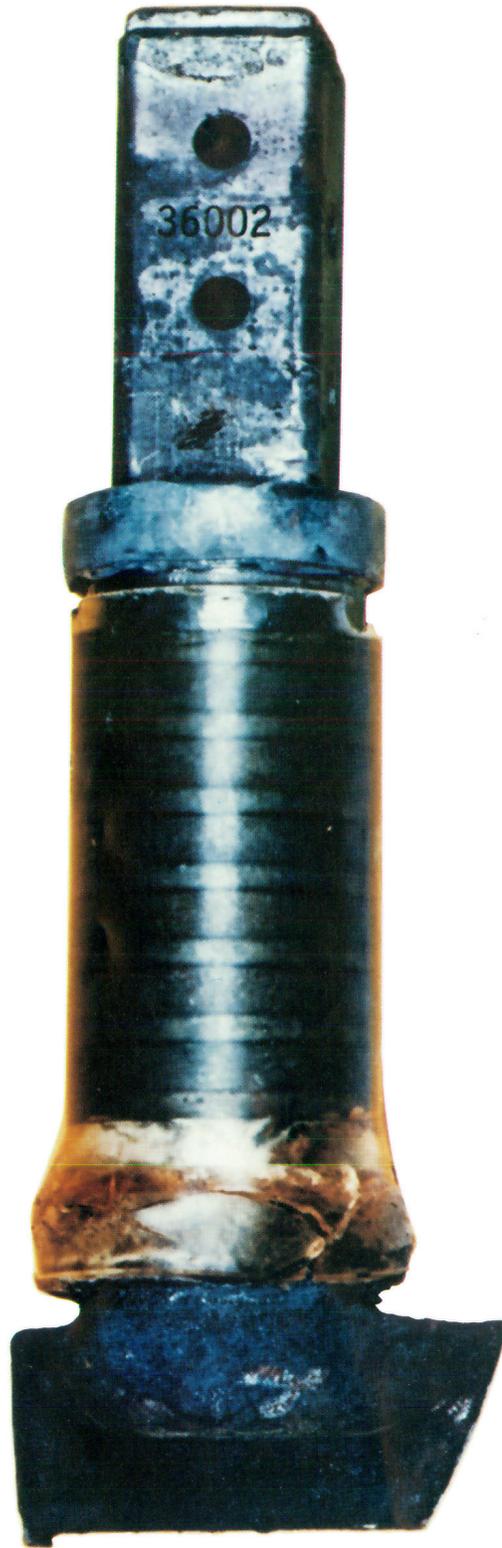
| RATING | DESCRIPTION (SEE NOTE) | EXAMPLES |
|---|---|---|
| | (b) Epoxy deteriorated (Note how epoxy has both vertical and horizontal cracks and appears to be falling off post) | Fig. 19 |
| | (d) Lower portion of epoxy appears severely swollen (flared), due to corrosion under epoxy | Fig. 19 |

Fig. 19—Rating 4—Deteriorated Epoxy

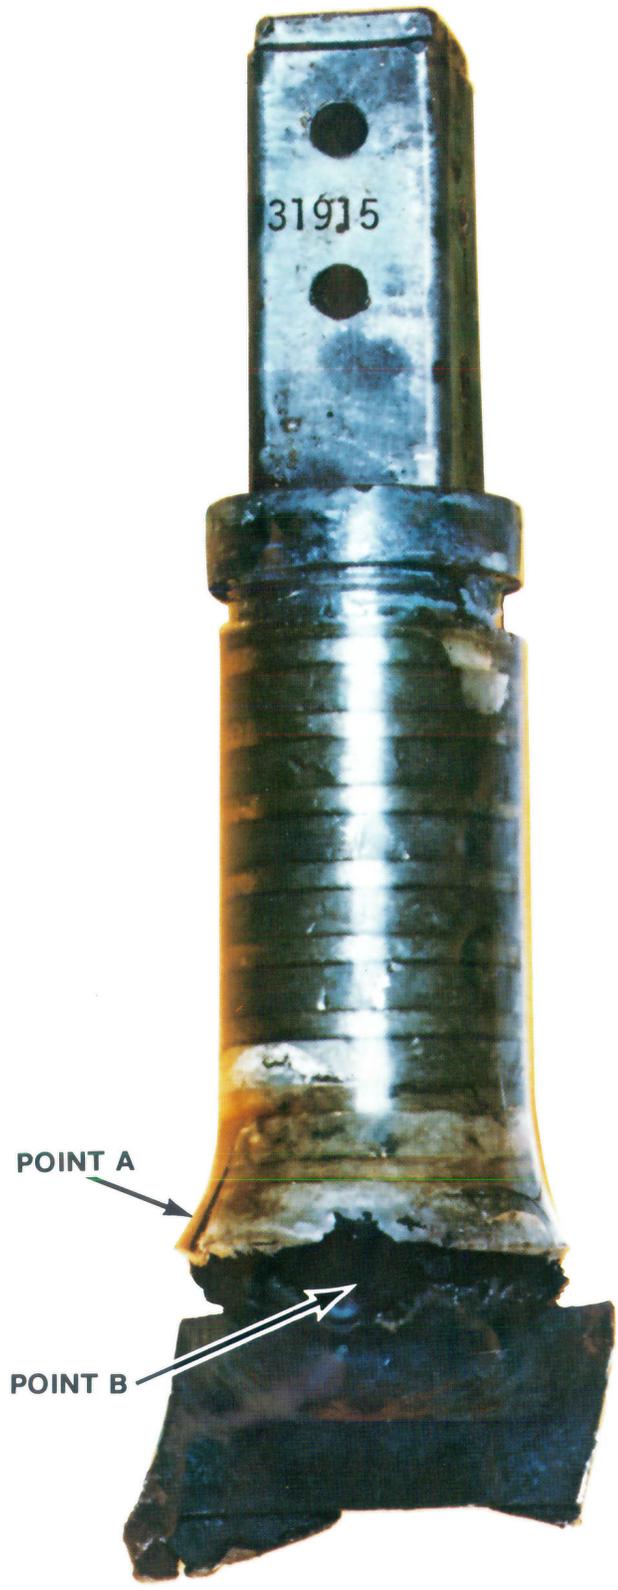
| RATING | DESCRIPTION (SEE NOTE) | EXAMPLES |
|---|---|---|
| | (c) Large portion of lead post is corroded | Fig. 20, Point B |

Fig. 20—Rating 5—Typical
