Installation Engineering Handbook 269
Western Electric
Northern Illinois Works

TM 5.084
Dated: 4/01/81
Expiration Date 1/01/82

TEMPORARY MEMORANDUM
FOR NO. 3 ESS
REPAIR OF DEFECTIVE SOLDER
CONNECTIONS ON FB372
JUNCTOR CIRCUIT PACKS

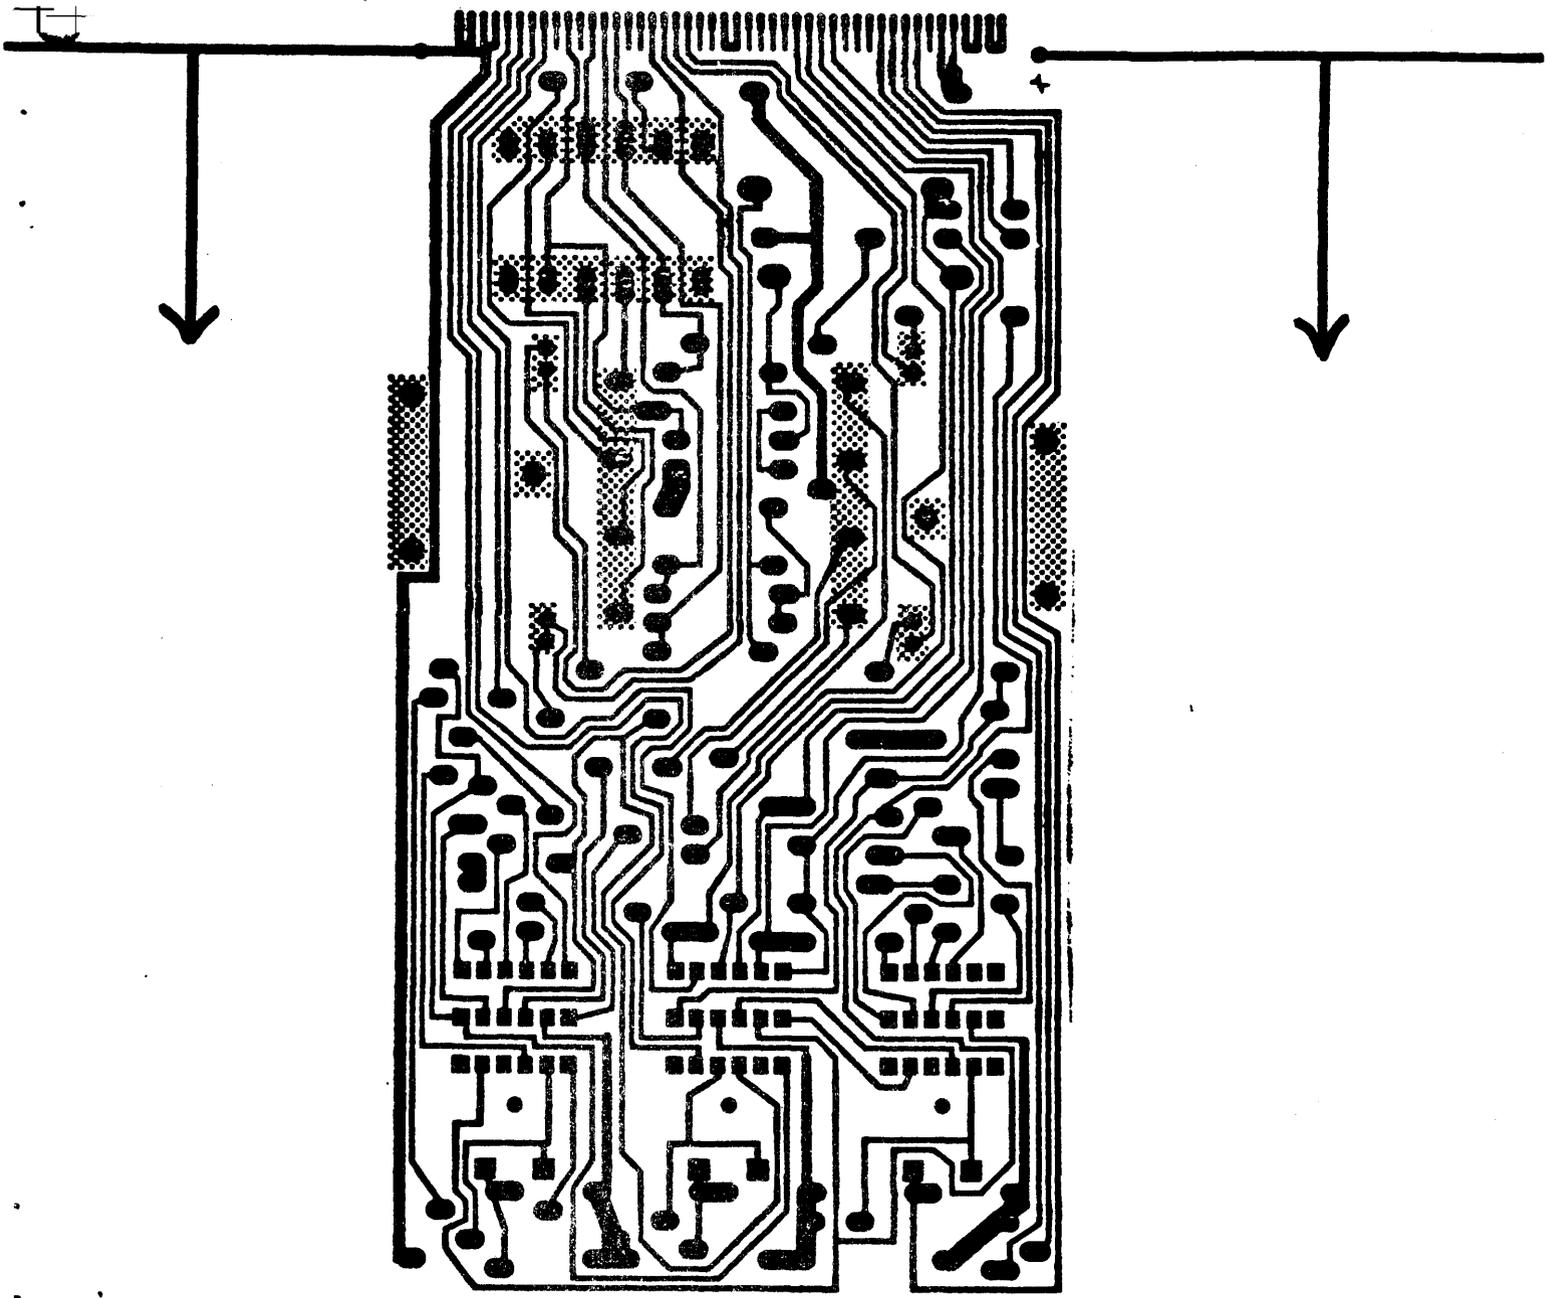
1.1 Trouble reports from the operating companies indicate that excessive numbers of FB372 Junctor Circuit Packs are failing during operation. This is causing problems with supervision and/or transmission due to defective solder connections on the printed wire boards of the circuit packs. The defect is caused by cracking of the solder in the printed wiring boards.

1.3 Specific instructions as to which components are to be resoldered are given in the template attached to this TM as Appendix A.

3.1 Refer to the template. All connections below the dotted line are to be resoldered.

3.2 Carefully heat the terminals and add enough solder to the connection to obtain a satisfactory fillet of solder surrounding the entire terminal. It should not be necessary to heat the terminal more than 3-4 seconds. Remember that applying too much heat to the terminal will overheat the printed wire land area and destroy its adhesive bond to the board or cause internal damage to the component.

3.4 To show that the junctor has been repaired according to procedures outlined in this TM, stamp 3/16-inch black plus sign (+) on the middle BF59 relay (K-2) coil so the plus sign is viewable when the pack is in service.
