**APPARATUS AFFECTED:** All ASR 33 Teletypewriter-Sets (Power Pack Assembly and Tape Reader).

**REASON:** Interim Change - To prevent possible damage to the rectifier diode bridge of the power pack assembly when the tape reader feed magnet terminals are accidentally shorted to ground.

Appendix 1, Section 574-100-401, Issue 4  
Teletypewriter Change Notice  
TCN 1140 Issue 3  
February, 1971

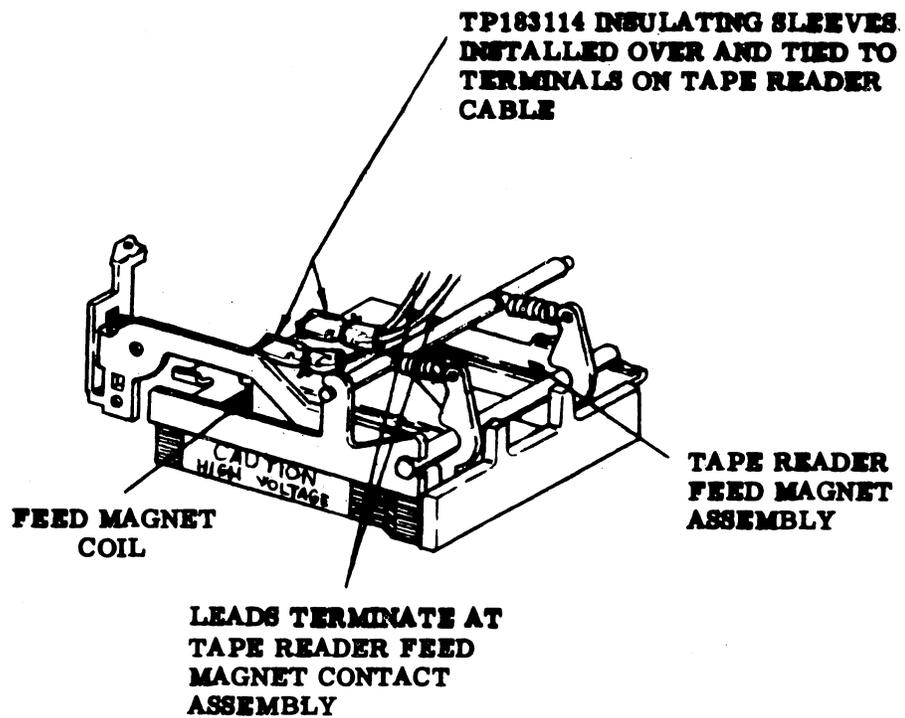
Attached Sheet 1

(1B) On the tape reader cable, the two terminals on the two leads that connect to the 277M magnet coil (part of the tape reader feed magnet assembly) are covered with 3/4-inch long heat shrink tubing. See SUPPLEMENTAL INFORMATION (1).

**SUPPLEMENTAL INFORMATION:** (1) For field application, FINAL CHANGE (1B) can be effected by insulating the two terminals on the tape reader cable using two TP183114 insulating sleeves (3/4-inch long, flexible vinyl plastic tubing). To prevent the TP183114 insulating sleeve slipping back off the terminal, the sleeve should be tied to the terminal. See illustration on Attachment Sheet 1.
