TP183518 AND TP183519 SETS OF PARTS, TP182793 HEAT SINK PLATE
AND TP180000 CODE BAR BASKET

APPARATUS AFFECTED: 33A, 33A-1, 33A-2, 33A-3, 33A-4, 33B, 33C-1, 33C-2, 33C-3, 33C-4, 33C-5, 33D, 33D-1, 33D-2, 33D-3, 33D-4, 33E, 33F, 33F-1, 33F-2, 33F-3, and 33F-4 Teletypewriter-Sets.

OBJECT: To improve the operation of the teletypewriter-set by replacing and/or modifying old style parts.

SECTION 574-100-800.15

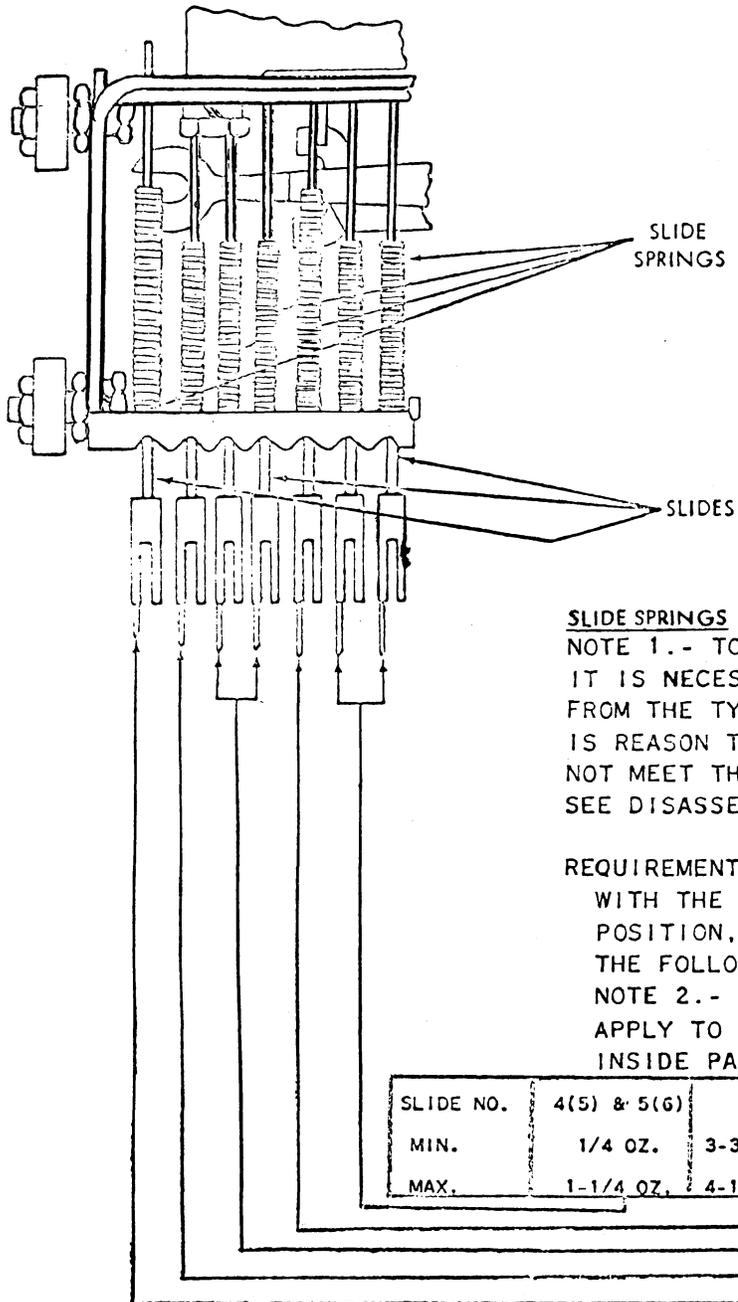
Fig. 2

WITH THE CARRIAGE POWER BAIL IN ITS STOP POSITION, TOWARDS THE FRONT, IT SHALL REQUIRE THE FOLLOWING TO START THE SLIDES MOVING.

NOTE 2.- SLIDE NUMBERS OUTSIDE PARENTHESIS APPLY TO 5 LEVEL TYPING UNITS. SLIDE NUMBERS INSIDE PARENTHESIS APPLY TO 8 LEVEL TYPING UNITS.

SLIDE NO.	4(5) & 5(6)	3(4)	1(2) & 2(3)	0(1)	P.S.*
MIN.	1/4 OZ.	3-3/4 OZS.	2 OZS.	1/4 OZ.	3-3/4 OZS.
MAX.	1-1/4 OZ.	4-1/2 OZS.	3 OZS.	1 OZ.	4-1/2 OZS.

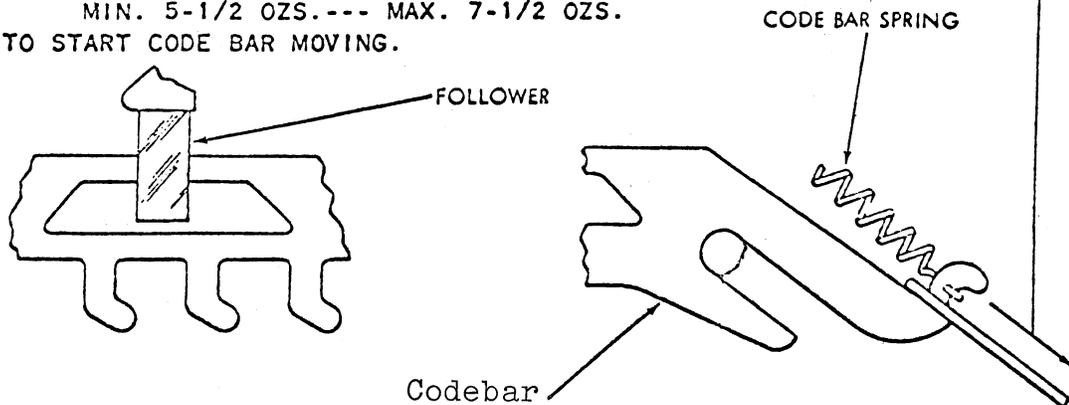
Fig. 3

PRINT SUPPRESSION AND NO.3* (4) CODE BAR SPRING
 REQUIREMENT

WITH PRINTER IN STOP CONDITION AND NO.3* (4)
 CODE BARS FOLLOWER ON CARRIAGE LIFTED.

MIN. 12 OZS. --- MAX. 14OZS.

CODE BAR SPRINGS

MIN. 5-1/2 OZS. --- MAX. 7-1/2 OZS.

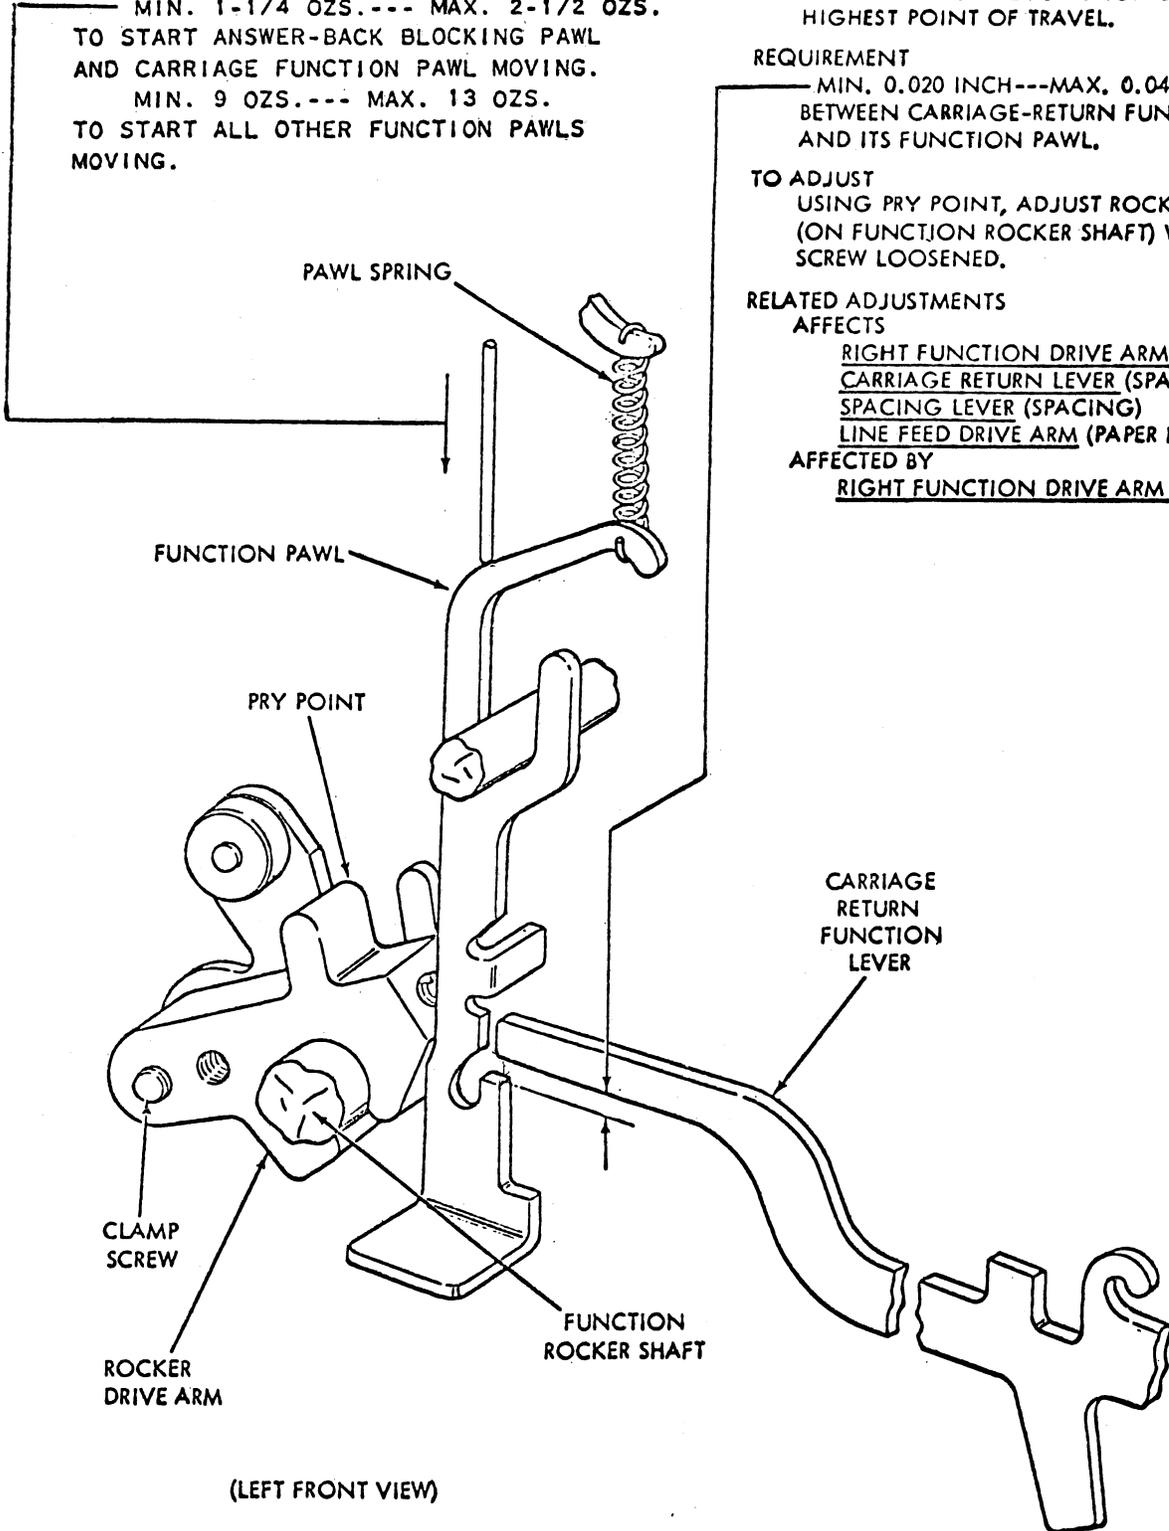
Fig. 4

**FUNCTION PAWL SPRING (FUNCTION)
REQUIREMENT:**

MIN. 1-1/4 OZS.--- MAX. 2-1/2 OZS.
TO START ANSWER-BACK BLOCKING PAWL AND CARRIAGE FUNCTION PAWL MOVING.
MIN. 9 OZS.--- MAX. 13 OZS.
TO START ALL OTHER FUNCTION PAWLS MOVING.

LEFT ROCKER DRIVE ARM (FUNCTION)

MIN. 0.020 INCH---MAX. 0.040 INCH BETWEEN CARRIAGE-RETURN FUNCTION LEVER AND ITS FUNCTION PAWL.

USING PRY POINT, ADJUST ROCKER DRIVE ARM (ON FUNCTION ROCKER SHAFT) WITH CLAMP SCREW LOOSENED.

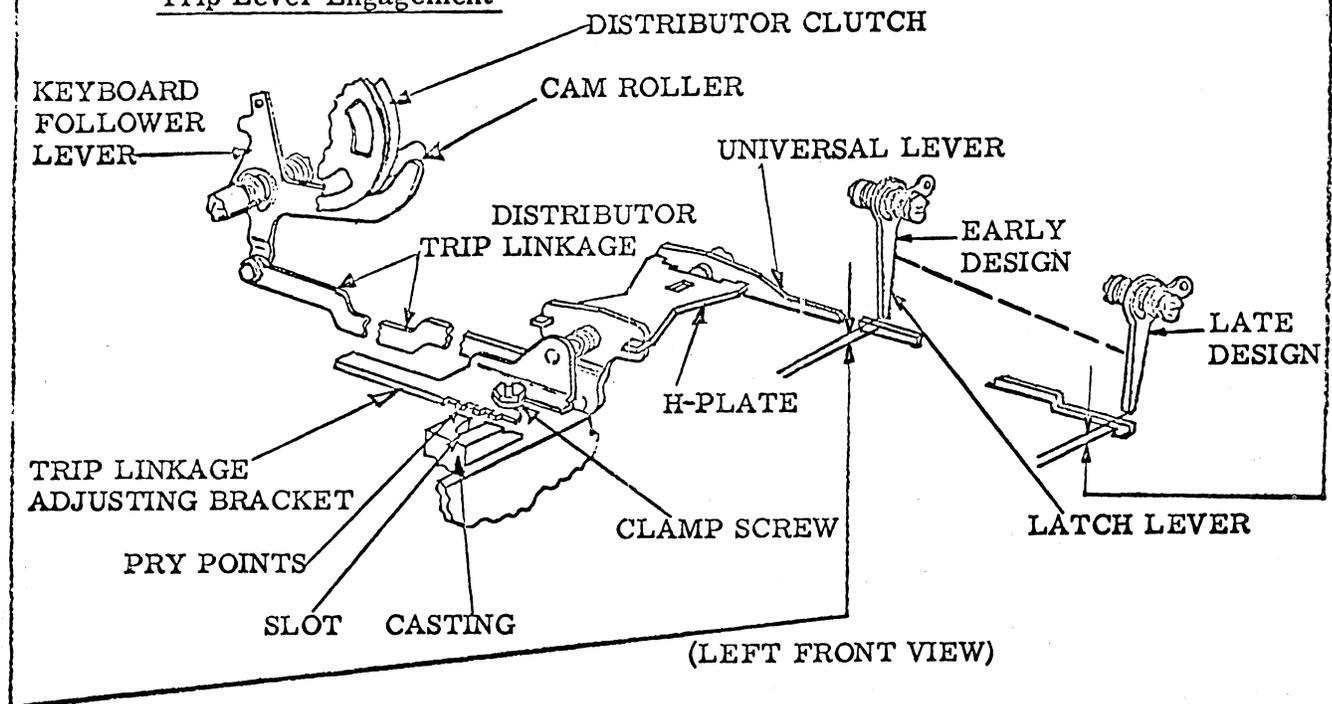
Fig. 5

Distributor Trip Linkage

Early design keyboards with universal lever 180086 :

Min. 0.010 inch---Max. 0.035 inch
between latch lever and universal lever.

Late design keyboards with universal lever 182240 :

Min. 0.010 inch---Max. 0.040 inch
between latch lever and universal lever.

With clamp screw loosened, position trip linkage adjusting bracket using slot in casting and pry points.

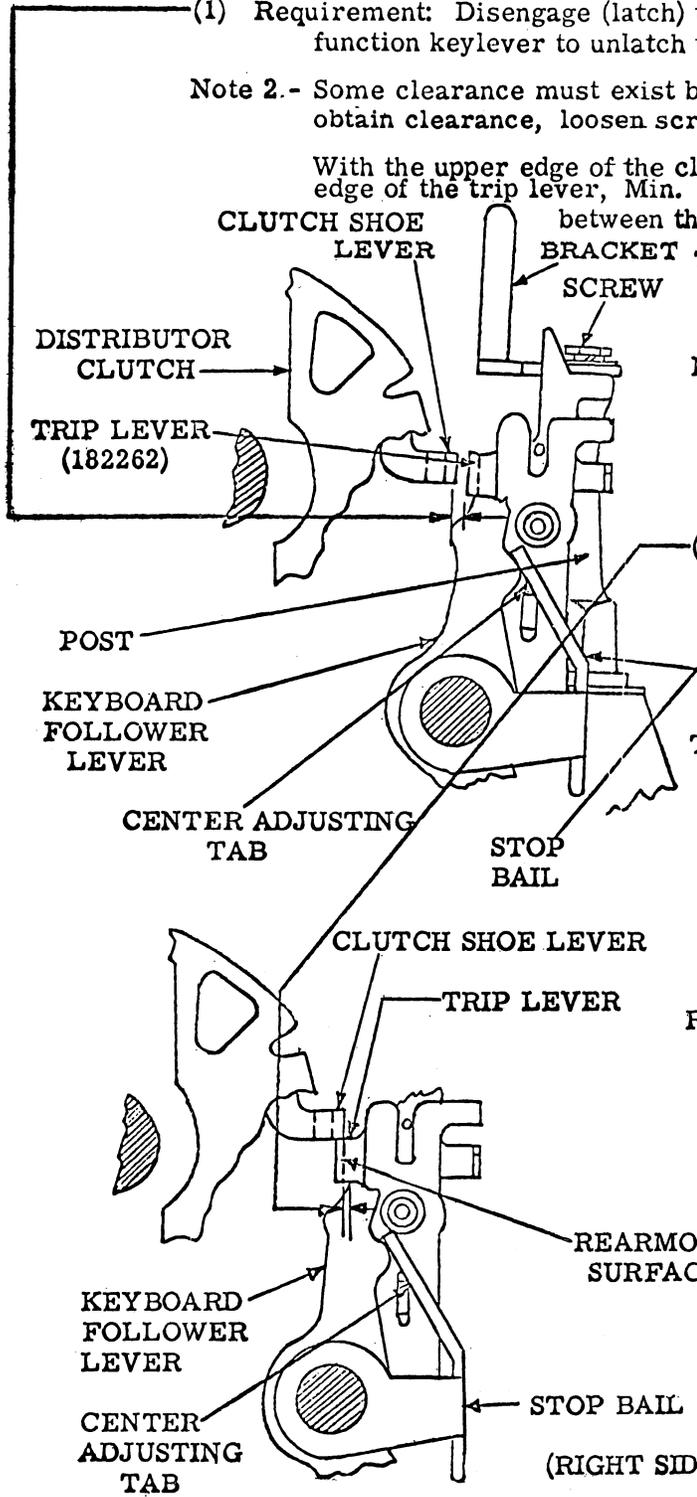
Fig. 6

Trip Lever Engagement

Note 1 - Requirement (1) applies only to printers of late design equipped with the 182262 trip lever.

With the upper edge of the clutch shoe lever in line with the upper edge of the trip lever, Min. 0.015 inch---Max. 0.035 inch, clearance between the clutch shoe lever and the trip lever.

(2) Requirement: With the printer operating under power and the keyboard universal lever in the latched position, the clutch shoe lever shall be Min. flush---Max. 0.015 inch beyond the rearmost surface of the trip lever.

To Adjust: Remove the answer-back drum. Bend the center adjusting tab with bending tool 180993. Replace answer-back drum.

To Adjust: Late design printers with the 182262 trip lever, with screw loosened friction tight, position bracket.

Early design printers without the 182262 trip lever, remove answer-back drum. Bend center adjusting tab with bending tool 180993. See note 3 above. Replace answer-back drum.

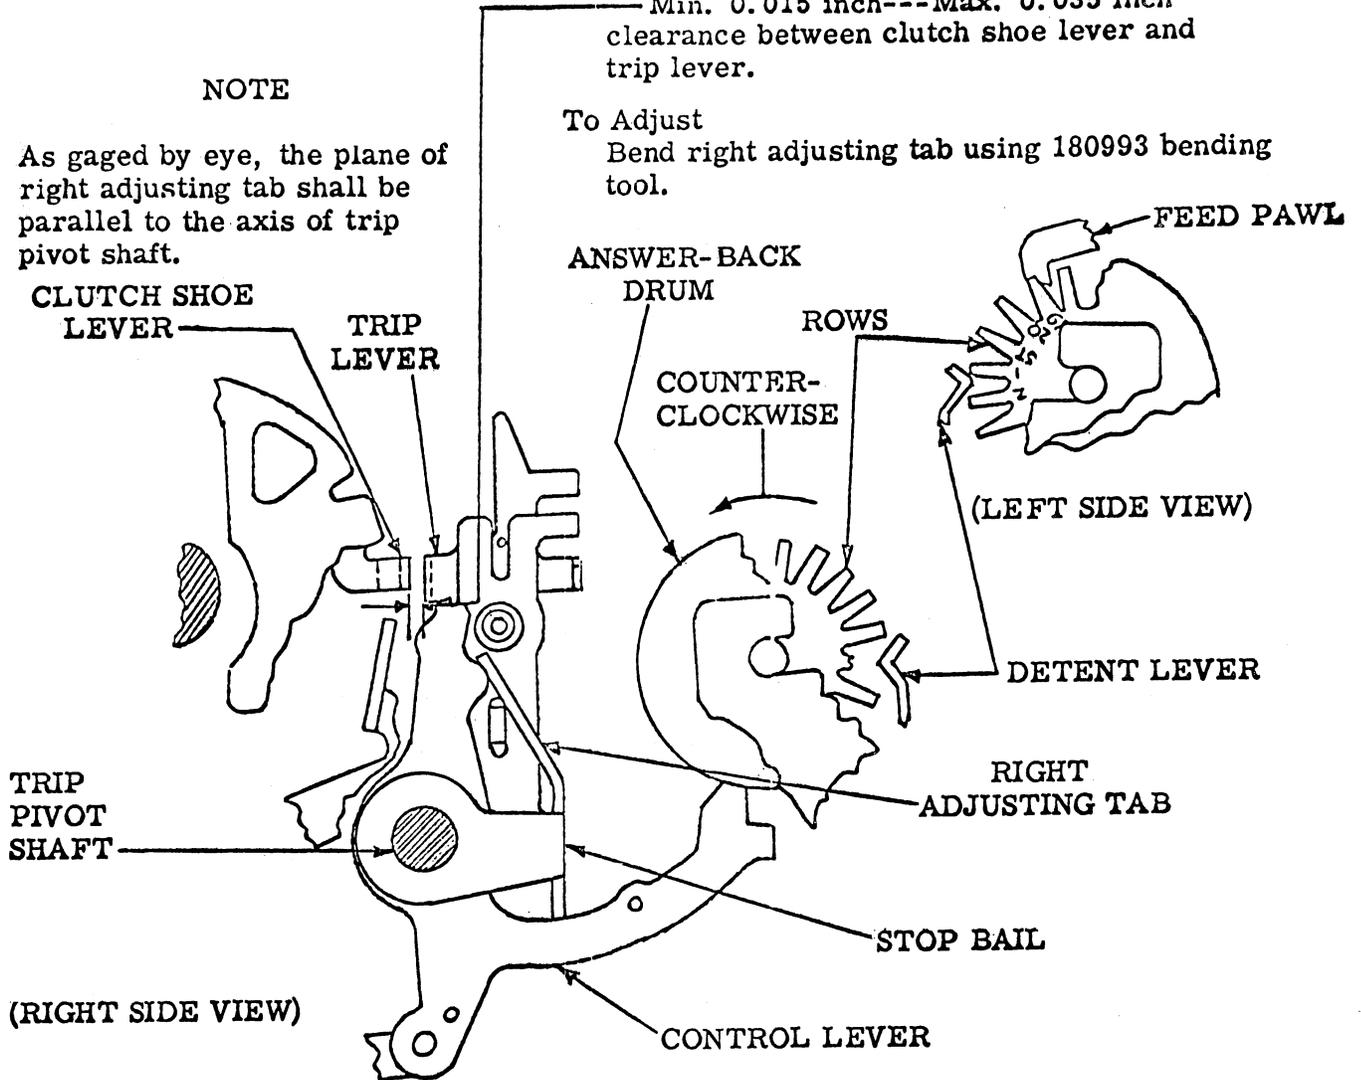
Fig. 7

Clutch Stop Bail

Min. 0.015 inch---Max. 0.035 inch clearance between clutch shoe lever and trip lever.

Bend right adjusting tab using 180993 bending tool.

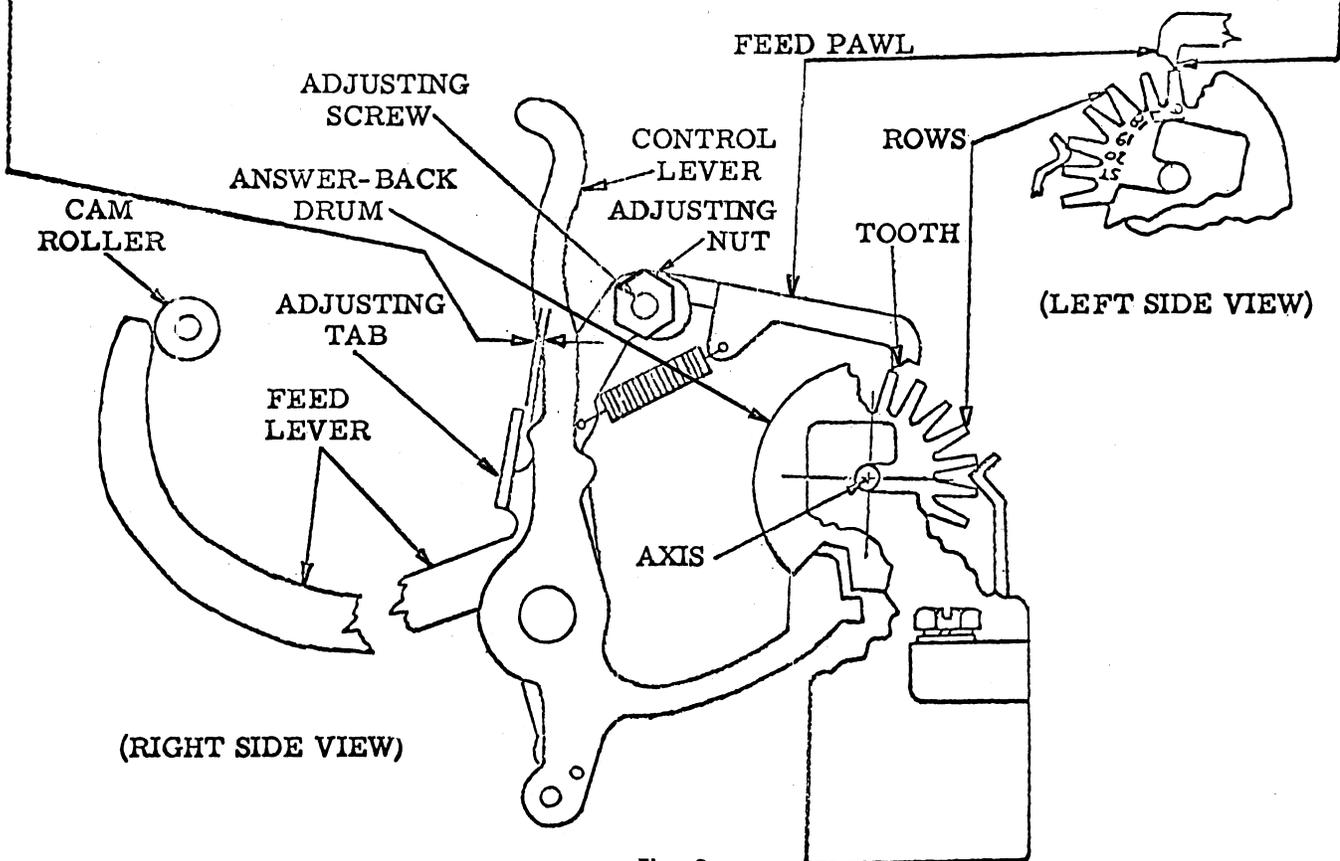
Fig. 8

Feed Pawl

Requirement: Some clearance between feed lever adjusting tab and control lever.

Requirement: Feed pawl tooth to rest on rear half of the top of row "16" of answer-back drum feed ratchet.

To Adjust: Bend feed lever adjusting tab toward the front of the printer.

To Adjust: With feed pawl adjusting nut and screw friction tight, position feed pawl.

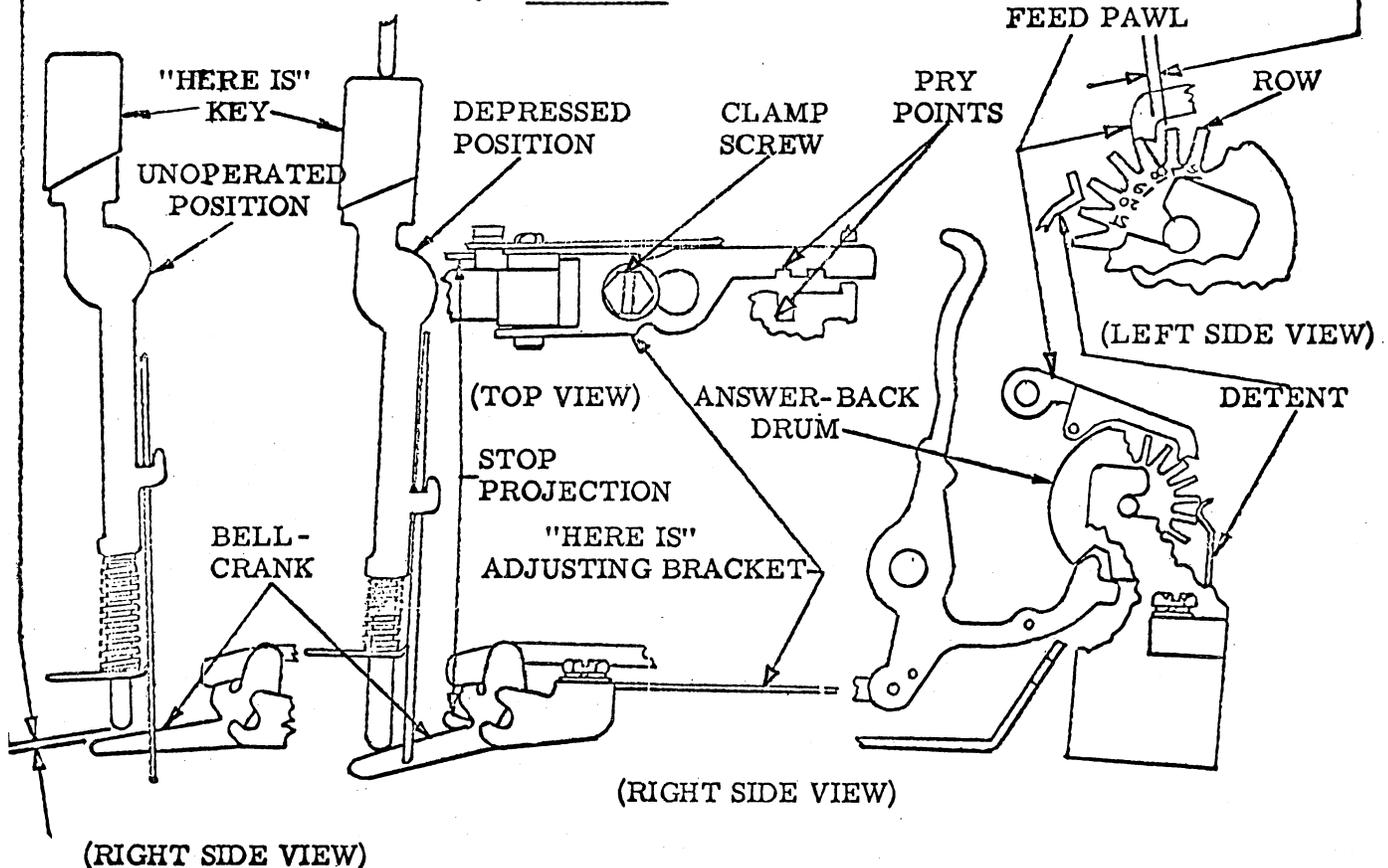
Fig. 9

HERE IS Adjusting Bracket

Requirement: Early design typing units equipped with HERE IS adjusting bracket without a stop projection. Min. 0.015 inch---Max. 0.030 inch overtravel between feed pawl and face of answer-back drum feed ratchet tooth of row "17".

Late design typing units equipped with HERE IS adjusting bracket with a stop projection. Min. 0.025 inch---Max. 0.045 inch overtravel between feed pawl and face of answer-back drum feed ratchet tooth of row "17".

Requirement: Some clearance between tip of HERE IS key and bellcrank.

To Adjust: With clamp screw loosened friction tight, position HERE IS adjusting bracket using pry points.

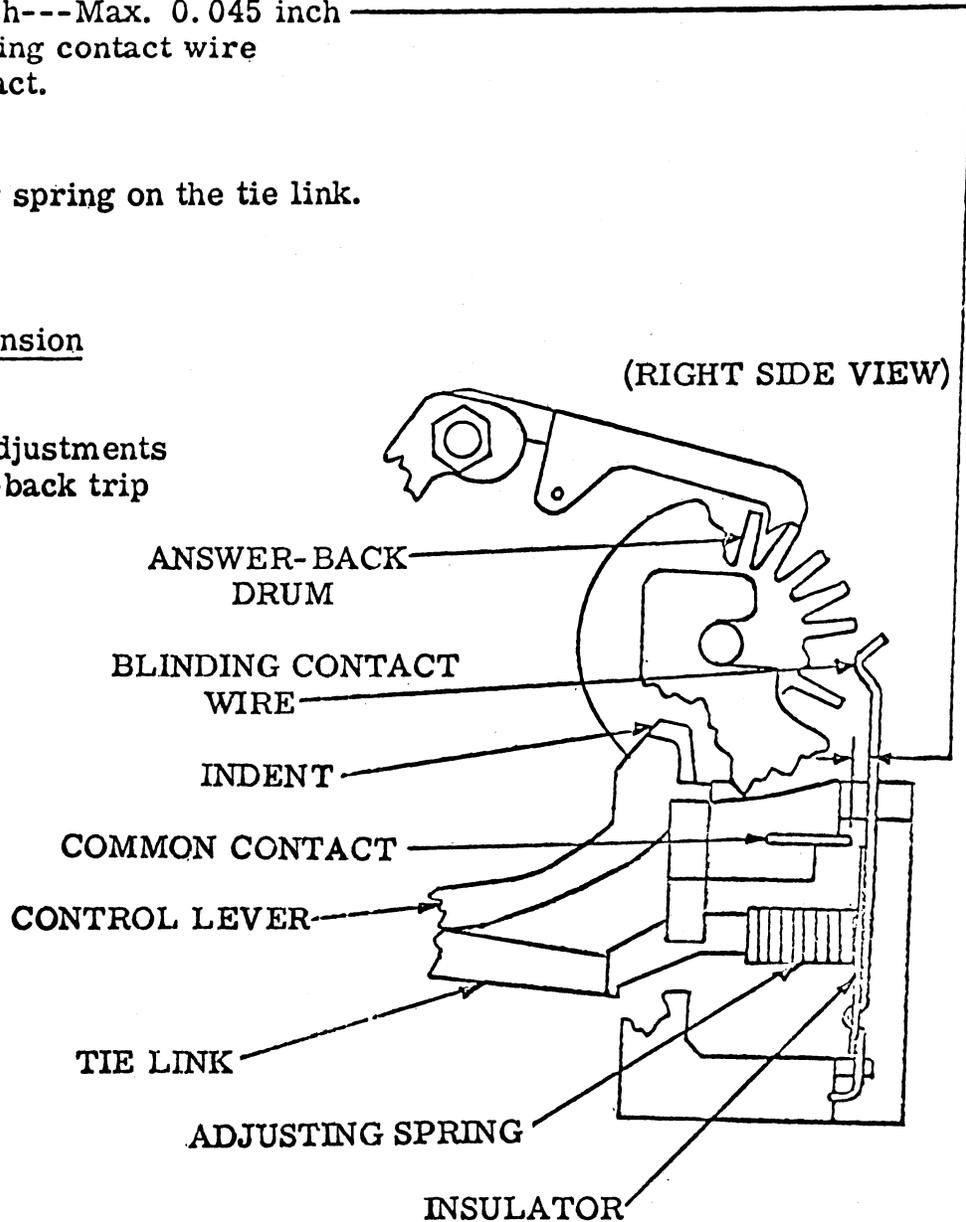
Fig. 10

Blinding Contact Wire

Min. 0.015 inch---Max. 0.045 inch gap between blinding contact wire and common contact.

Position adjusting spring on the tie link.

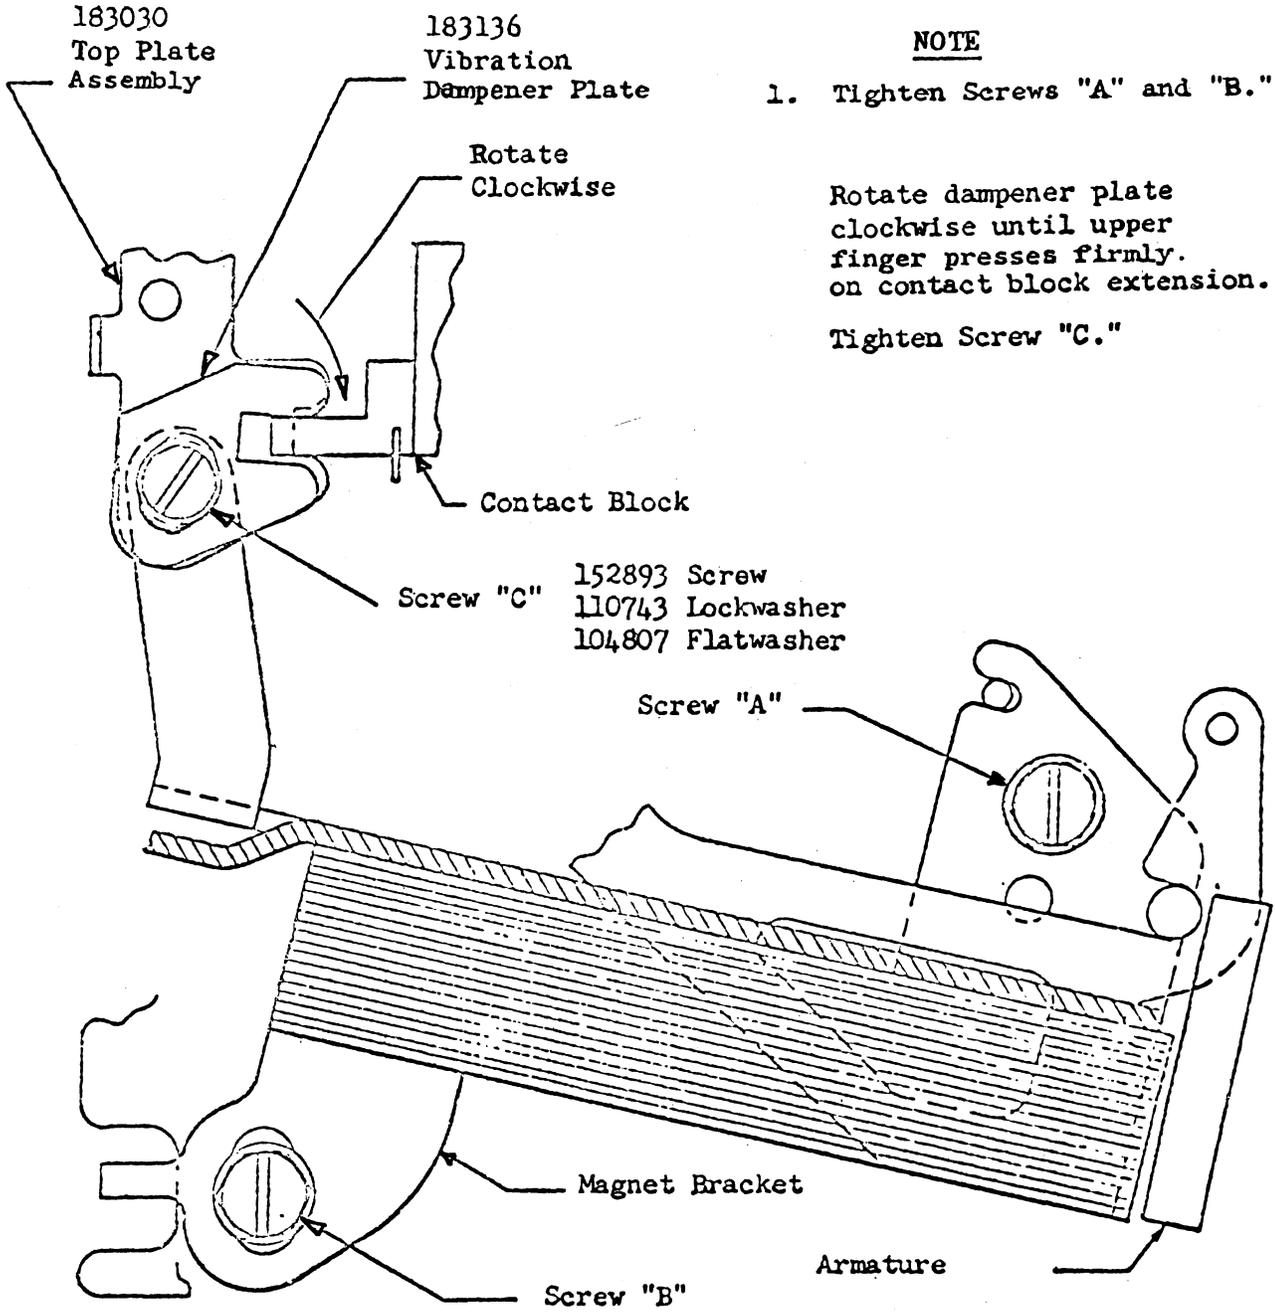
Fig. 11

TP183136 vibration dampener plate (resembles the lower section of the outer vertical section of the TP183030 top plate assembly shown as TP183048 top plate assembly on page 6-3) has been added to the tape reader assembly. The new plate mounts to the outer vertical section of the TP183030 by means of a new TP152893 screw (replaced TP151152 screw) and the existing TP110743 lock washer and TP2034 flat washer formerly used to mount the TP183030 top plate assembly to the TP183061 magnet core assembly (see page 6-4).

Tape Reader Vibration Dampener Plate Assembly

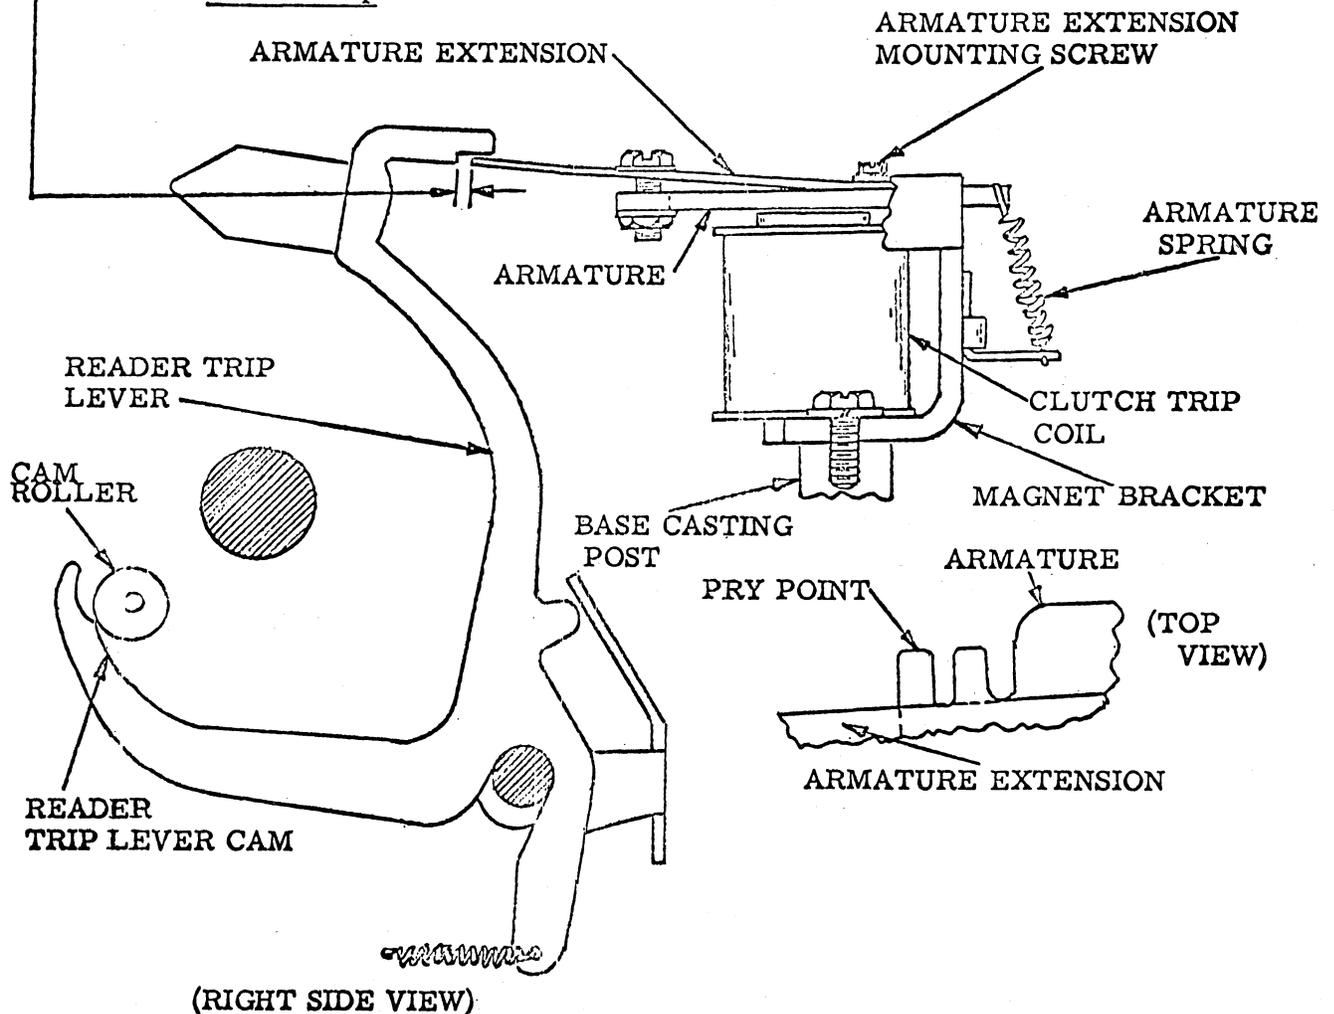
Fig. 12

Trip Lever Overtravel
To Check

Min. 0.010 inch---Max. 0.018 inch clearance between the end of armature extension and latching surface of reader trip lever.

With armature extension mounting screw loosened friction tight, position armature extension using pry point.

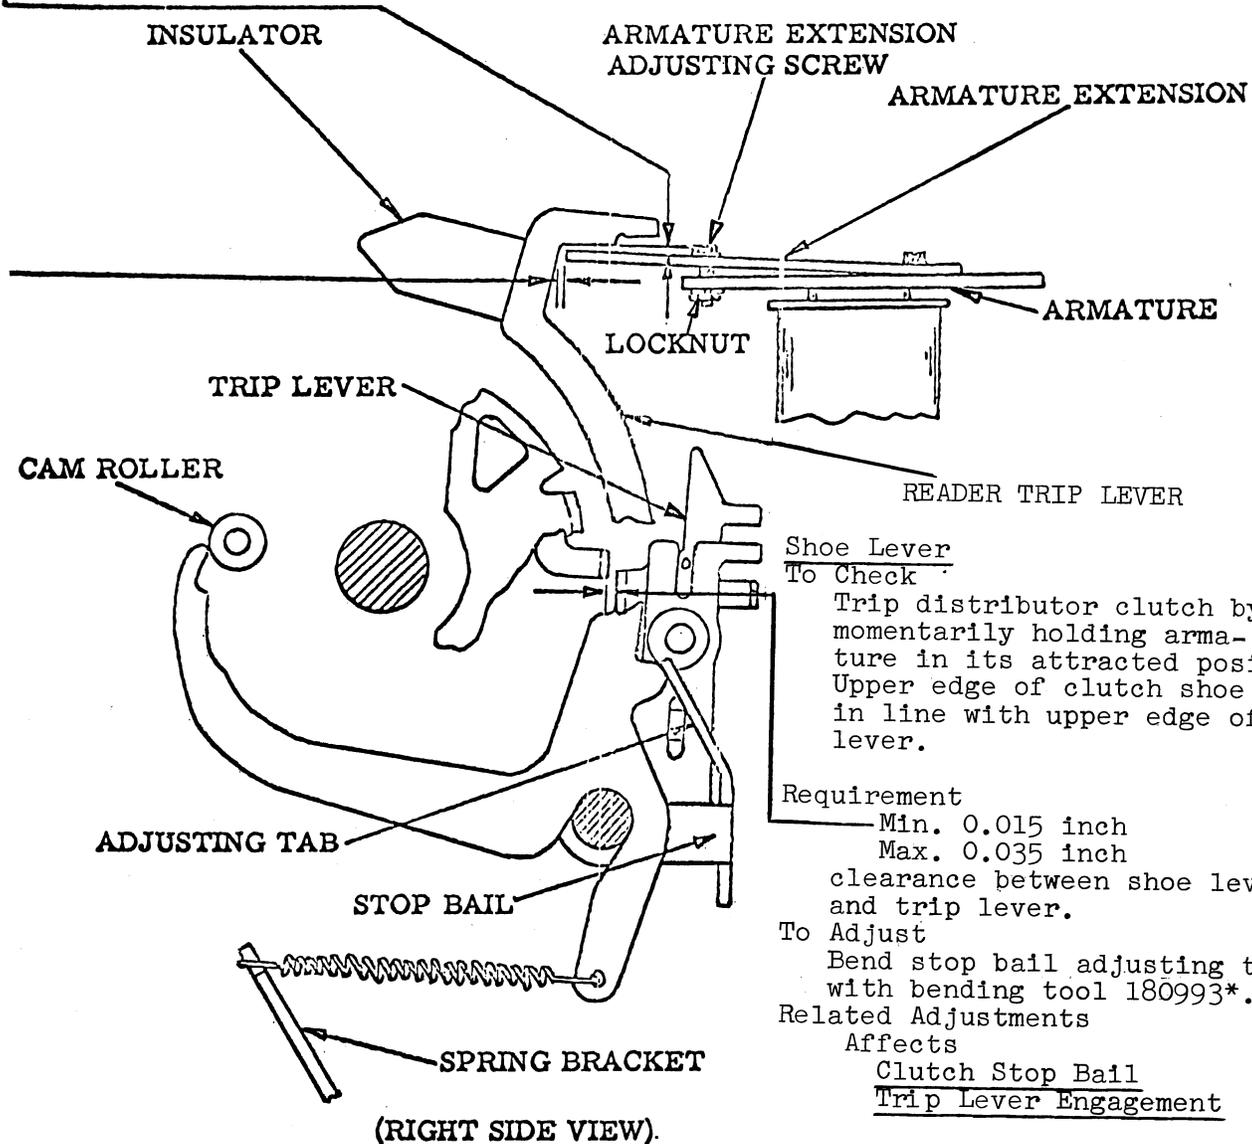
Fig. 13

Armature Extension

Min. some---Max. 0.010 inch clearance between the armature extension and reader trip lever at its closest point.

Shoe Lever
To Check
 Trip distributor clutch by momentarily holding armature in its attracted position. Upper edge of clutch shoe lever in line with upper edge of trip lever.

Requirement
 Min. 0.015 inch
 Max. 0.035 inch
 clearance between shoe lever and trip lever.

With armature extension adjusting screw and locknut loosened, position armature extension using armature extension adjusting screw.

To Adjust
 Bend stop bail adjusting tab with bending tool 180993*.
Related Adjustments
 Affects
Clutch Stop Bail
Trip Lever Engagement

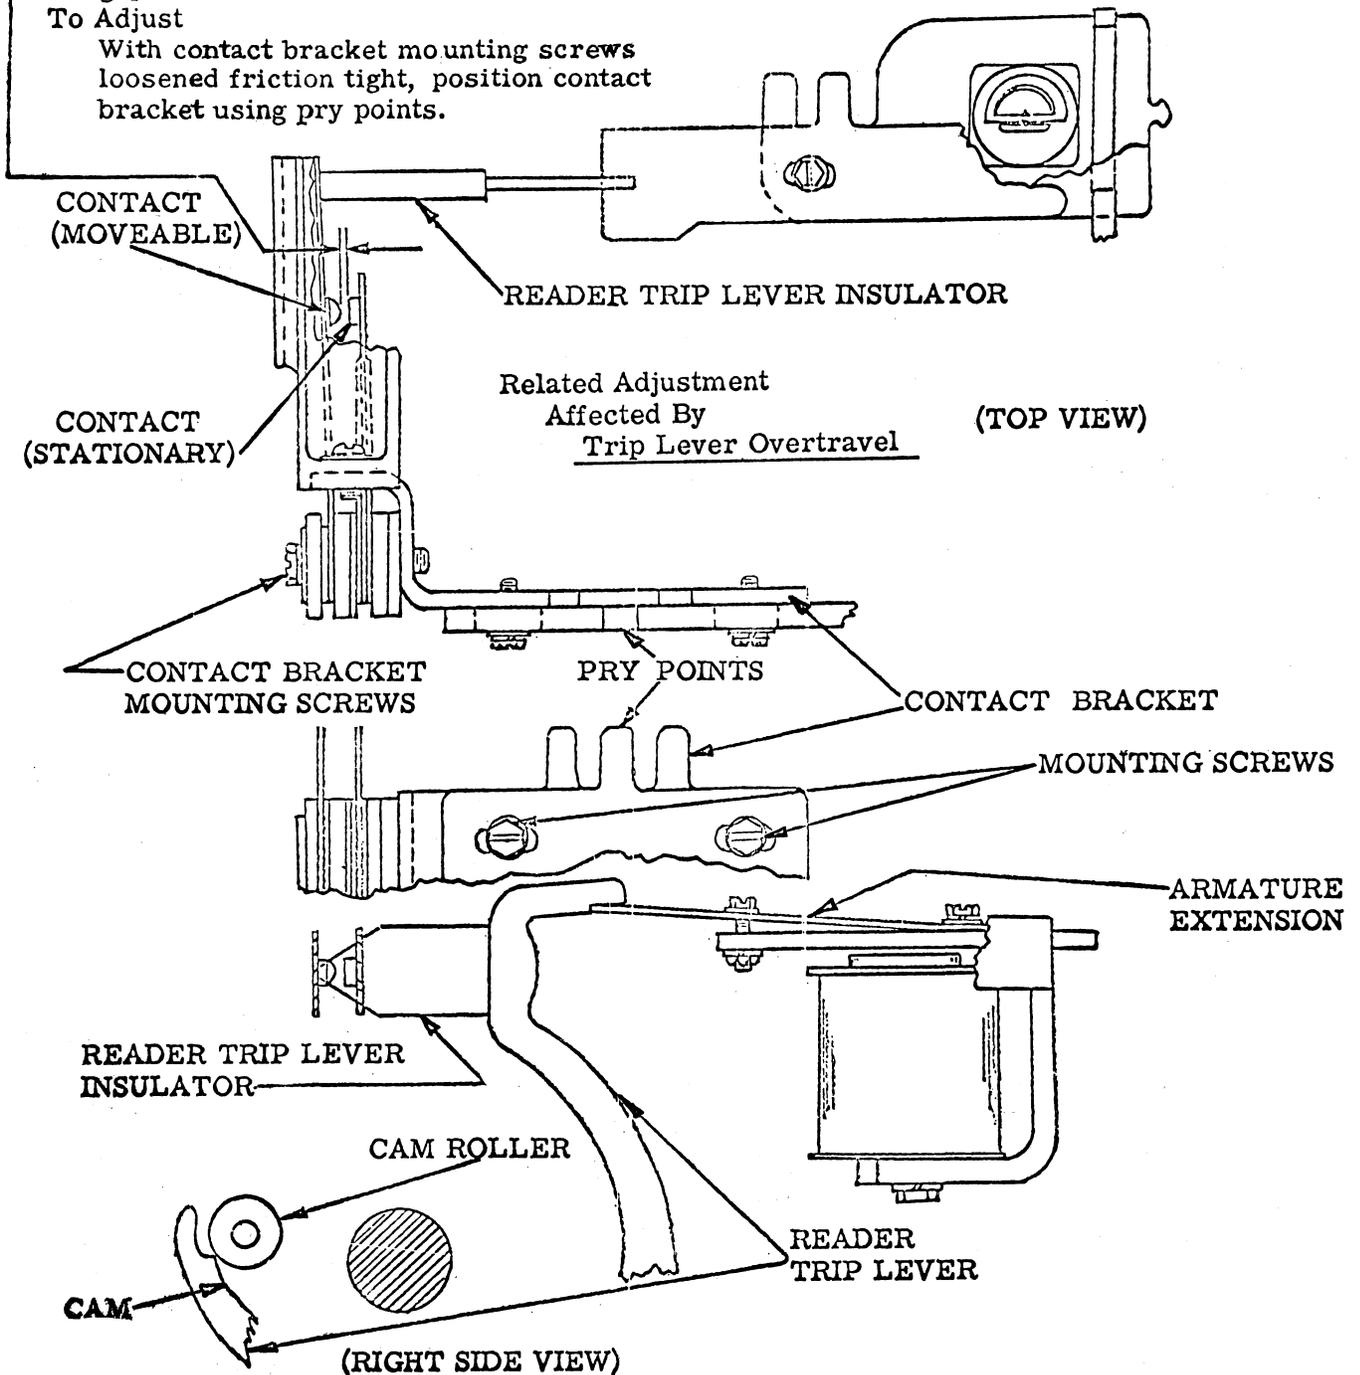
Fig. 14

Contact Gap

Min. 0.027 inch---Max. 0.041 inch gap between contacts.

With contact bracket mounting screws loosened friction tight, position contact bracket using pry points.

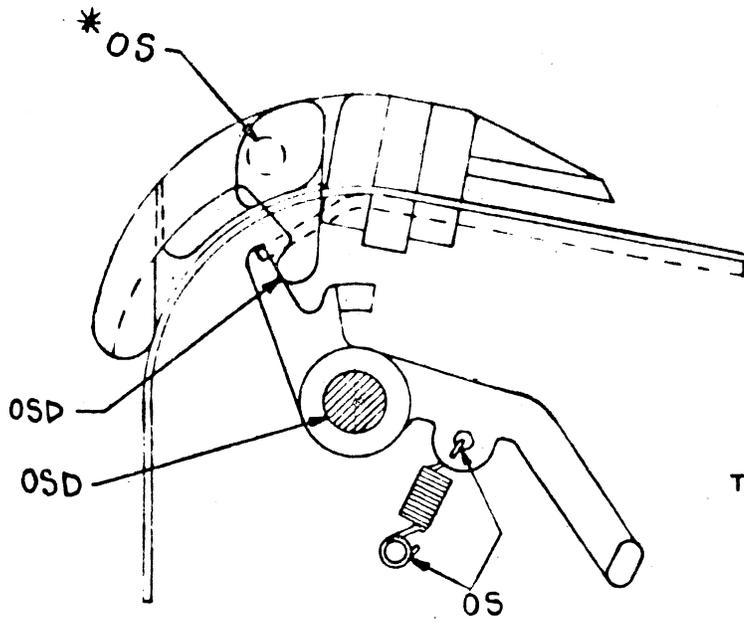
Fig. 16

LUBRICATION REQUIREMENTS
TIGHT TAPE MECHANISM

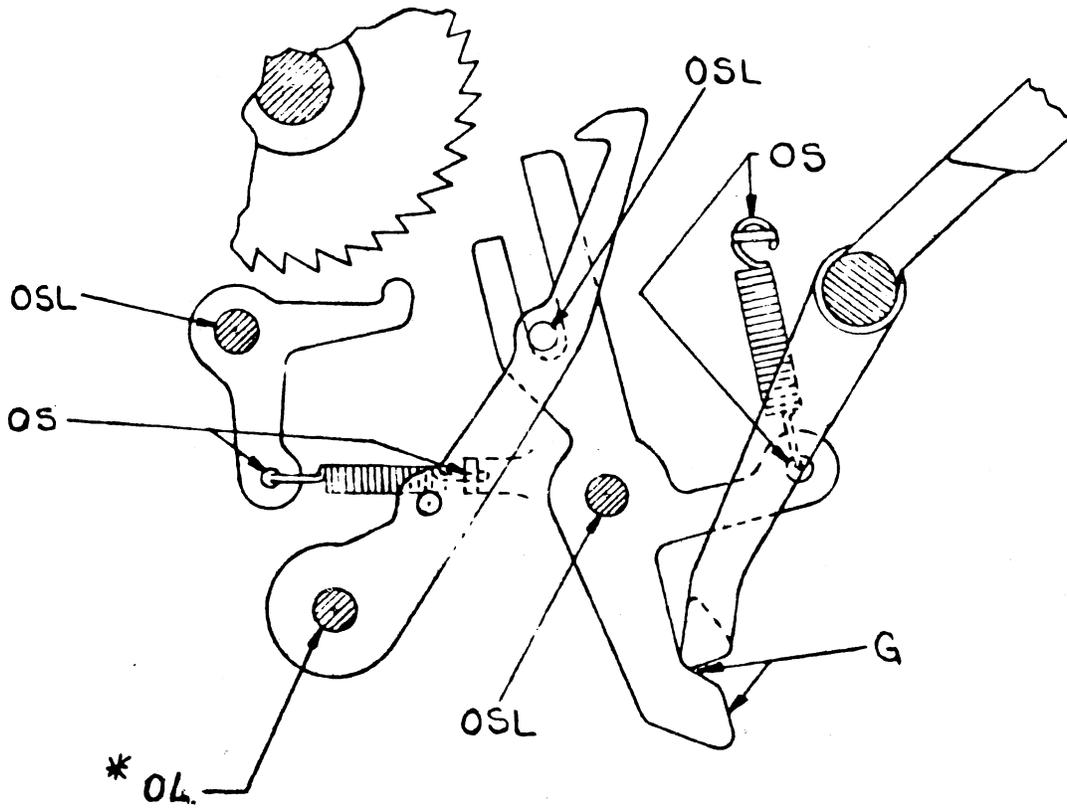
Fig. 17

LUBRICATION REQUIREMENTS
FEED PAWL MECHANISM

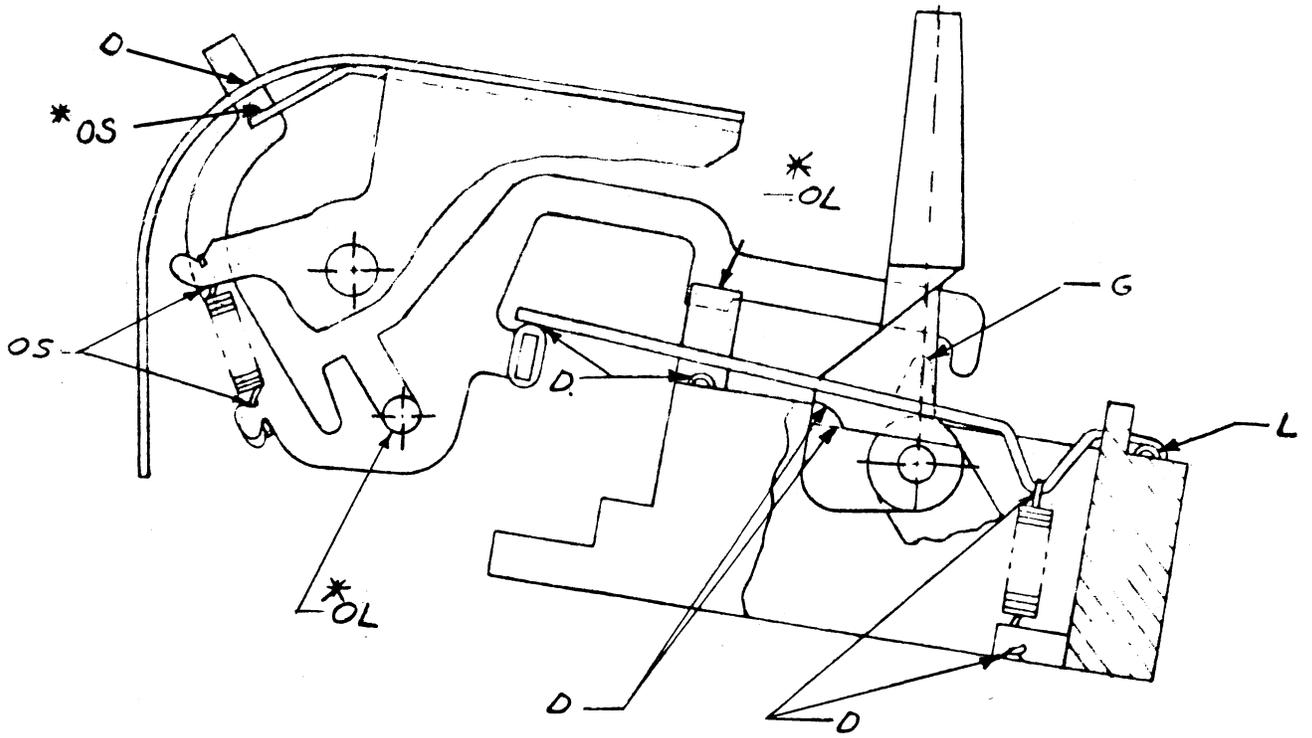
Fig. 18

LUBRICATION REQUIREMENTS
CONTROL MECHANISM
