**TP3606 NUT (6-40 HEX.), TP124177 LOCKWASHER,
TP311516 POST, AND TP193755 COVER**

APPARATUS AFFECTED: 35A Typing Reperforator Unit; 35A and 35B Tape Typing Units; TP193755 Magnet Coil Cover.

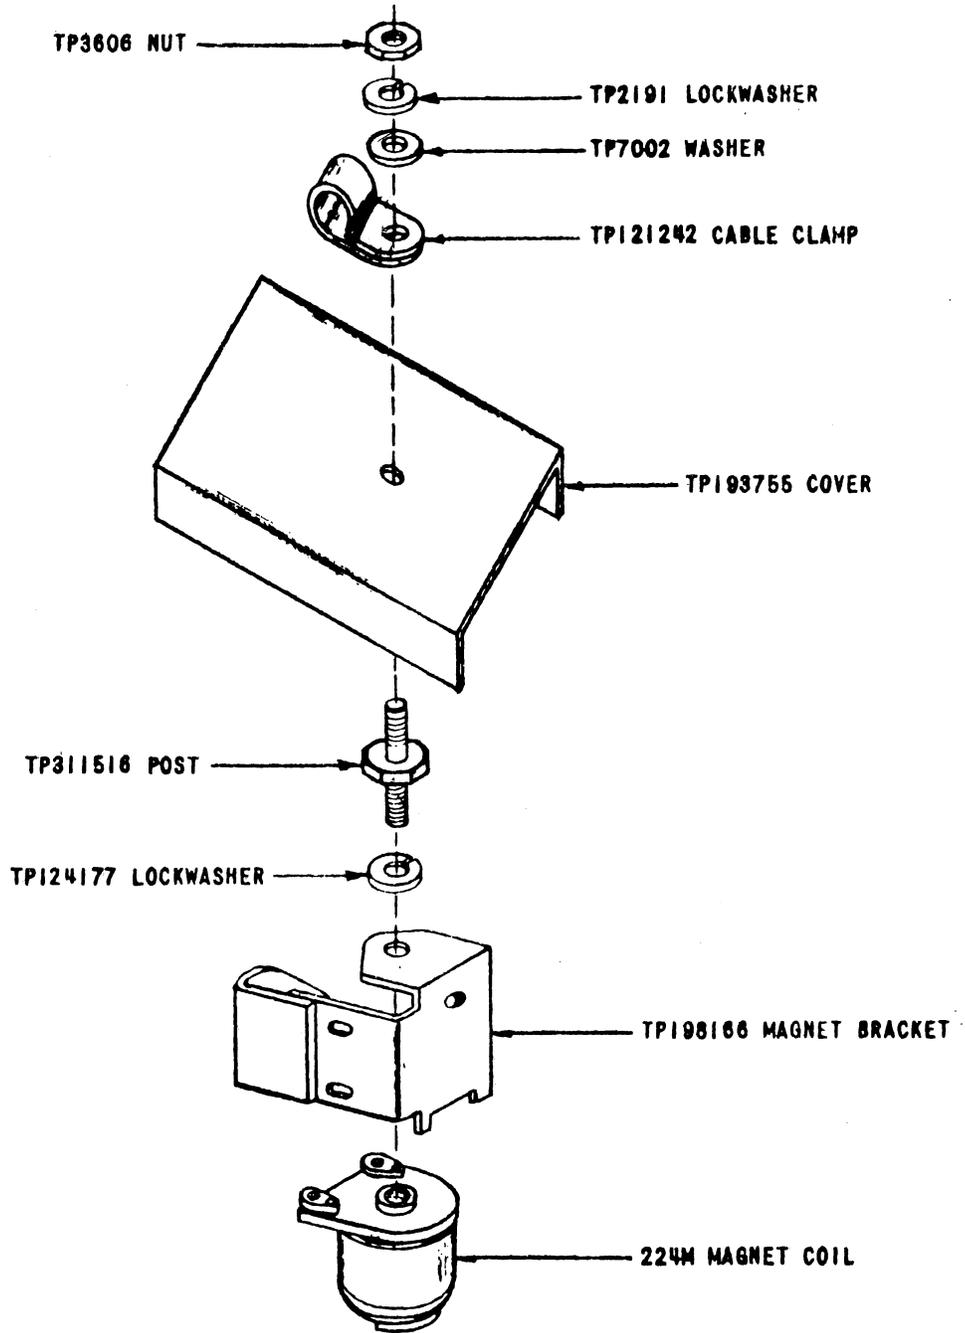
Fig. 1

OBJECT: To prevent possible loosening of the print suppression magnet assembly.

CHANGE: The following changes have been made on the ribbon shift mechanism: (a) The TP93380 flat washer and TP151442 (6-40 by 1/2" hex.) or TP153839 screw (6-40 by 5/8" hex.) have been removed. The TP311516 post, TP124177 lockwasher and TP3606 nut (6-40 hex.) have been added. (b) The 0.125-inch diameter (tie point) hole on the TP193755 cover has been deleted.

PART OF RIBBON SHIFT MECHANISM

APPLICATION TO APPARATUS IN THE FIELD: Old style parts giving satisfactory service need not be replaced.
