**CHANGE IN RIBBON SHIFT MAGNET ARMATURE (TP192908) AND
BLOCKING LINK (TP192901); NEW UP-STOP BRACKET (TP195485)**

APPARATUS AFFECTED: 35A and 35B Tape Typing Unit (LTP800 and 801) used in 35AB, 35AD and 35AE Teletypewriter Sets.

SECTION 574-231-800

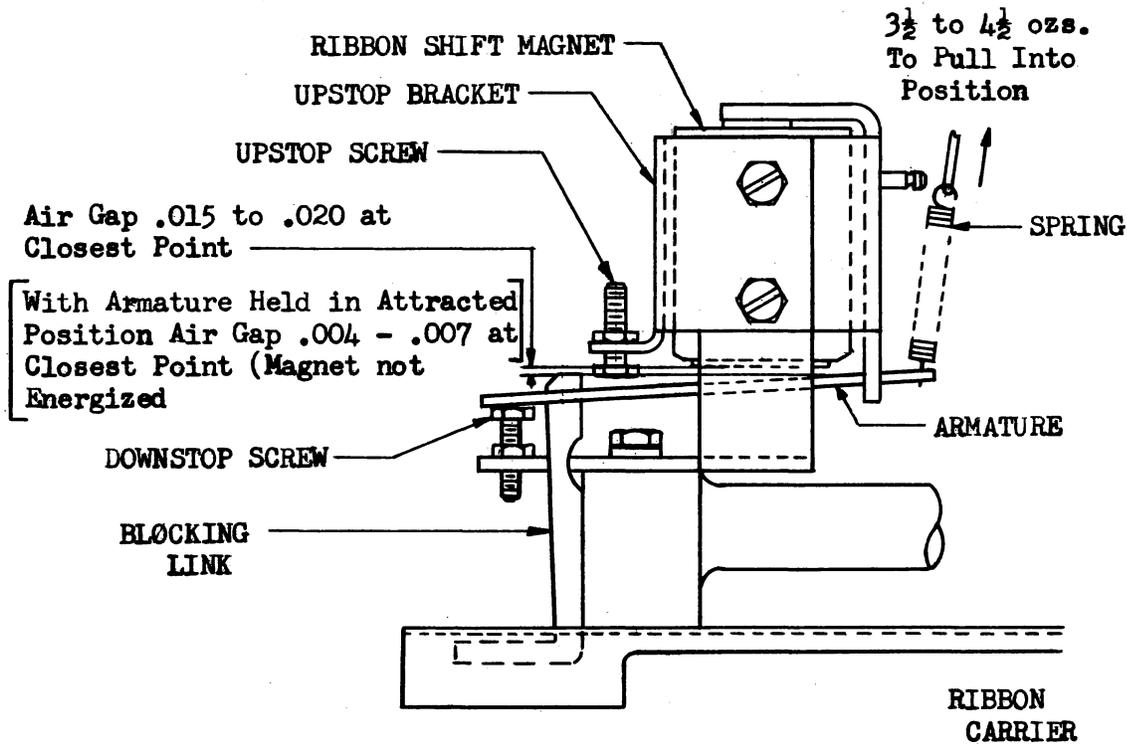
- a. With the rocker bail in the extreme left position and the ribbon carrier biased in a downward direction, there should be some to .005 clearance between the top surface of the blocking link and the lower surface of the ribbon carrier.
- b. To adjust: Position magnet armature downstop screw with the locknut loosened.

- a. With the armature resting on the downstop screw there should be .015 to .020 inch clearance between the magnet core and the armature at the closest point.
- b. To adjust: Position magnet bracket with the screws loosened. Check for binds.

- a. With the armature held against the upstop screw (Magnet is not to be energized) there should be .004 — .007 inch clearance between the magnet core and the armature at the closest point.
- b. To adjust: Position the magnet armature upstop screw with the locknut loosened.

1. Armature Downstop Adjustment

2. Armature Air Gap Adjustment

3. Armature Upstop Adjustment
