APPARATUS AFFECTED: 37 Electrical Service Units (YESU) part of 37 ASR, RO and ROTR Teletypewriter Sets used in Multipoint Private Line Service.
TP332541 Circuit Card Set (RO).
TP332549 Circuit Card Set (RO).
TP332587 Circuit Card Set (ROTR).
TP332642 Circuit Card Set (ASR).
TP332658 Circuit Card Set (ASR).
See NOTE in CHANGE.

PART AFFECTED: TP322308 Multipoint Private Line Channel Control Circuit Card Assembly (MC308).

REASON: To assure motors remain off while terminal is out of service.

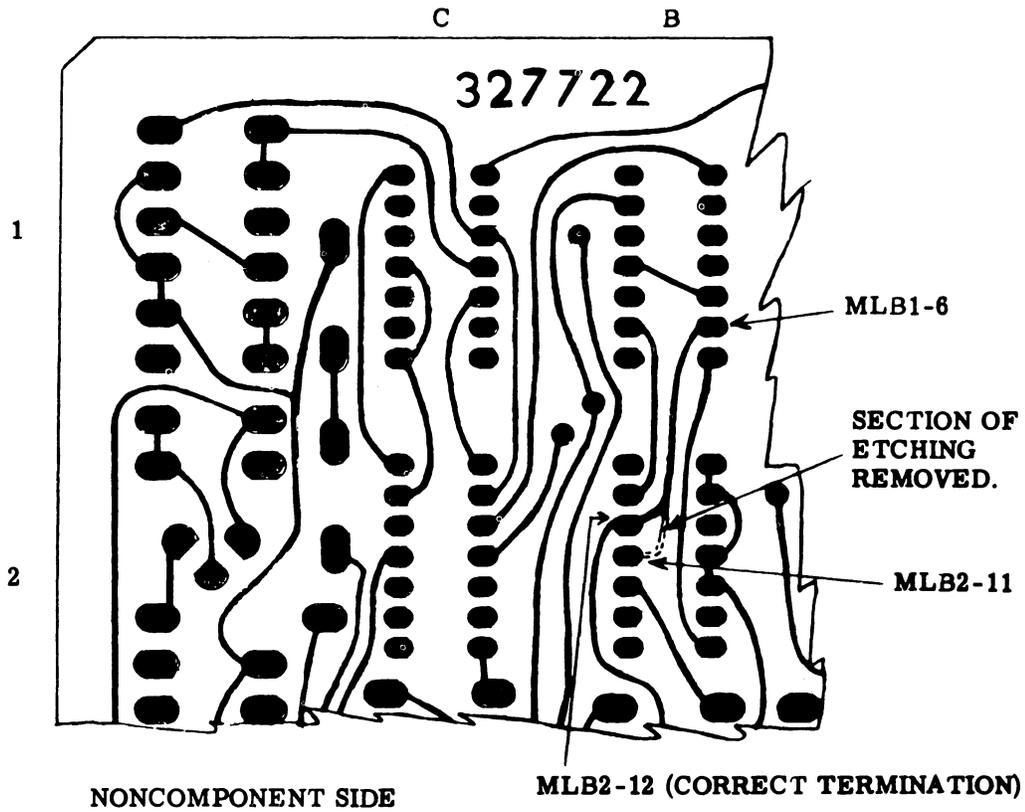
Attached Sheet 1

NOTE: This change only affects some TP322308 circuit card assemblies that were manufactured with a connection between MLB1-6 and MLB2-11 instead of between MLB1-6 and MLB2-12; however, all TP322308 circuit card assemblies should be checked to determine whether or not modification per Attachment Sheet 1 is required.

**MODIFICATION OF TP322308 CIRCUIT CARD ASSEMBLY THAT HAS
MLB1-6 CONNECTED TO MLB2-11 INSTEAD OF TO MLB2-12:**

CHANGE: On the etched circuit board of the TP322308 circuit card assembly (noncomponent side), the etched circuit path between MLB1-6 and MLB2-11 is removed and an etched circuit path between MLB1-6 and MLB2-12 is added.

**REMOVE SECTION OF ETCHING AT MLB2-11 (SHOWN DOTTED)
AND CONNECT ETCHED CIRCUIT PATH (FROM MLB1-6) TO
MLB2-12, AS SHOWN.**
