APPARATUS AFFECTED: DATASPEED 40 Pedestals 40CAB901/AA, 40CAB901/AB, 40CAB901/AF, 40CAB901/AG and 40CAB901/AJ.

REASON: To provide an improved power switch.

Appendix 1, Section 579-505-350, Issue 1
Teletypewriter Change Notice
TCN 2201 Issue 1
March, 1976

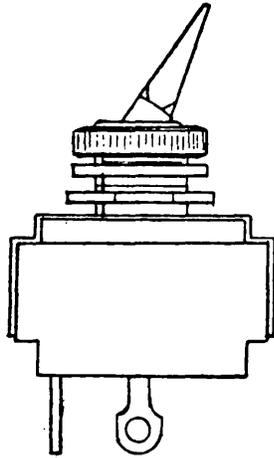
TP401673 SWITCH (OLD)

IDENTIFICATION: The TP401673 switch (old) has solder terminals. The TP408018 switch (new) has screw terminals.

On the old-style TP401665 ac distribution panel assembly, the wires of the 2 - conductor cable are soldered to the terminals on the TP401673 switch (old).

The TP401673 switch (15 amp - 125 VAC) is replaced by a TP408018 switch (16 amp - 125 VAC).

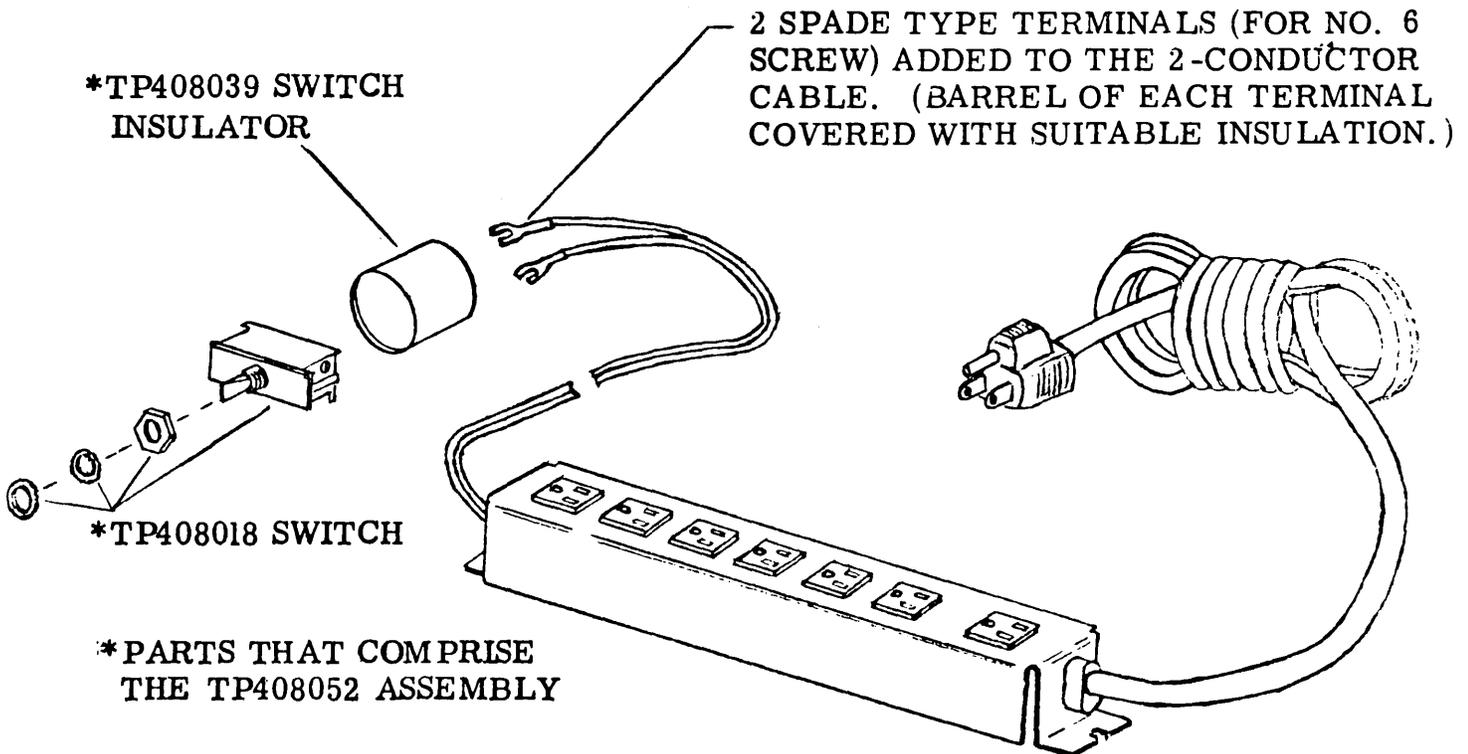
NEW-STYLE TP401665 AC DISTRIBUTION PANEL ASSEMBLY

On the new-style TP401665 ac distribution panel assembly, the wires of the 2 - conductor cable have spade type terminals and are connected to screw terminals on the TP408018 switch (new). The screw terminals on the wired switch are covered with electrical tape or the TP408039 switch insulator (rubber tube).

*TP408039 SWITCH INSULATOR

2 SPADE TYPE TERMINALS (FOR NO. 6 SCREW) ADDED TO THE 2-CONDUCTOR CABLE. (BARREL OF EACH TERMINAL COVERED WITH SUITABLE INSULATION.)

*TP408018 SWITCH

Two TP320410 spade type terminals are added to the 2 - conductor cable to enable connection to screw terminals on the TP408018 switch (new). The barrel of each terminal is covered with suitable insulation.

A TP408039 switch insulator is added. After connection of the 2 - conductor cable to the switch, the TP408039 insulator is installed on the TP408018 switch to cover exposed portions of the switch screw terminals.

NOTE: THE SCREW TERMINALS ON THE TP408018 SWITCH (NEW) MUST BE COVERED WITH A TP408039 SWITCH INSULATOR OR WITH TWO OR MORE THICKNESSES OF ELECTRICAL TAPE AFTER CONNECTION OF CABLE.
