ADOSO SYSTEM
(Automatic Distribution of Service Orders)

Message Registers
(Veeder Root-Counters)
Maintenance Adjustment

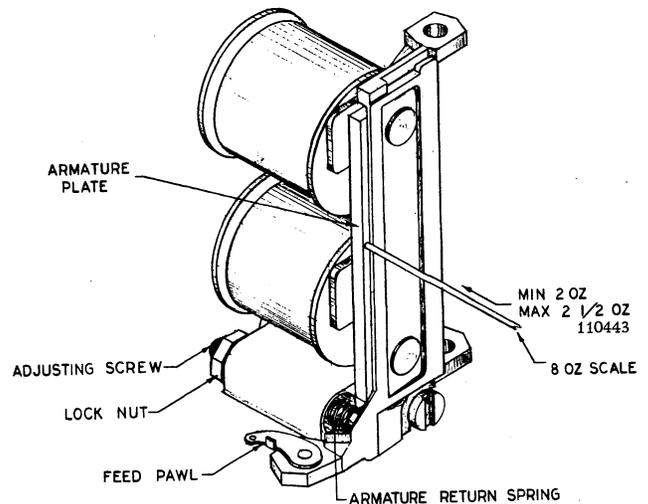
FIG 1

1.01 This section provides adjusting information for the Veeder Root-Counters used for message registers in the ADOSO I and ADOSO II Systems. Some counters in service have developed a case of trouble, undercounting messages.

1.02 Investigation shows this to be caused by the armature failing to release far enough for the feed pawl to engage the wheel to advance the count. This condition is due, in part, to the position in which the counters are mounted in the ADOSO systems.

1.03 Mounted horizontally, or partially so, the weight of the armature tends to overcome the force of the armature return spring. To correct this condition, it is necessary to apply more pressure to the armature return spring, ensuring the armature's positive return.

2.01 Remove the counter from its mounting; break the wax seal on the cover opposite the manufacturer's name plate. Remove cover, and place assembly in position as in sketch: vertical with feed pawl down. Loosen locknut on adjusting screw. Do not remove the number wheel. It is omitted from the sketch to more clearly show the portion on the assembly being affected by the adjusting process.

2.02 Using a TP 110443 8 oz. scale applied to the midpoint of the armature's leading edge as shown in Fig. 1, the adjusting screw shall be tightened until it requires a min. of 2 oz. to max. of 2 1/2 oz. to just move the armature. Do not apply enough pressure to move the numbers wheel. This will be adequate to ensure positive action.

2.03 Upon completing the adjustment, tighten the locknut on the adjusting screw, replace cover and remount the counter.
