APPARATUS AFFECTED: DATASPEED 40/4 Device Cluster Controllers (DCC). -402 Series.

PARTS AFFECTED: TP410509 Circuit Card
TP410510 Circuit Card
TP410511 Circuit Card

REASON: To improve program tab routine and to return keyboard display (KD) to local mode after an unsolicited select.

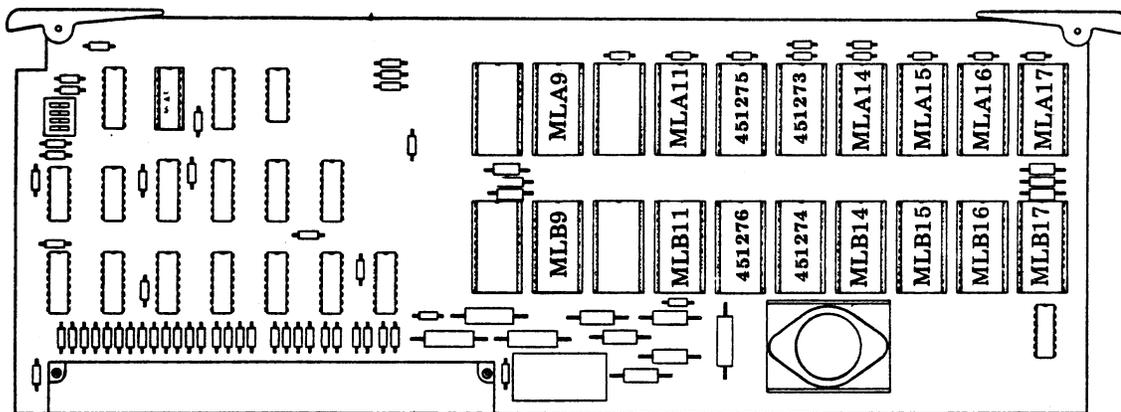
New-style TP410509 circuit card labeled Issue 4A with new EPROMs.

TABLE A — Circuit Card TP410509

<u>REMOVE</u>	<u>POSITION</u>	<u>INSTALL</u>
451048	MLA 13	451273
451049	MLB 13	451274
451050-2	MLA 12	451275
451051-2	MLB 12	451276

Change issue of card from 3A to 4A

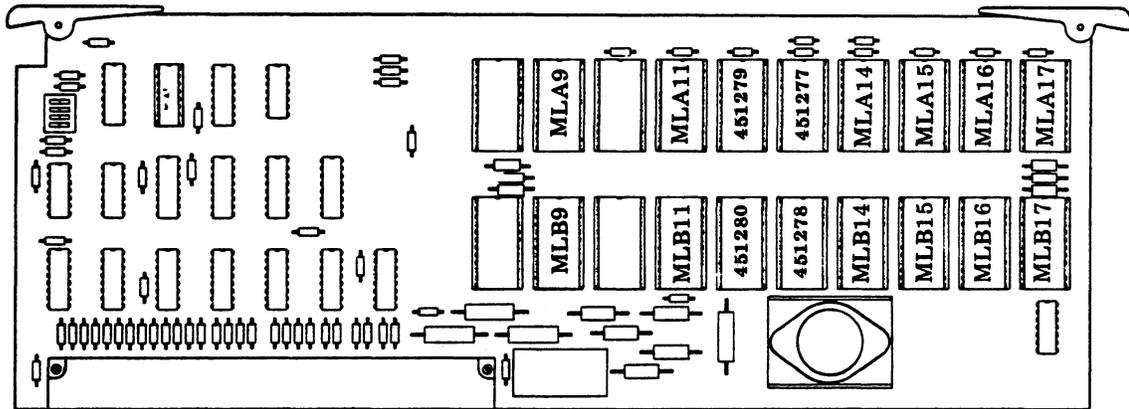
New-style TP410510 circuit card labeled Issue 4A with new EPROMs.

TABLE B — Circuit Card TP410510

<u>REMOVE</u>	<u>POSITION</u>	<u>INSTALL</u>
451060	MLA 13	451277
451061	MLB 13	451278
451062-2	MLA 12	451279
451063-2	MLB 12	451280

Change issue of card from 3A to 4A

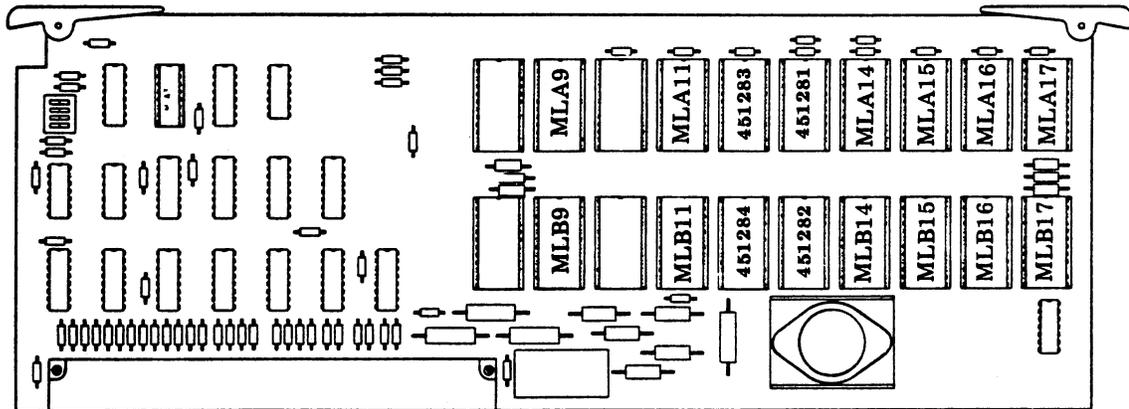
New-style TP410511 circuit card labeled Issue 4A with new EPROMs.

TABLE C — Circuit Card TP410511

<u>REMOVE</u>	<u>POSITION</u>	<u>INSTALL</u>
451074	MLA 13	451281
451075	MLB 13	451282
451076-2	MLA 12	451283
451077-2	MLB 12	451284

Change issue of card from 3A to 4A
