Subject: Digital Channel Banks - Modifications for D1D, D2, and D3 to increase carrier failure delay timing SL: IL 81-02-438

type letter: Information Letter

date: February 20, 1981

Reviews carrier failure alarm delay timing for digital terminal equipment, and provides ordering information for modifications to change most of the early channel banks to agree with current design. Application considerations are reviewed.

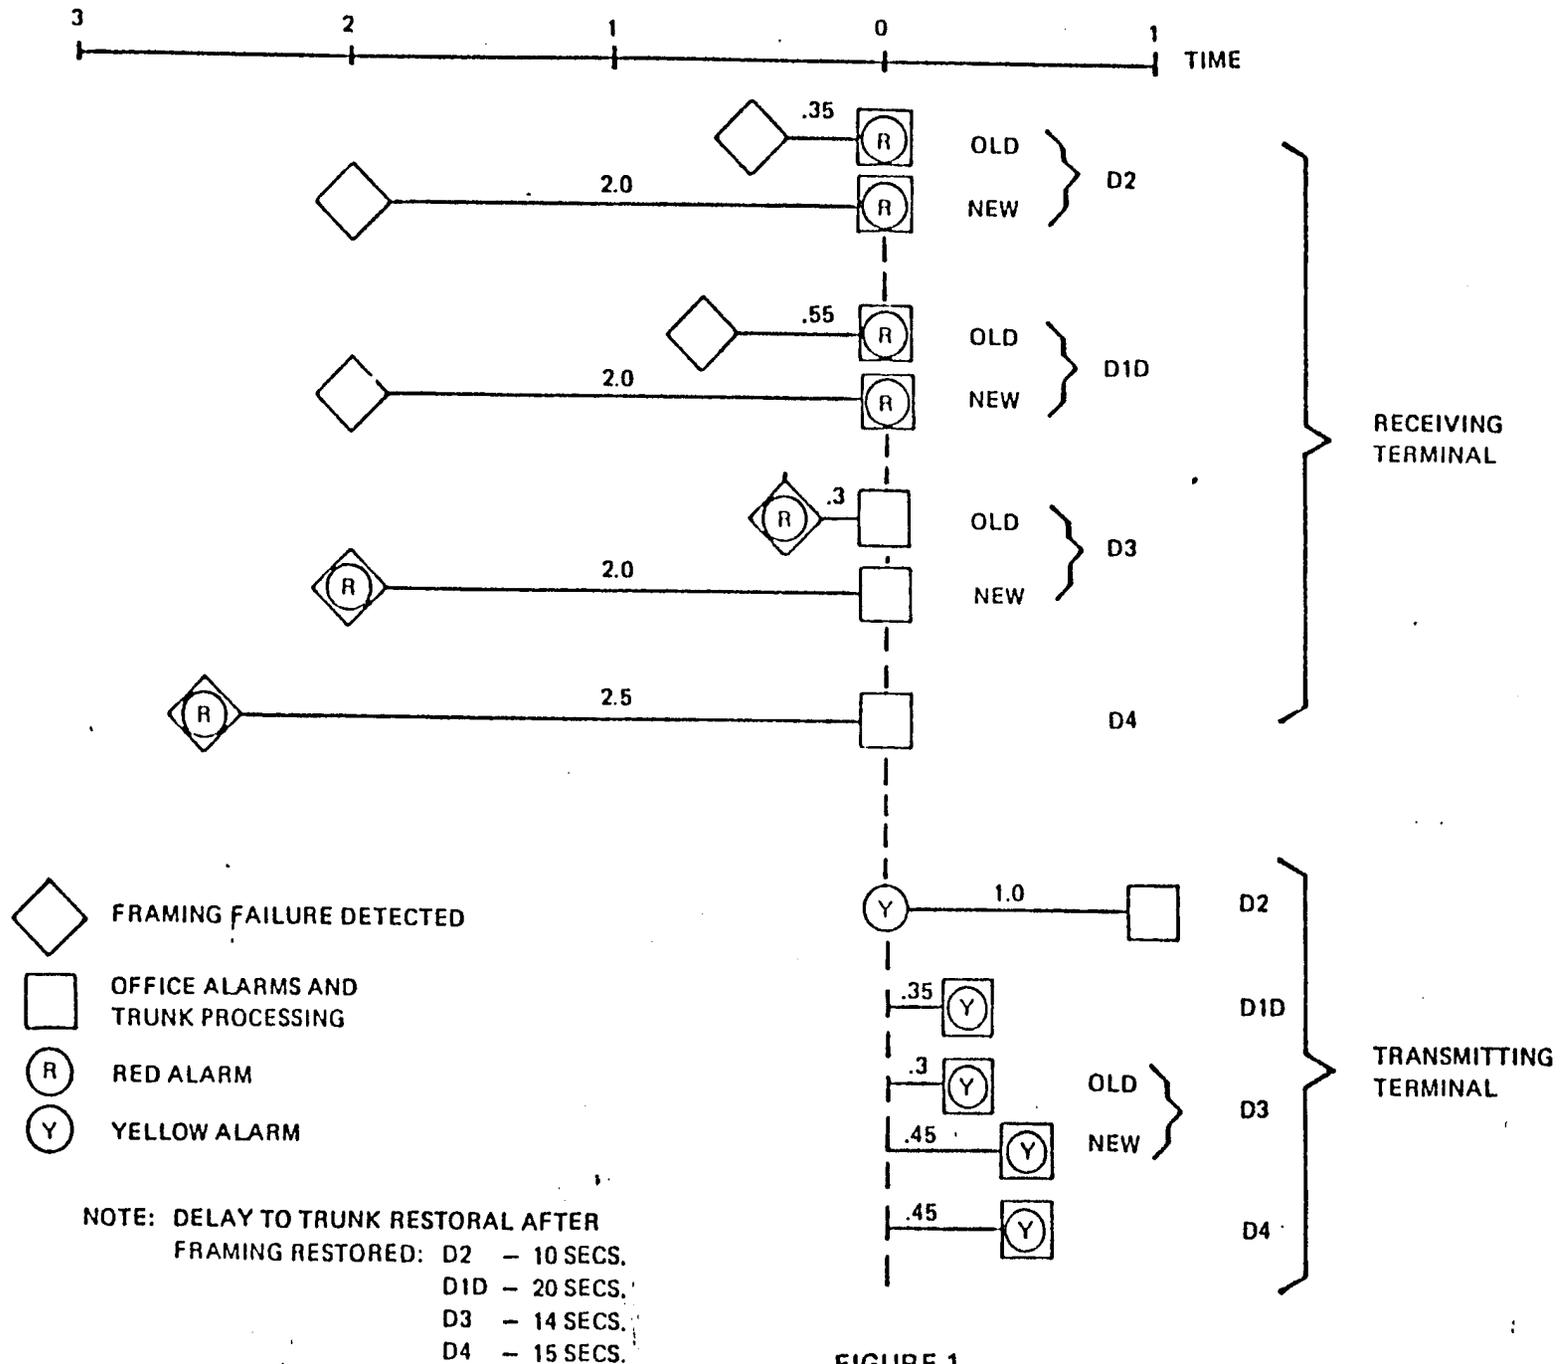
FIGURE 1

Figure 1 shows the timing sequence for all W.E. D3 compatible banks. On the Figure, time is normalized to the moment office alarms and trunk processing occur at the terminal that has lost framing.

ALARM AND TRUNK PROCESSING TIMING FOR D-TYPE CHANNEL BANKS – EL4246
