SECTION P65.924.03

## ADOSO SYSTEM

### (Automatic Distribution of Service Orders)

#### Message Registers (Veeder Root-Counters) Maintenance Adjustment

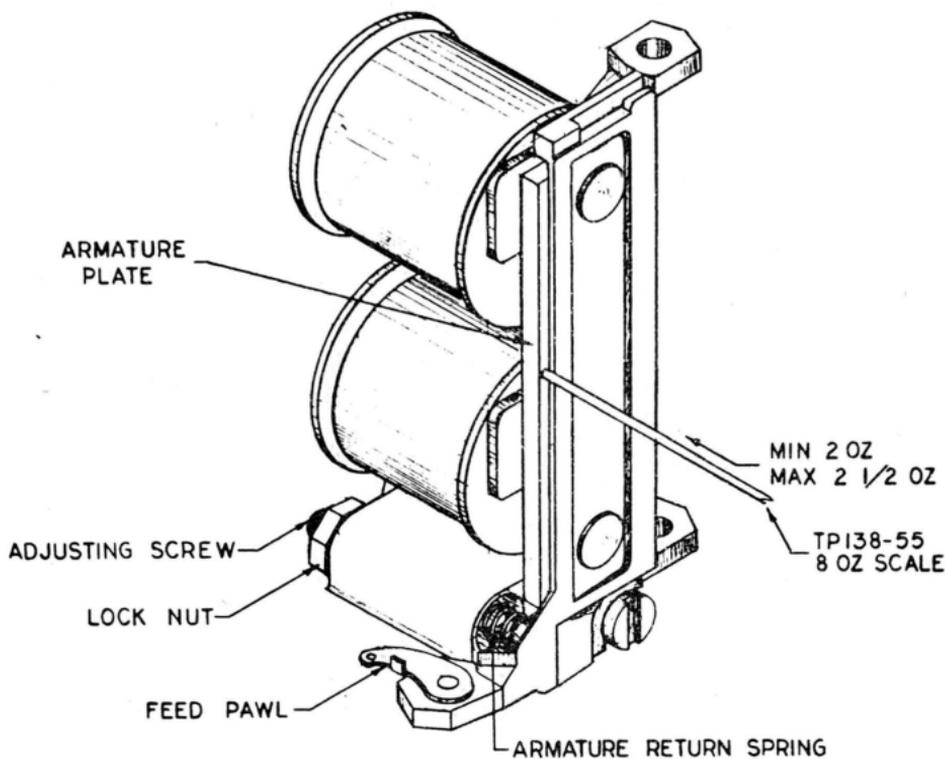
FIG 1

1.02 Investigation has shown that this is caused by the armature failing to release far enough for the feed pawl to engage the wheel to advance the count. This condition is due in part to the position in which the counters are mounted in the ADOSO systems.

1.03 Mounted horizontally, or partially so, the weight of the armature tends to overcome the force of the armature return spring. To correct this condition, it is necessary to apply more pressure to the armature return spring, ensuring the armature's positive return.

2.01 Remove the counter from its mounting, break the wax seal located on the cover opposite the manufacturer's name plate. Remove cover, and place assembly in position shown in sketch: vertical with feed pawl down. Loosen locknut on adjusting screw. Do not remove the number wheel. It is omitted from the sketch in order to more clearly show the portion on the assembly being affected by the adjusting process.

2.02 Using a TP 138-55 8 oz. scale applied to the midpoint of the armature's leading edge as shown in Fig. 1, the adjusting screw shall be tightened until it requires a min. of 2 oz. to max. of 2 1/2 oz. to just move the armature. Do not apply enough pressure to move the numbers wheel. This will be adequate to ensure positive action.

2.03 Upon completing the adjustment, tighten the locknut on the adjusting screw, replace cover and remount the counter.
