Lenovo ThinkCentre A70z Backlight Cable Replacement

The ThinkCentre A70z Monitor lamp turns off so can't see display without a light to verify LCD screen is working.

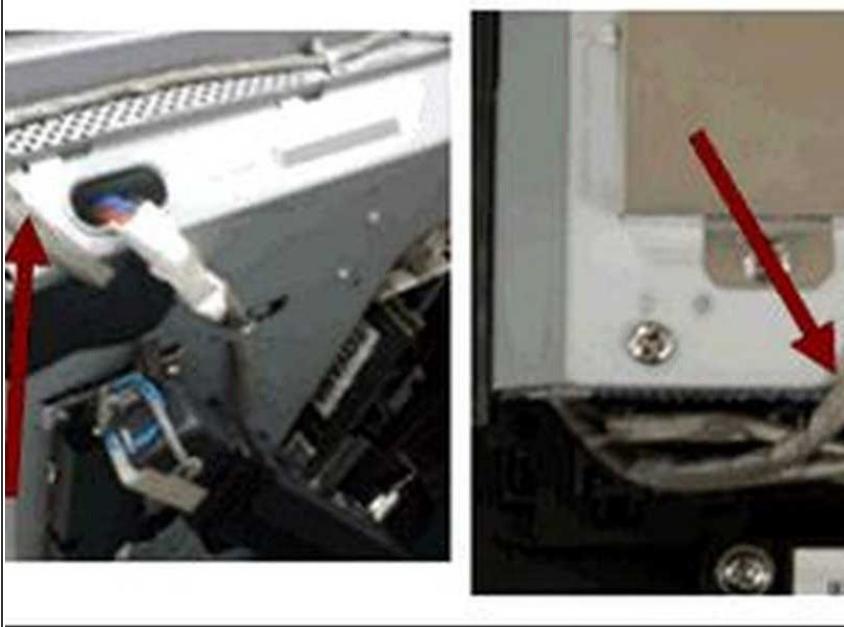
Step 1 — Remove Conductive Tape from Backlight Cable

The issue is caused by the conductive tape wrapped around the backlight cable as seen below.

The issue has a low failure rate with the woven type of conductive tape. However, has a high failure rate with an aluminum foil type of conductive tape.

LG panel mentioned, "do not attach a conducting tape to lamp connecting wire directly. If the lamp connecting wire attach to a conducting tape. LCD module will have a risk for low luminance.

I removed the conductive tape wrapped around the backlight as noted and now the computer is working great again other than a login issue that will be corrected with a Windows 10 reset or I'm thinking a fresh install of a Linux OS for a multiboot system.

- Remove conductive tape wrapped around the backlight cable as below seen below.
- The issue has a low failure rate with the woven type of conductive tape. However, has a high failure rate with an aluminum foil type of conductive tape.
