Motorola Tablet Xoom 2 USB Port Repair

REPAIR ON MOTOROLA MZ617 USB PORT GUIDE

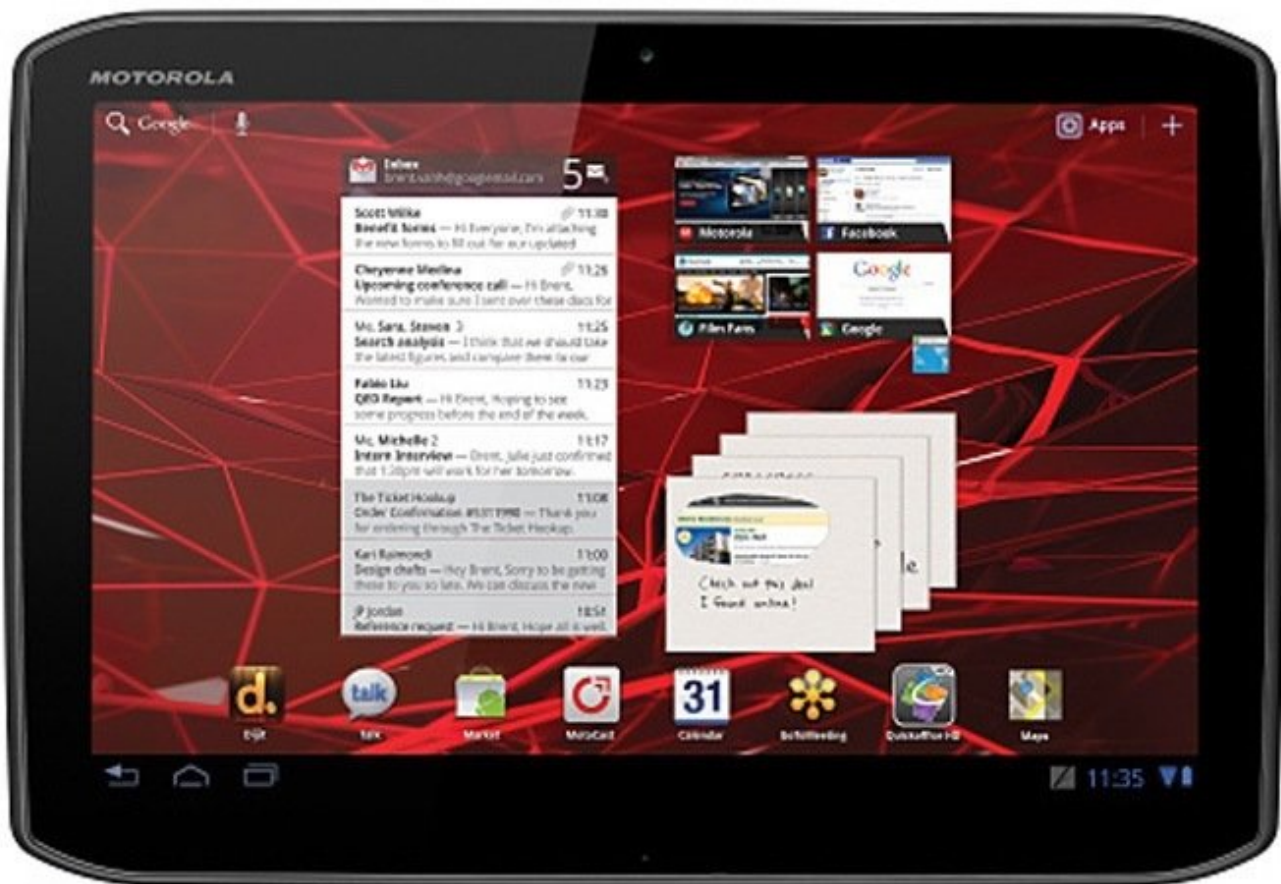
2 issues:

bricked battery and

USB port lifted on the MZ617

Direct charging batteries, reinforcing with Loctite Chipbonder helps with lifted USB port.
