Philips Wake-Up HF3520 Power supply repair

Flashing or flickering light when using radio can be caused by a malfunctioning switchmode power supply IC.

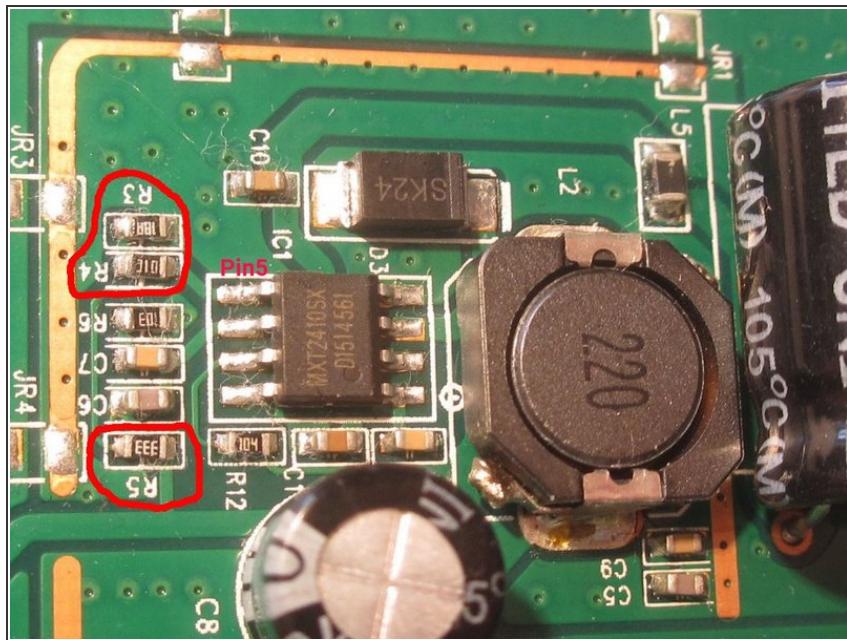
Step 2 — Replace IC

The IC (chip) inside the lamp seems to die slowly resulting in flickering/flashing lamp operation when using the radio. Also the buttons may become unresponsive.

The problem occurs specifically when the device is cold and/or humid. Heating up the IC makes it work again.

- On the main PCB with the power-jack, replace the MTX2410 switchmode regulator IC (SO-8 Package).
- There is a pin-compatible device from Quorvo (ACT4060ASH-T) which has a different internal voltage reference but otherwise works fine. Only a resistor must be changed for this to work.
- Feedback Voltage for MXT2410 is 1.222V, for ACT4060 is 1.293V, so voltage divider on Pin5 must be changed accordingly.
 - One can best adjust R4+R3 (series). Remove R4, measure R3 and R4, and increase. It should measure about 10.67kOhm (R3 plus R4), and it can be slightly increased to 11.51kOhm. So basically add 1kOhm to R3+R4.
