Philips Wake-Up HF3520 Power supply repair

Flashing or flickering light when using radio can be caused by a malfunctioning switchmode power supply IC.

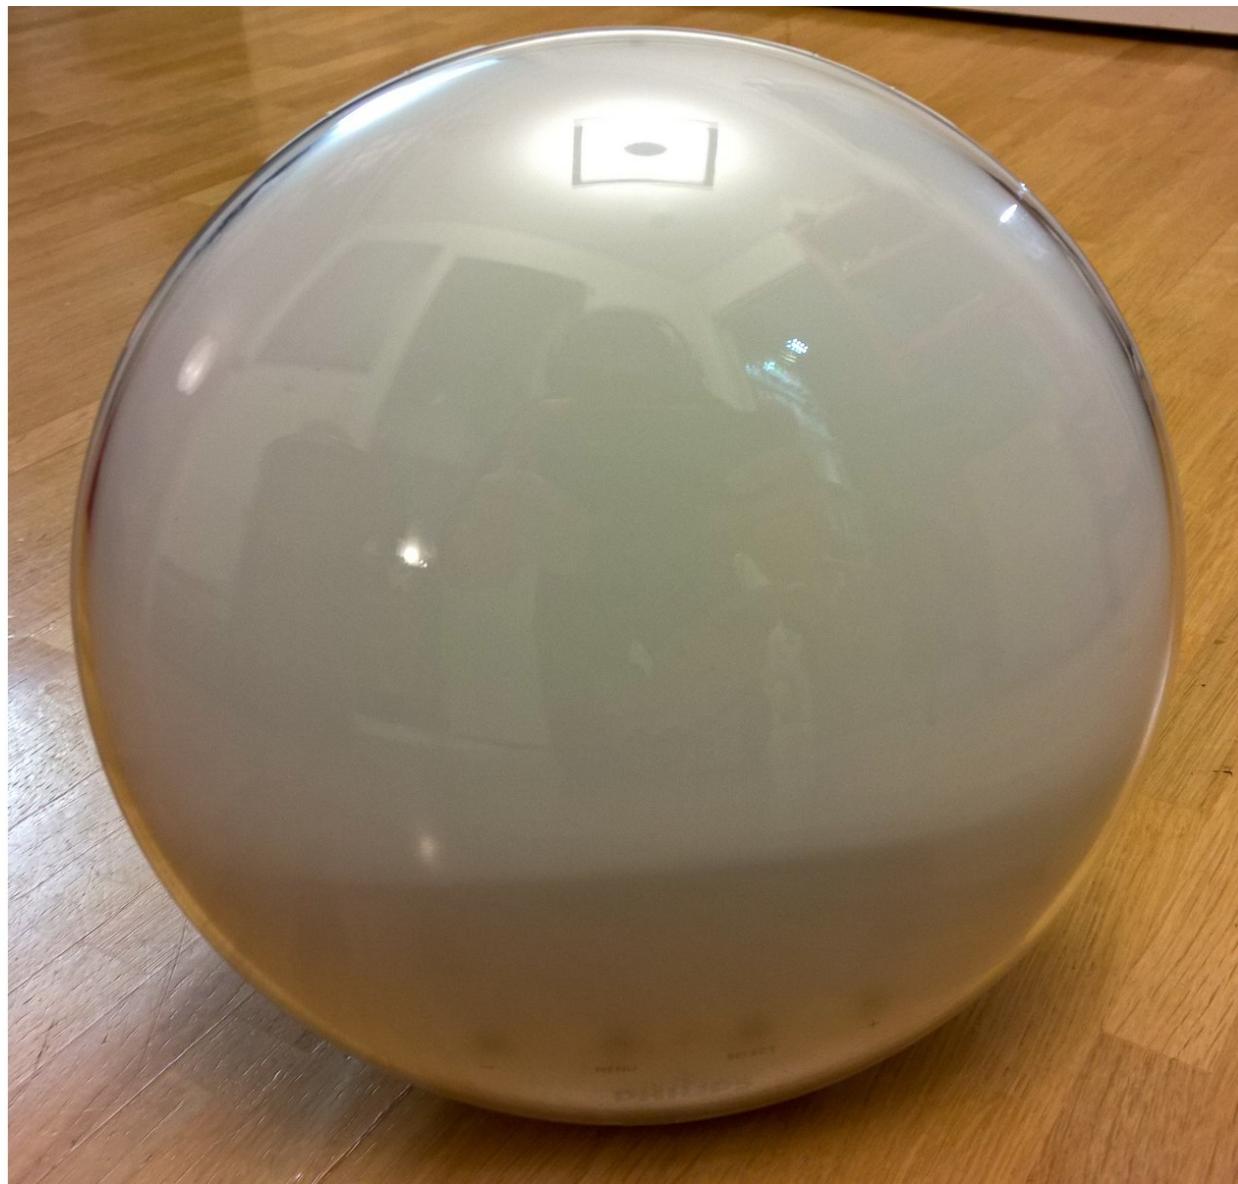
The IC (chip) inside the lamp seems to die slowly resulting in flickering/flashing lamp operation when using the radio. Also the buttons may become unresponsive.

The problem occurs specifically when the device is cold and/or humid. Heating up the IC makes it work again.

- On the main PCB with the power-jack, replace the MTX2410 switchmode regulator IC (SO-8 Package).
- There is a pin-compatible device from Quorvo (ACT4060ASH-T) which has a different internal voltage reference but otherwise works fine. Only a resistor must be changed for this to work.
