iPhone 7 - Replace U3101 Audio IC

Fix the Audio problem that affects iPhones 7 and 7 Plus with this method! Requires soldering.

Audio issues on iPhone 7 and iPhone 7 Plus

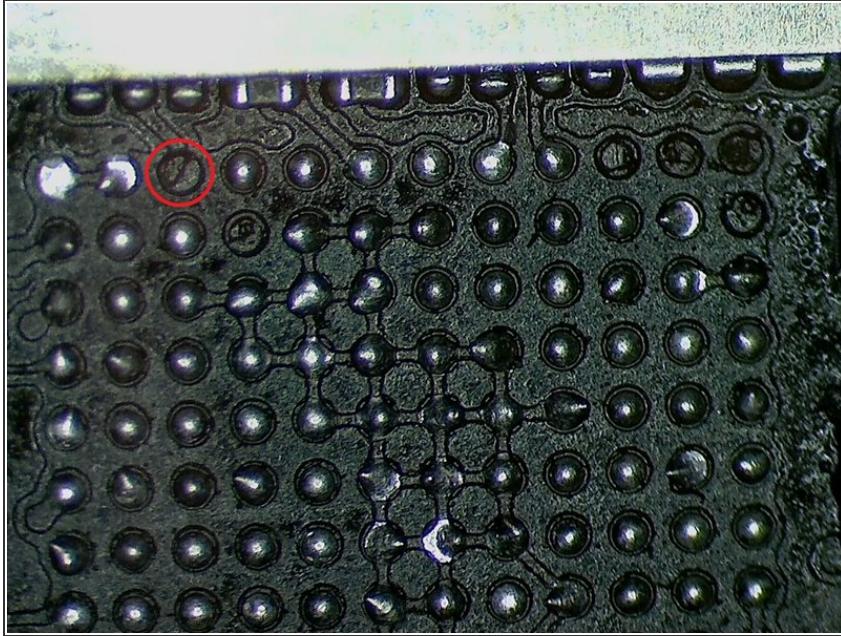
Step 1 — Remove U3101

- Remove the chip cleanly, with warm air. On my Quick 861DE station, I use as settings 400 °C and 100L / min. For you to decide which settings you prefer, you can find the Quick 861DW on the shop.
- Clean the tracks with a soldering iron, tin and flux. I use a tip about 1mm in diameter with my JBC Nase 2C, at 360 °C.
- Clean the map.
- Inspect the card under the microscope. We can see on the picture below that a track is missing!
