iPhone X Bottom Speaker Not Working Repair

Written By: Phryne

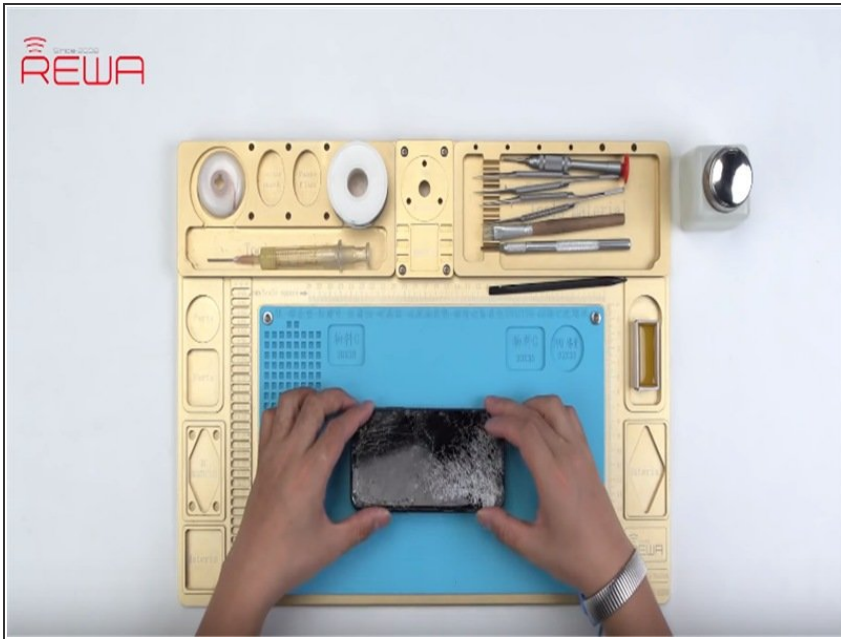
Step 1 — iPhone X Bottom Speaker Not Working Repair

- The phone features a broken screen and a deformed housing. Get a new display assembly installed and test, the phone turns on normally. There is no output sound when selecting a ringtone. Yet the sound works fine with headphones in.
- The preliminary judgement is that the audio circuit is in normal condition. It's just that the bottom speaker is not working.

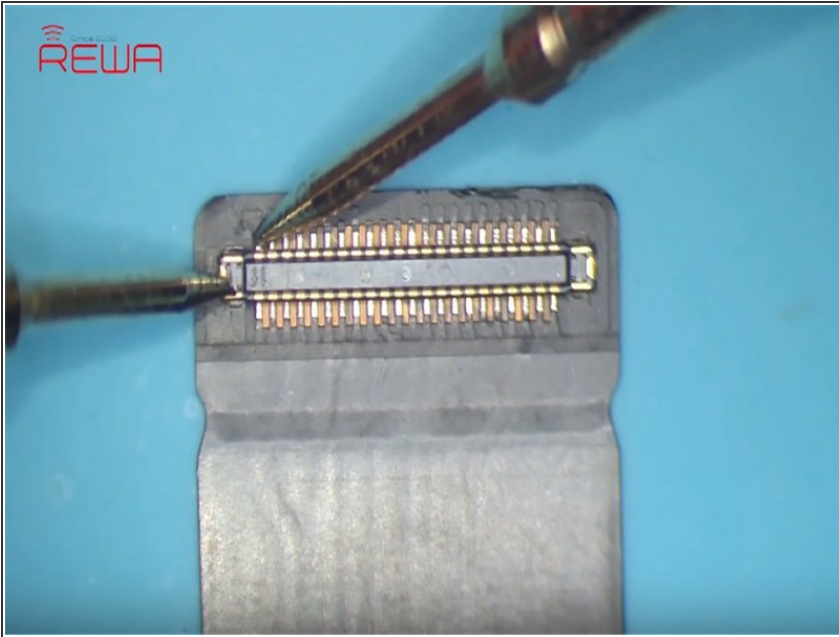
Step 2

- Run diode mode measurement of the DOCK connector. The measured value is normal. Which indicates that the bottom speaker is in normal condition.
- Continue to measure the motherboard connector. Judging by the measured value, relevant circuits of one Pin on the connector has open-circuited.

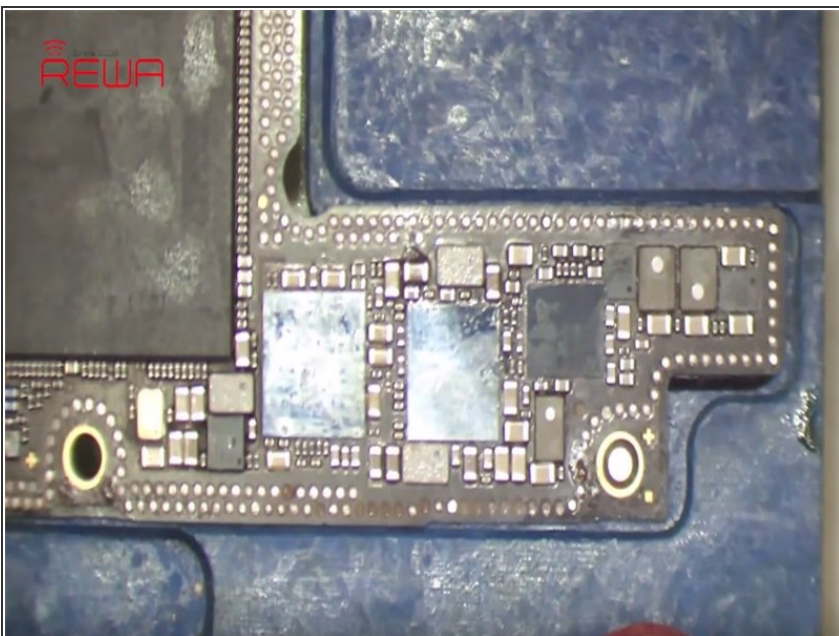
Step 3

- Remove the upper layer with Hot Air Gun. We can see that there are multiple missing pins on the upper layer.
- Judging by this, the phone has been dropped, which also resulted in pseudo soldering of the motherboard, accompanied with the detachment of pins.

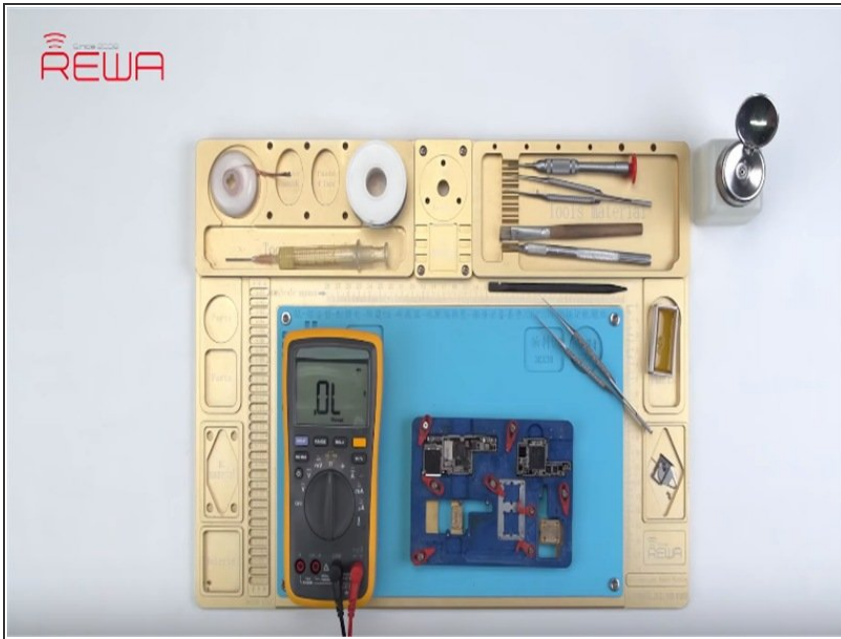
Step 4

- Run diode mode measurement of Pin S162 and Pin S163. The measured value is normal.
- Judging by this, the open-circuited condition is caused by pseudo soldering of the third space PCB.

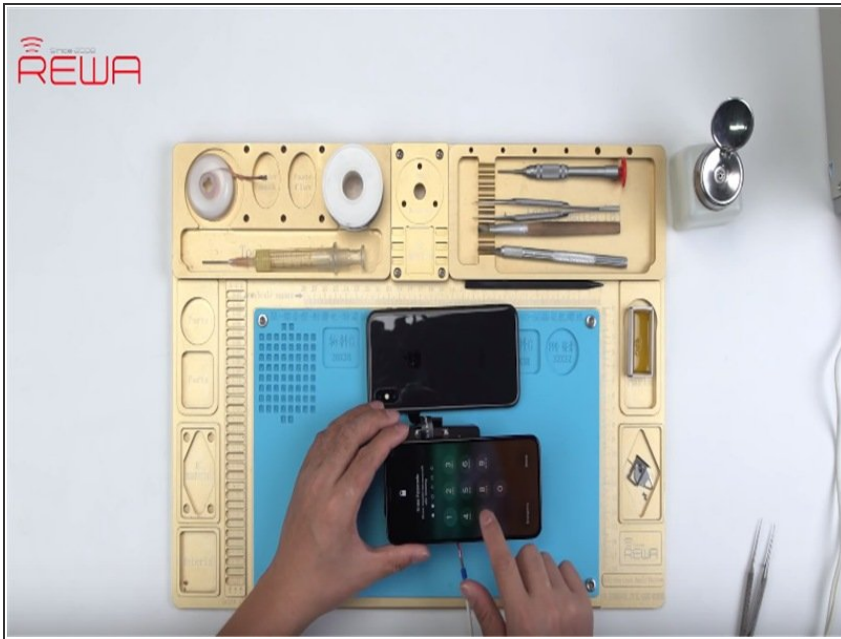
Step 5

- Get the motherboard installed to the testing kit and test. Current reading on the ammeter is normal. Go to Settings>Sounds&Haptics>Ringtone. Select a default ringtone. Normal output sound this time.
- We can confirm now that the fault is caused by pseudo soldering of the third space PCB. We can fix the problem by soldering the two layers together.
