Brocade Fabric OS v2.6.1d Release Notes_v1.0

January 14, 2004

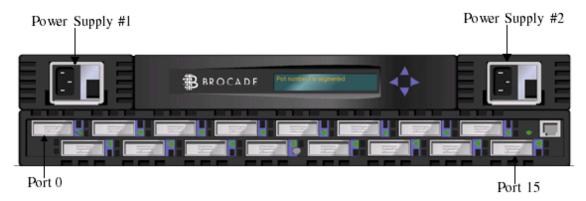
Figure 1-1 on page 1-1 of the *SilkWorm 2800 Hardware Reference Manual* has mislabeled callouts. The power supplies 1 and 2 are reversed; they should be labeled as follows:
