Brocade Fabric OS v2.6.1e

Release Notes_v1.0

March 15, 2004

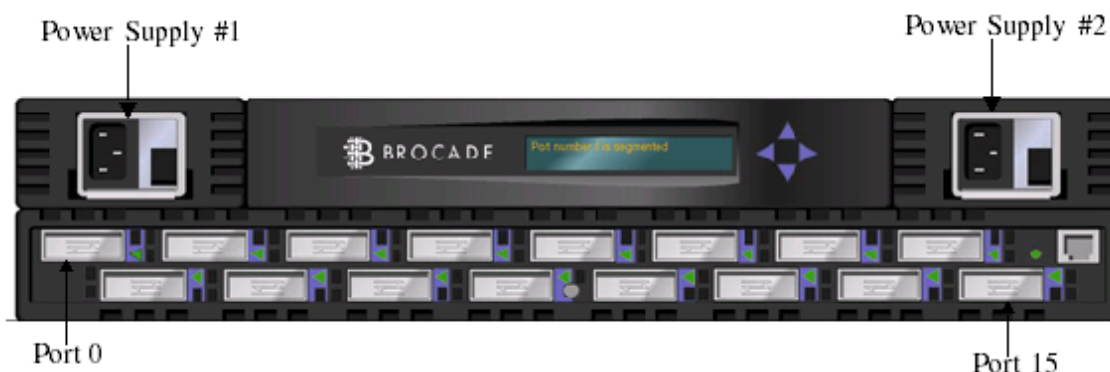
Figure 1-1 on page 1-1 of the *SilkWorm 2800 Hardware Reference Manual* has mislabeled callouts. The power supplies 1 and 2 are reversed; they should be labeled as follows:
