To FlashPort upgrade a Mobile radio:

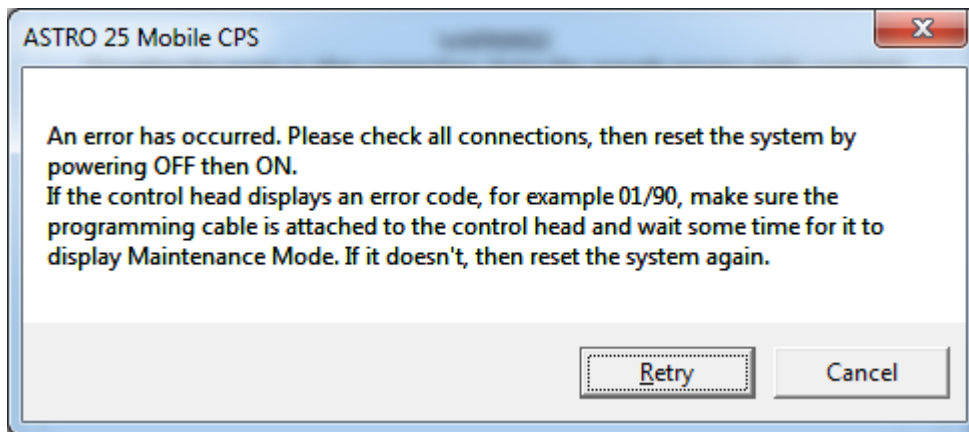
If you've attempted to flash upgrade the mobile radio through control head and it failed (see screen shot below – do not press “Retry” or “Cancel” until you perform the process detailed below the screen shot),

Perform the following process to fix it:

1. Power down radio
2. Press the power button + orange emergency button + right-most menu button simultaneously to force the CH into bootmode . The Control Head screen should be green now.
3. Now the USB will enumerate again and one can resume Flashport upgrading by pressing “Retry” on the CPS screen, (again, please refer to the screen shot above).
