# Technical Note TN-3255-SR

## TB9100 / Console Gateway / P25 TAG

### Version 4.10 Release Note

29 March 2022

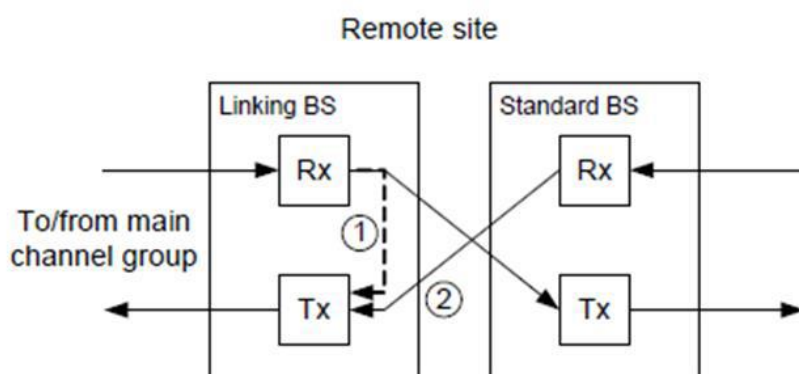
1. Although the linking base station at the remote site is configured as a linking transceiver and the Allow loopback check box is cleared, loopback can still occur sometimes, as shown in the above diagram 1. This happens at the end of a call from a radio at the remote site and may result, depending on configuration, in an endless loop. Another call or putting the base station in standby ends the loop.
2. If the remote site is stressed by several quick PTT presses in succession, the linking base station may not transmit the call back to the main channel group (2 in the above diagram). (TIMS00077806). Workaround: Contact Tait for assistance.
