TECHNICAL NOTE TN-969f

How to Upgrade Firmware in TM8100 and TM8200 Mobile Radios

1 July 2005
(Updated 20 March 2008)

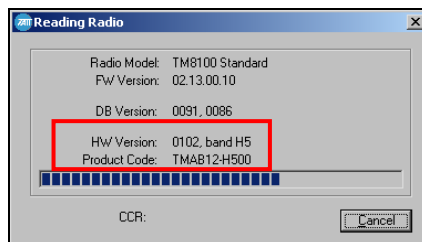
- STEP 2b**
- It is not usually required, but if the TM8100 FPGA image needs to be updated it is critical the correct version only is downloaded or this will render the radio unusable. The original TM8100's were built with 1C6 FPGA's and these can be identified with Hardware v01xx.

After serial number **19257949** in April 2007 TM8100's are built with 2C5 FPGA's and these are identified with Hardware v02xx.

The FPGA file for a 1C6 is TM8100_FPGA_v01xx and the FPGA file for a 2C5 is TM8100_FPGA_v02xx.

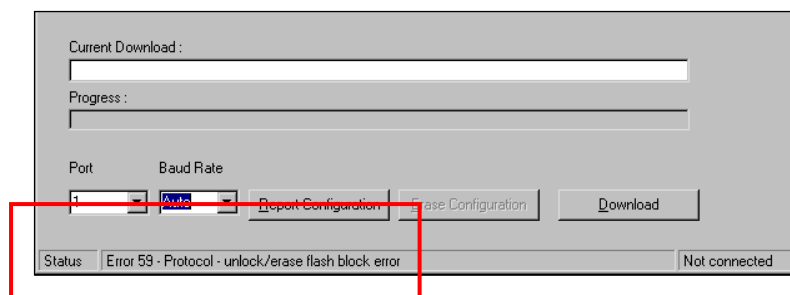
"Error 59 – Protocol – unlock/erase flash block error" in the Download App Status display the radio has not been reset correctly as defined in Step 2b.

Ensure the DC supply is removed from the radio as this correctly resets the FPGA device.
