**TECHNICAL NOTE TN-1234-AN**  
**TM8000, TM9100 and TP9100 Firmware  
Upgrade Process**

7<sup>th</sup> March 2007

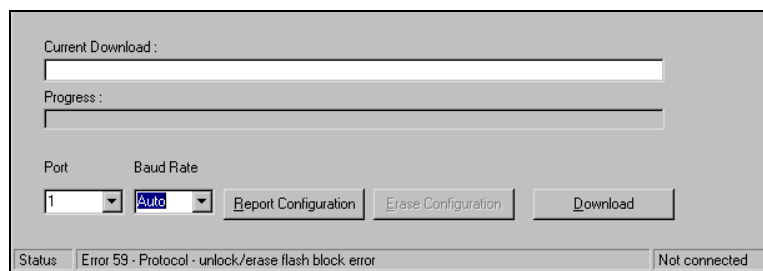
## Getting Error 59 ?

"Error 59 – Protocol – unlock/erase flash block error" in the Status display the radio has not been reset correctly as defined in Step 3b above. Ensure the DC supply is removed from the radio as this correctly resets the FPGA device.
