Technical Note TN-3448-SR

This Software Release note applies to DMR cadence releases of v3.x software.

10 May 2024

DMR Cadence v3.04 (R24.1)

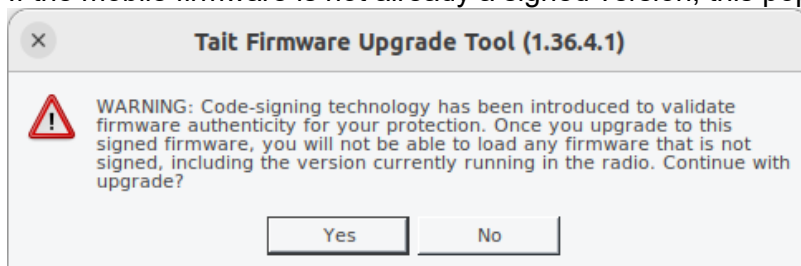
The release of the color control heads requires the TM9300 and TM9700 bodies using (or intending to use) these to upgrade to exactly match the control head's firmware.

If not done so the head will display 'Firmware Mismatch'.

If the mobile firmware is not already a signed version, this pop-up may also appear:

See further details in TN-3397c-AN.

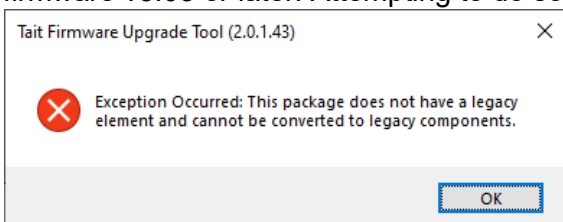
TP9300 and TM9300's that are operating with firmware v2.xx cannot be upgraded directly to firmware v3.03 or later. Attempting to do so will display this pop-up:

They must first be upgraded to firmware v3.01-**signed**.

From v3.01(signed) the radios are able to upgrade to v3.03 or later and can also downgrade later to v3.01 (signed) if required.

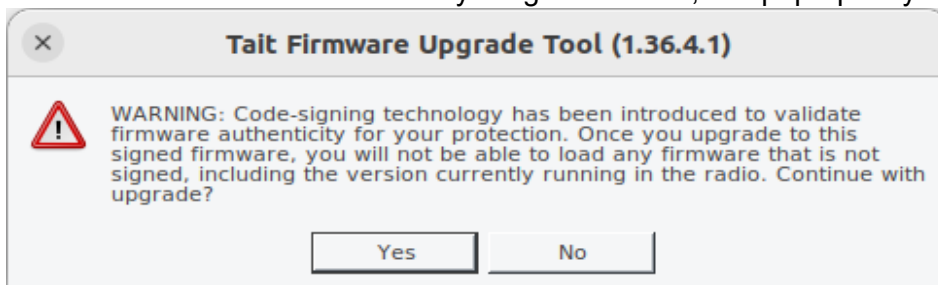
The release of the color control heads requires the TM9300 and TM9700 bodies using (or intending to use) these to upgrade to exactly match the control head's firmware. If not done so the head will display 'Firmware Mismatch'. If the mobile firmware is not already a signed version, this pop-up may also appear:

See further details in TN-3397c-AN.

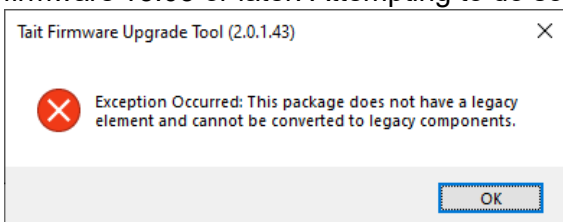
TP9300 and TM9300's that are operating with firmware v2.xx cannot be upgraded directly to firmware v3.03 or later. Attempting to do so will display this pop-up:

They must first be upgraded to firmware v3.01-**signed**.

From v3.01(signed) the radios are able to upgrade to v3.03 or later and can also downgrade later to v3.01 (signed) if required.

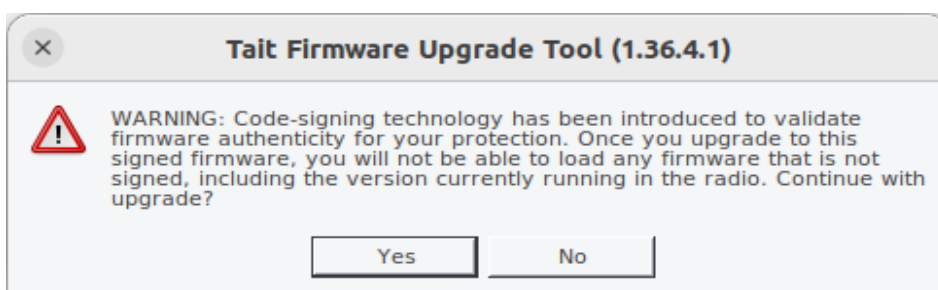
The firmware in the body must exactly match the firmware in the control head.

At the start of the upgrade this pop-up will appear:

See further details in TN-3397c-AN.
