**NUMBER NETWORK FRAME**  
**313A AND 313B PANELS**  
**PIECE-PART DATA AND REPLACEMENT PROCEDURES**  
**NO. 1 CROSSBAR OFFICES**  
**ARRANGED FOR ANI-TYPE B**

**1.02** This section is reissued to include piece-part data and replacement procedures for the three types of network assemblies available. Figures have been added to show the latest equipment design.

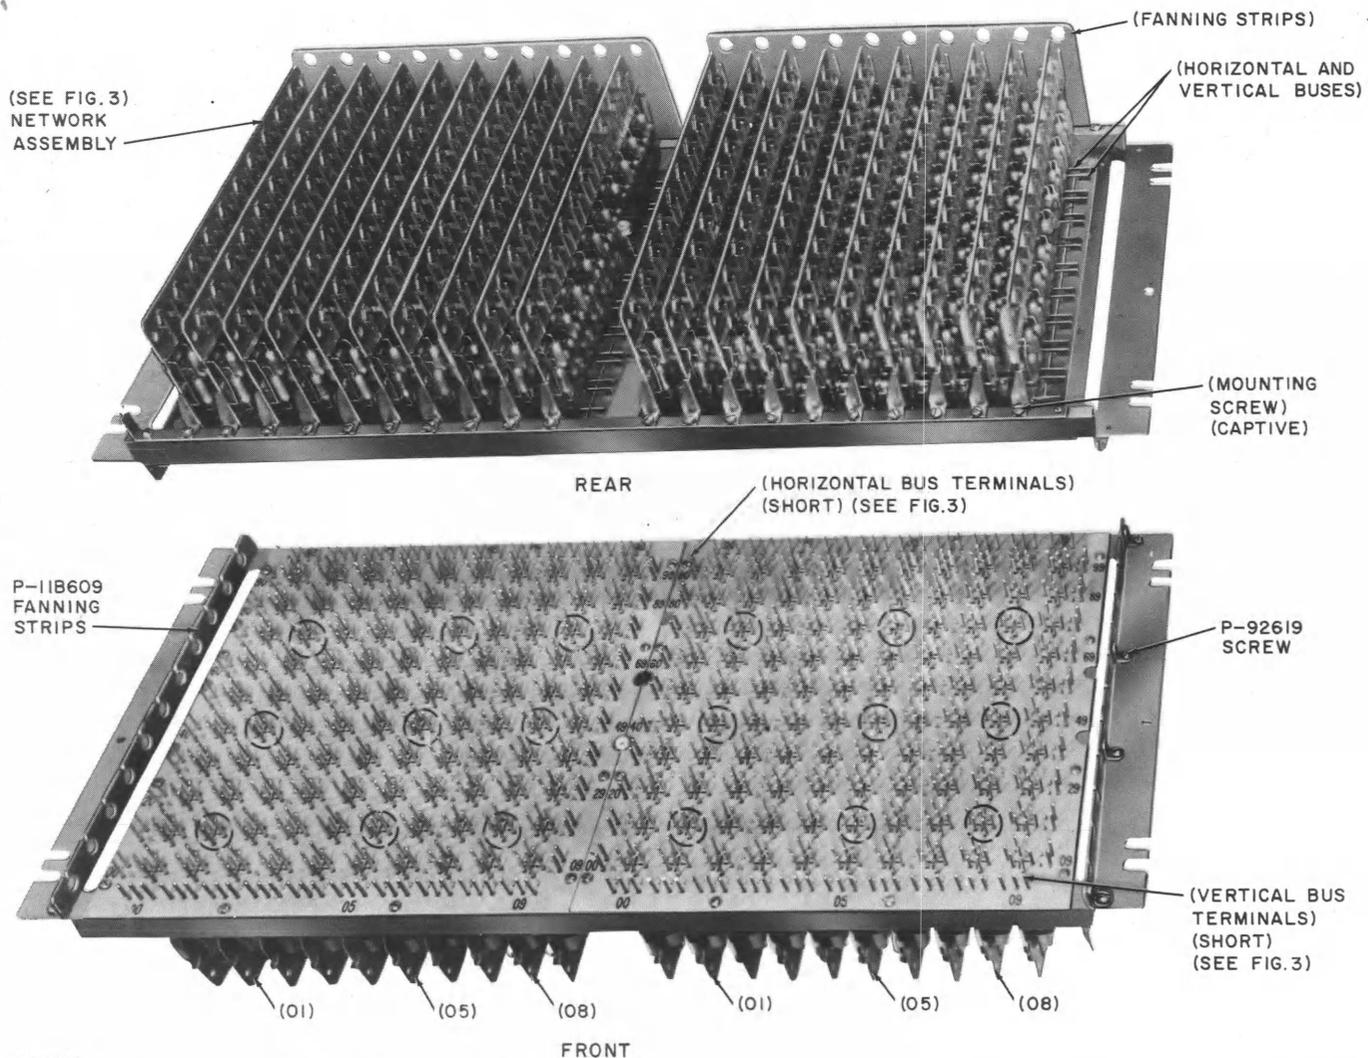
**Fig. 1—313-Type Panel—Front and Rear Views—313A Panel Shown**

**2.04** The early design of the 313A network panel was such that the panels could be bowed inward by the wrapping tool while placing cross-connections. This bowing resulted in crosses between network terminals and buses. To overcome this, bushings were placed on certain terminals of particular network assemblies in each panel [Fig. 1 and 2(A2)]. On panels of later design, the terminals were made with a longer shoulder [Fig. 2(B1)] which reduced this bowing and should have eliminated the need for bushings. However, bowing was not entirely eliminated and a new bushing [Fig. 2(B2)] or a mylar strip [Fig. 2(B3)] was used on the panels, the strip being used for panels in the field. Fig. 2(C) shows the latest type terminal which eliminates the need for either bushing or mylar strip. Network assemblies of early design used a spring clip to hold the capacitor. This clip is not provided on the later design.

1. CIRCLED (O) POSITIONS SHOW THE LOCATIONS OF NETWORKS ON WHICH BUSHINGS PI2B72I OR P40YOI8 ARE USED DEPENDING ON PERIOD OF MANUFACTURE. (POSITION NUMBERS 11, 15, 18, 41, 45, 48, 71, 75, AND 78).
2. PANELS HAVING BUSHINGS PI2B72I (0.266 IN. LONG)(FIG. 2(A2)) HAVE A 1/8 IN. BLACK DOT ON THE REAR OF THE CENTER STRIP OF THE PANEL AND LOCATED APPROXIMATELY 2 IN. ABOVE THE BOTTOM. PANELS WHICH HAVE HAD THESE BUSHINGS INSTALLED IN THE FIELD HAVE A 3/16 IN. DIAMETER BLACK CIRCLE. PANELS HAVING BUSHINGS P40YOI8 (0.065 IN. LONG) (FIG. 2B2) HAVE A BLACK X IN THE SAME LOCATION.
3. PANELS INCORPORATING THE LATER TYPE TERMINAL (FIG. 2B1) HAVE A 1/8 IN. BLACK DOT ON THE REAR OF THE CENTER STRIP OF THE PANEL AND LOCATED APPROXIMATELY 2 IN. BELOW THE TOP.
4. PANELS INCORPORATING THE (MYLAR) STRIP P44FI47 (FIG. 2(B3)) WILL HAVE NO MARKING SINCE IT IS VISIBLE

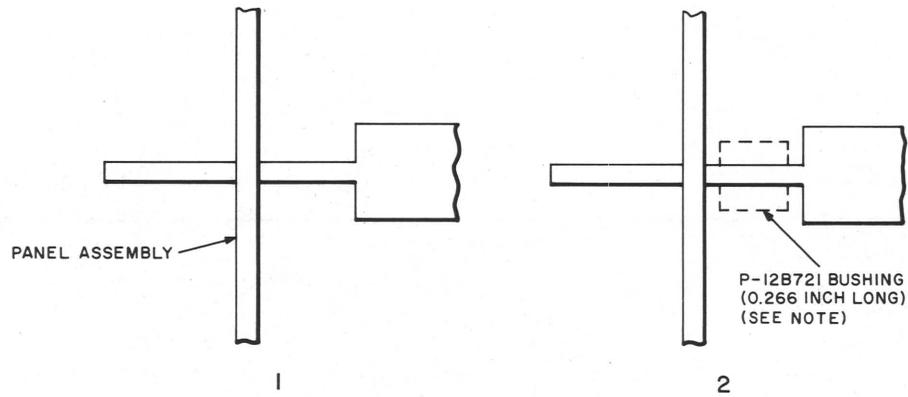
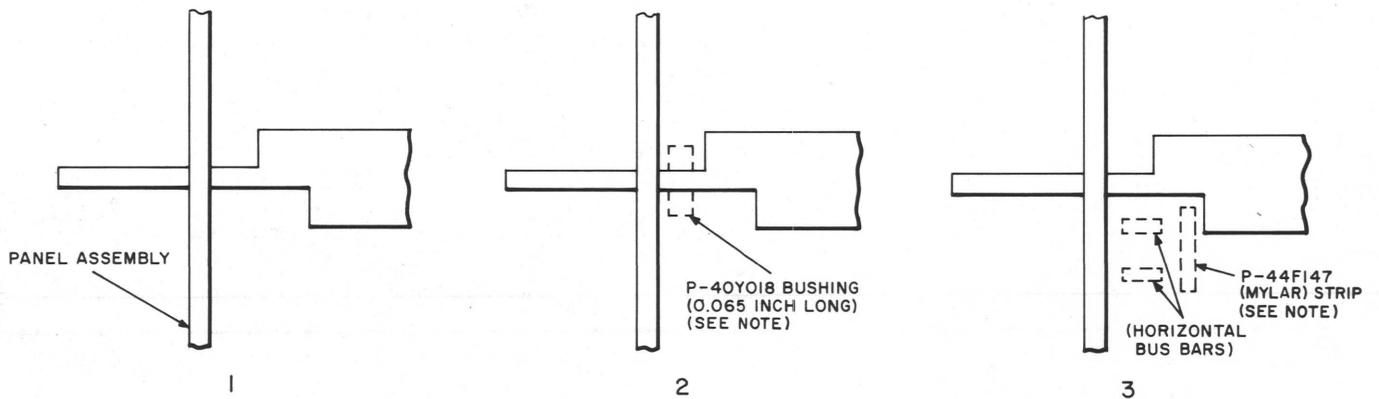
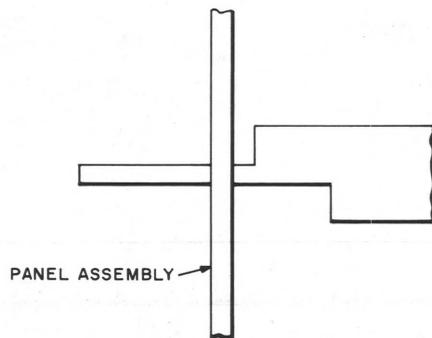
Fig. 2—Number Network Terminal Design, Bushings & Strip

A-EARLY DESIGN TERMINAL

B-LATER DESIGN TERMINAL

C-LATEST DESIGN TERMINAL

**Note:** A bushing (0.266 of 0.065 inch long, depending on period of manufacture) may have been installed over certain terminals on the defective network assembly. Also, some network assemblies may have had a mylar insulating strip instead of the bushing placed

between the horizontal bus bars and the terminals in the field. These bushings or mylar strips are not required on the replacement assembly since the latter will normally have terminals of the latest design.

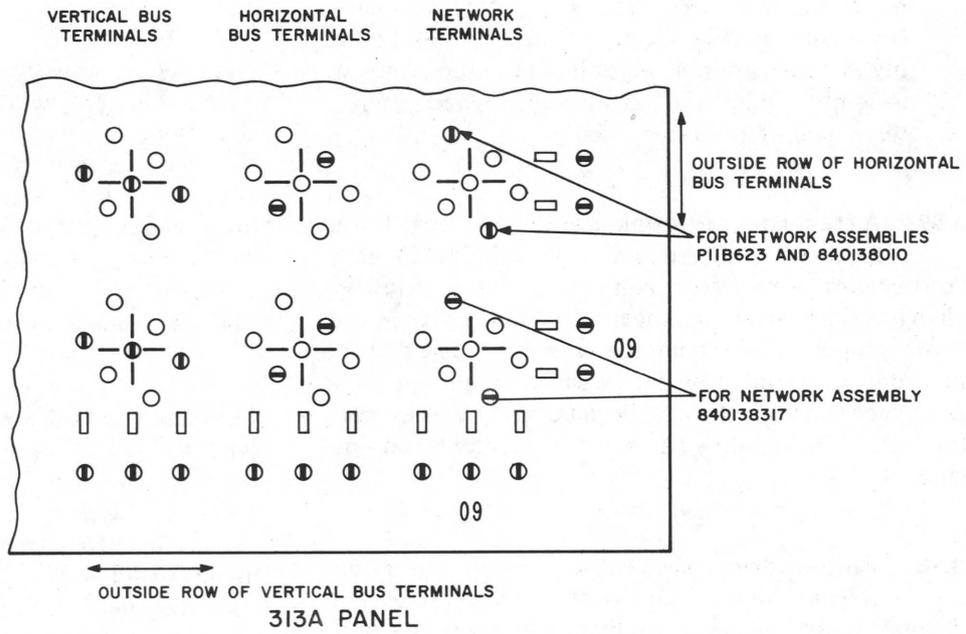
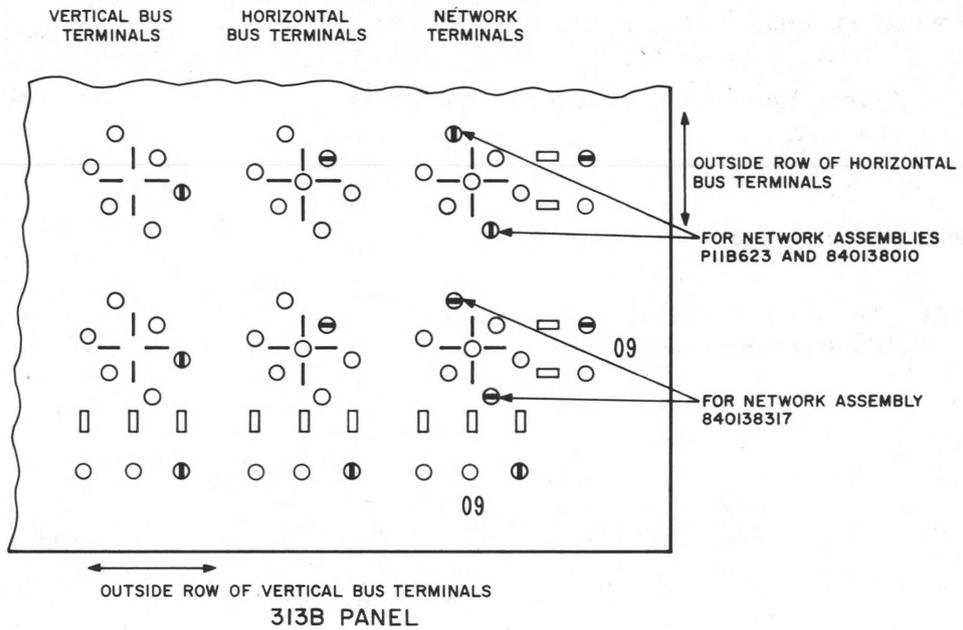
Fig. 3—View of Terminal Ends—Lower Right Corner Shown

**3.11** Terminals which have been broken from the bus cannot be replaced.

**3.12** To remake the connection which is broken, unwrap the other end of wire which is wrapped to the network terminal. Discard this wire. Using a sufficient length of insulated-type BU, 24-gauge red wire, make the connections from the affected network terminal to the nearest outside vertical or horizontal bus multiple terminals used in secondary network connections. This connection should always be made to the same bus which had the broken terminal. The red wire will indicate that the connection was a repair and is therefore nonstandard.
