ADDENDUM

“DATASPEED®” PRINTER

RECEIVE-ONLY STATION

CHECKOUT AND TROUBLESHOOTING

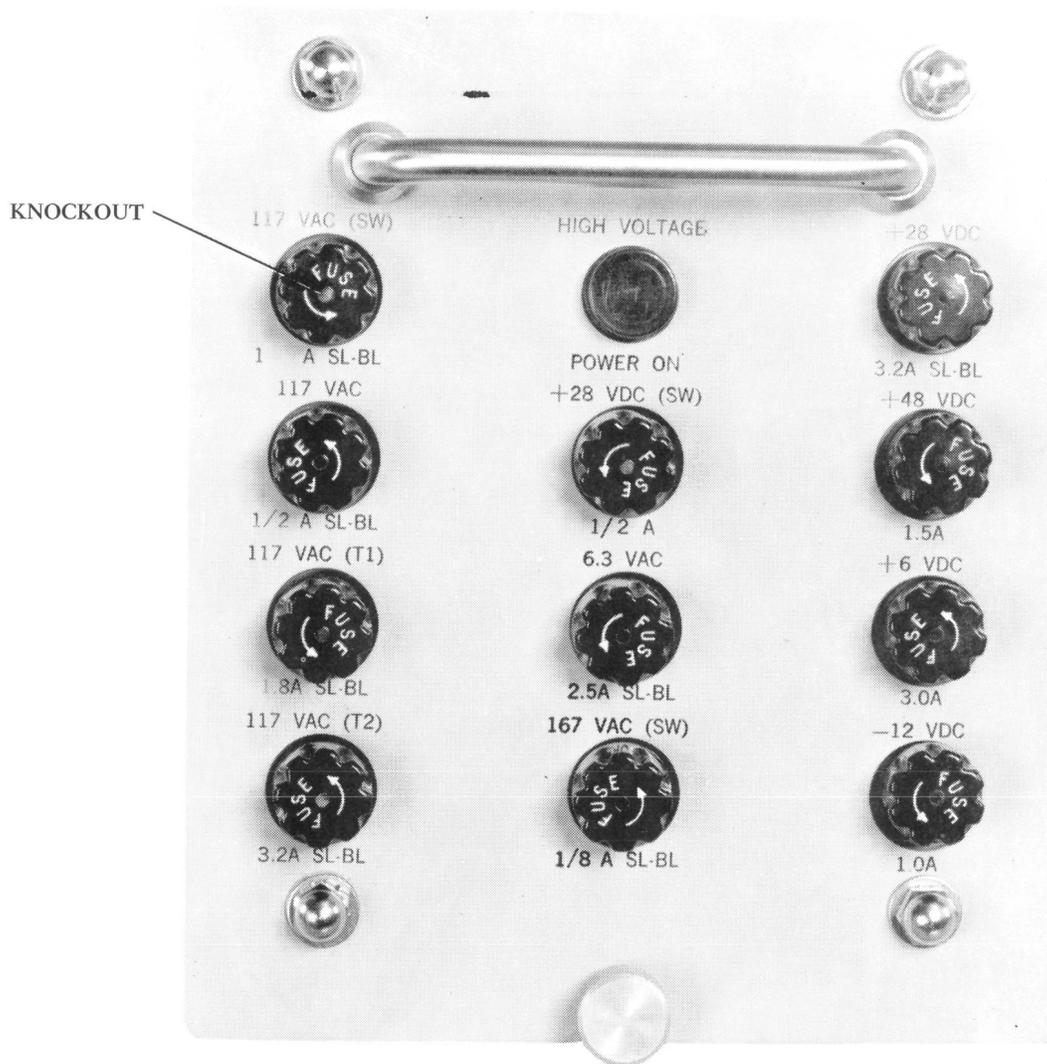
Figure 19 - Location of Knockouts on Power Supply Fuses

Note: All power supply fuses have plastic knockouts in the center of the cap (Figure 19). A meter can be used to measure voltages at fuses (through knockouts) with respect to frame to determine whether any voltages are missing or too low.
