BCG800XL Grinder Jamming due to Worn Impeller

This guide will walk through replacing the impeller to fix the most common cause of jamming with the Breville BCG800XL and BCG800 Smart Grinder.

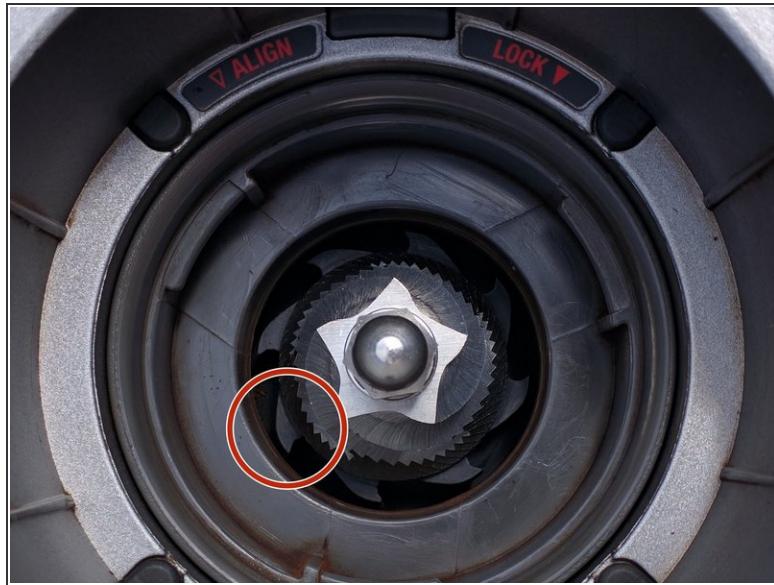
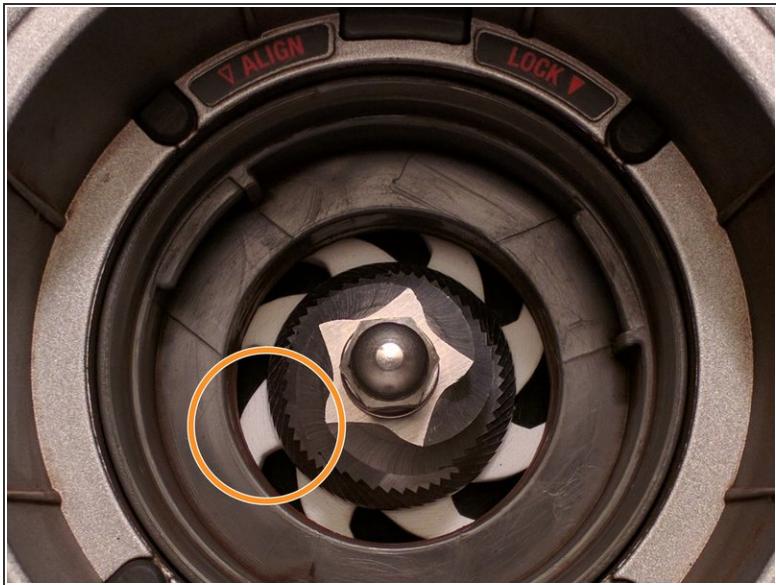
Step 1 — Inspect your grinder impeller

- Remove the hopper and take the upper burrs out. Empty out any coffee grounds (An air gun or vacuum helps) and then inspect the impeller blades.
- If the impeller can fit through the hole (ie: be removed just by taking out the lower burr) then it definitely needs replacement.
- A good impeller should not be removable without dis-assembly and the tips of the impeller blades should not be visible.

If your impeller is made of **stainless steel** rather than plastic you likely have a newer model with significant design changes (eg: BCG820). Stainless steel should not wear out and so your problem is elsewhere.

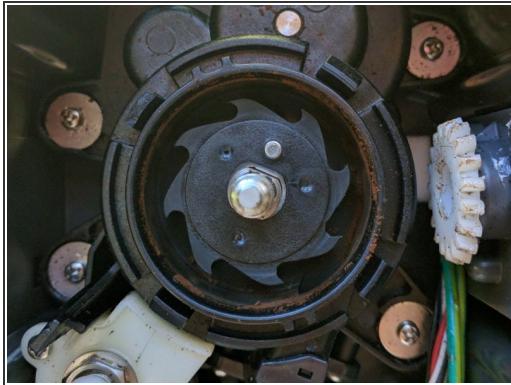
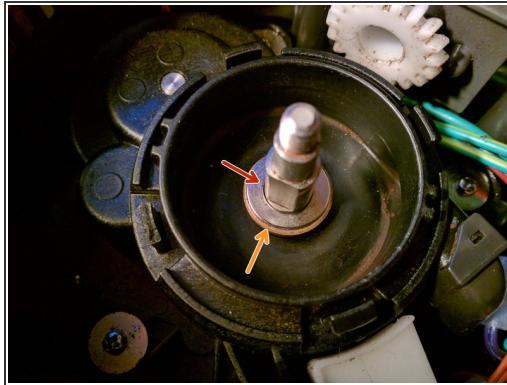
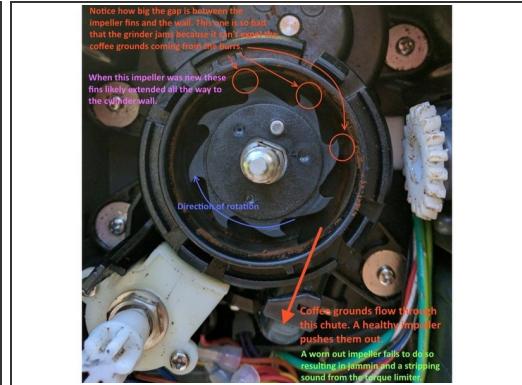
Step 9 — Worn impeller removal

- Lift out the old impeller making sure the **TWO thin steel washers** underneath the impeller do not fall out. These are very important for the overall height of the lower burr and thus grind fineness.
- NOTE: Discard the fibrous felt ring below the impeller. It is usually in pretty bad shape. This piece is no longer needed as the new impeller design hugs the bushing pedestal more closely and does a good enough job keeping grounds away from the bushing and drive shaft.

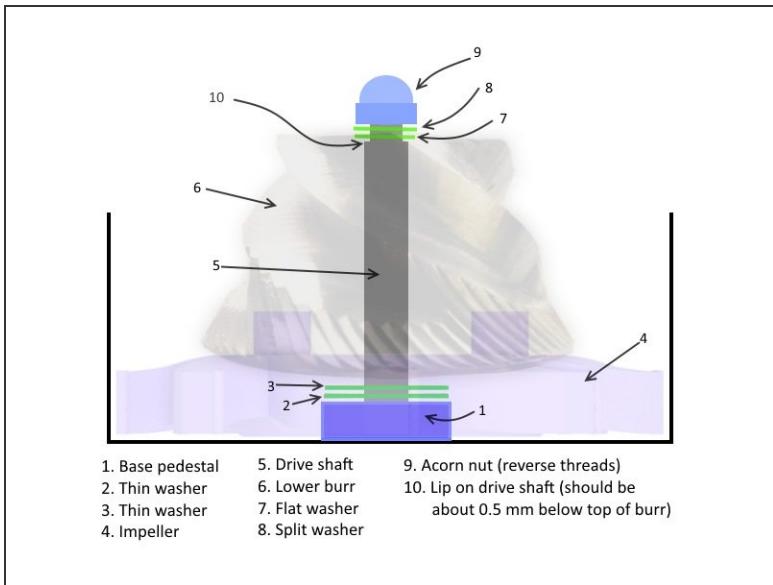
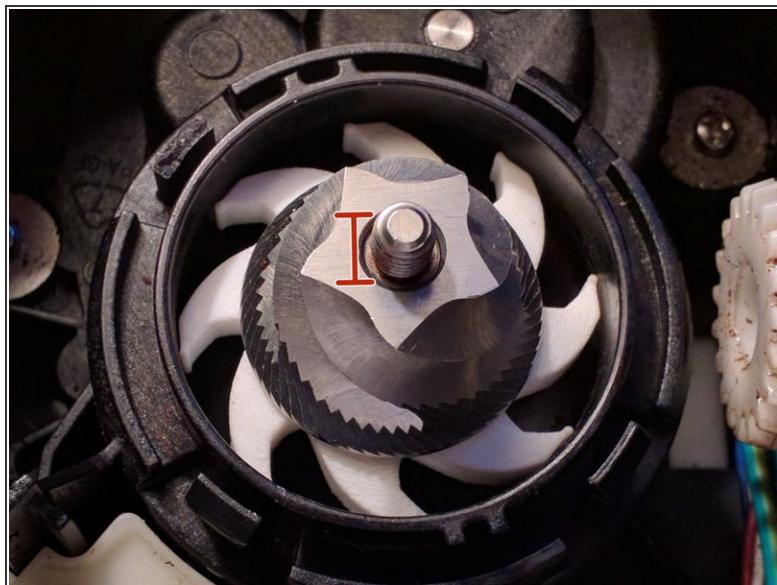
Step 12 — Checking Fit and Burr Elevation

- Before reassembly, check that the conical lower burr and impeller fit well onto the driveshaft with both steel washers underneath. Make sure all parts in the cutaway diagram are accounted for.
- The lip on the drive shaft should be within about 0.5mm of the top surface of the conical burr. When the nut is tightened it will squish to about flush.
- If the burr is too high above the lip on the shaft (higher than in the pic), try putting the acorn nut + washers on (See 7, 8, 9 in the pic), tightening hard, and then taking it back off.
- If the lower burr is still sitting too high on the shaft, take a quick detour to [Step 20](#) and then come back.

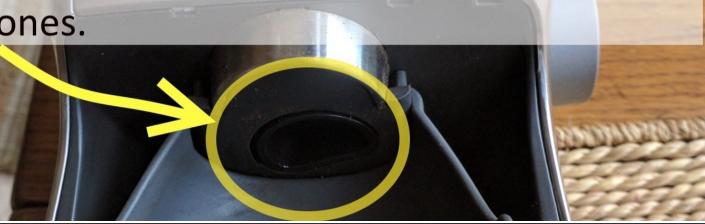
Step 19 — Troubleshooting #1 - Overspray

- If you encounter ground coffee escaping the chute and getting on the counter, it may mean your coffee is too dry, humidity is too low (static charge), or even that the grinder chute is too clean.
- To fix this, try placing a tiny dab of cooking oil on your finger and rubbing it high up inside of the coffee chute. This will allow a fine layer of grounds to coat the walls of the chute.
- The added friction of the grounds on the wall of the chute should slow the velocity of the grounds down enough that the overspray stops.
- FYI: This whole step happens naturally with oily coffee beans, but takes a little longer than with the vegetable oil trick.
- Also for static charge issues, see here:
<https://www.youtube.com/watch?v=T0Dh1W40...>

If you have any coffee grounds coming out too fast and getting on the counter you can fix it by rubbing a tiny drop of cooking oil inside the chute. This allows a fine layer of coffee dust to stick to the walls of the chute and adds a bit of friction to slow down exiting coffee. FYI: This happens naturally with oily coffee beans, but not so much with dry ones.

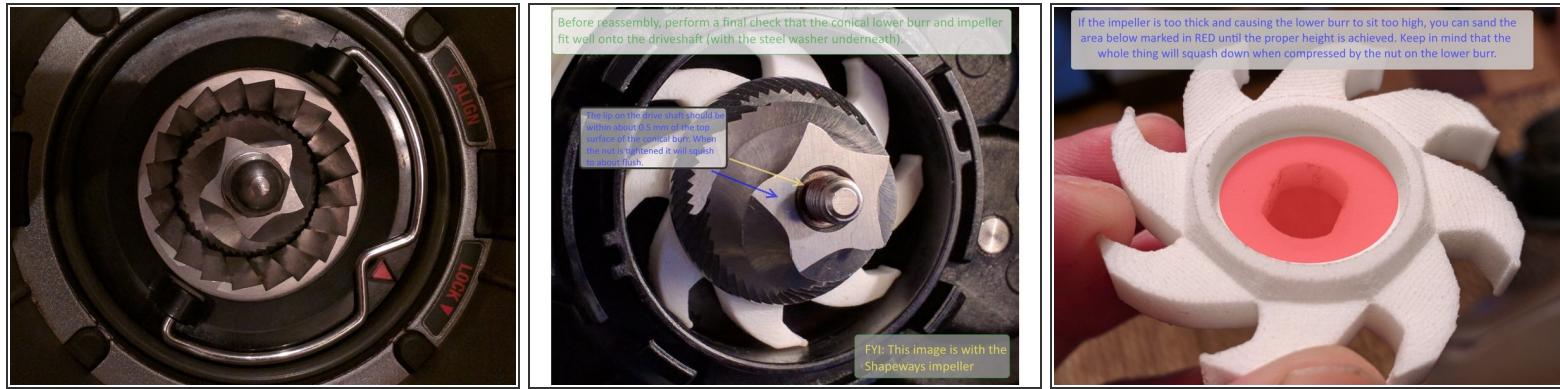
Step 20 — Troubleshooting #2 - Burr Clearance

- **TOO CLOSE** (ie: grinding too fine): If the burrs are too close, or even touching (but centered), the nut on the lower burr may not be tight enough. With the ratchet and 10mm socket, give it a quick counter-clockwise jerk. If that fails, recheck your fit-up against the second photo to make sure the lower conical burr is the proper height.

- **TOO FAR**: If the burrs are too far apart such that the grind isn't fine enough, it could be that the steel washer underneath the impeller got left out. See step #9. Additionally, you can try removing ***one*** of the two washers above the lower burr and not tightening the nut as much. There's also a shim kit offered by Breville if you contact them.

- If it's clear that the lower burr is sitting too high on the impeller, see the 3rd picture and sand the area highlighted in RED. While doing this, periodically install and re-check the lower burr height until it matches photo #2. Careful not to sand off too much as it's easy to remove thickness but hard to add it back.

- Lastly, both of the above issues can happen if the alignment in "Step 12" got shifted. If so, you may need to pop-off and adjust the rotation of the upper-burr holder assembly. This is tricky, but doable. I suggest marking the existing alignment with permanent marker before experimenting.

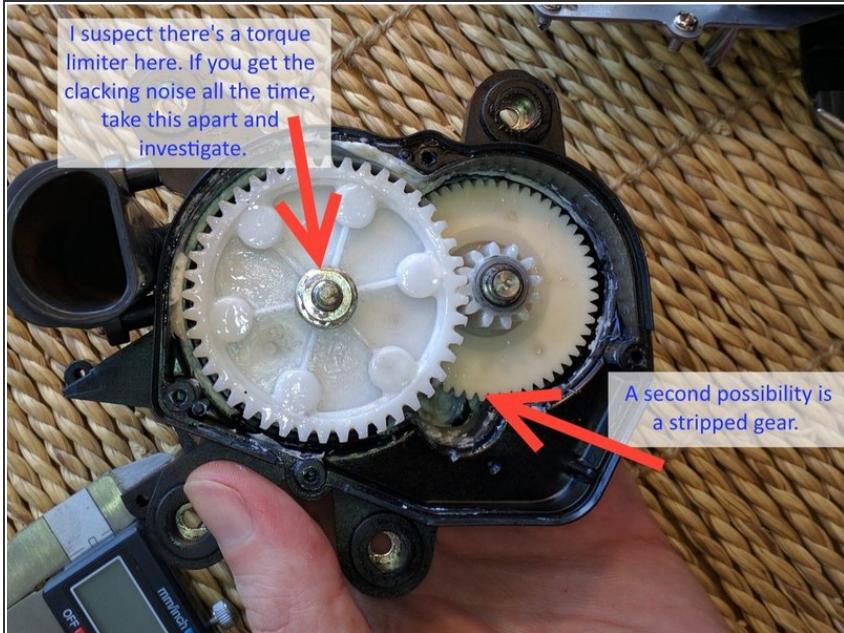
Step 21 — Troubleshooting #3: Horrible clacking sound when running (Even without beans!)

- If it sounds horrible when running (even without coffee beans) like this: <https://www.youtube.com/watch?v=PcQcbHIP...> then it's probably either a damaged torque limiter or a stripped drive gear. FYI: The situation in the video was the aftermath of a rock getting jammed in the burrs.

- I don't cover tear down all the way to the gear box. Step #9 is as close as I go. In the photo though there are 4 washer screws and 2 screws on the encoder. If you remove those you'll be well on your way to investigating the gear box.

- The options to fix either of these are not as well explored, so if there is damage here and you fix it successfully, post a comment below. FYI: Breville has a repair service for about \$90 and that may still be the best option in this situation.

- The torque limiter may be "fixable" by stretching each of the radially-distributed springs about 2mm each. This should increase the torque at which it slips.

- The drive gear on the right has a potential source found by a user below (Thanks Dave Gordon!):
<http://www.forumappliances.com/breve...> This is not yet verified to work, but the price is reasonable, so if you try it out and it works, post below so we can know!

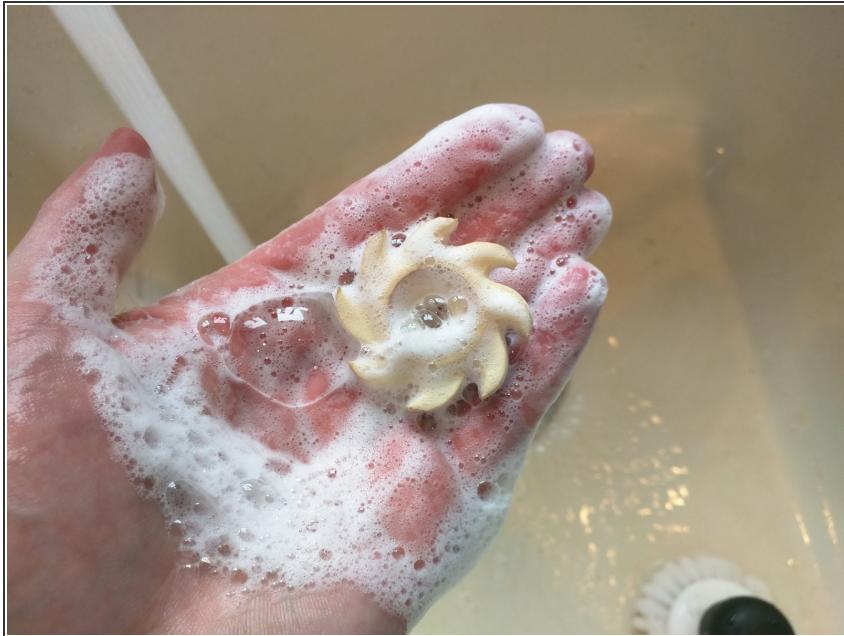
Step 22 — Troubleshooting #4: Static Electrical Charge on Coffee Grounds

- Occasionally a user reports statically charged coffee grounds coming out that seems to defy the laws of gravity. They float up into the air and cling to things, making a mess!
- Often it will stop on its own after the impeller gets a few days of use. It's a bit of a mystery however, I believe the issue arises mainly in dry climates, with certain beans in combination with the plastic impeller.
- To fix the issue, simply give your impeller a scrub and rinse in the sink and then pat it down with a towel until dry.
- This slight bit of moisture seems to take care of static issues permanently. I suspect it gets us by until the impeller builds up a natural coat of coffee, which also serves to prevent static charge.
- See also:
<https://www.youtube.com/watch?v=T0Dh1W40...>

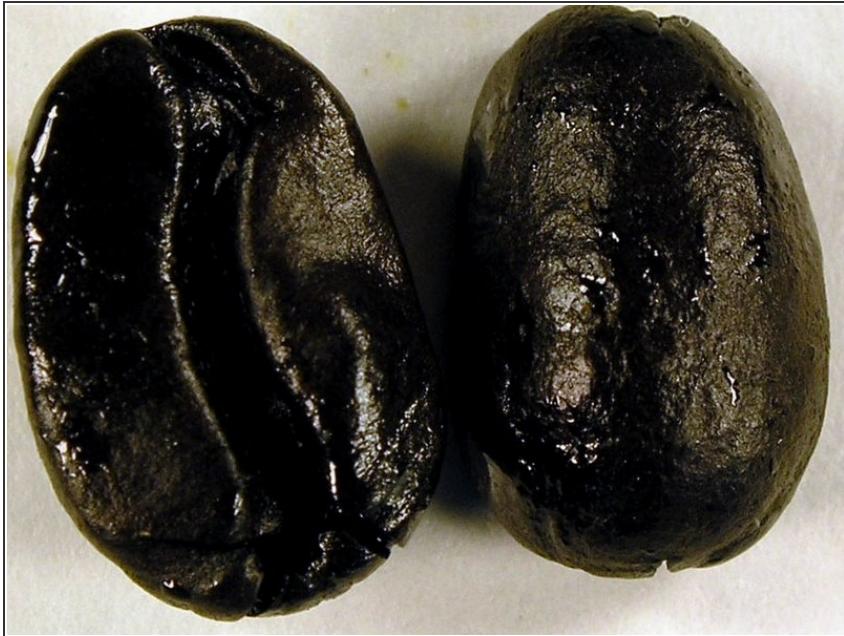
Step 23 — Troubleshooting #5: Clumpy Grounds or Little to Nothing Coming Out

- Some beans, especially the "roasted so dark it's nearly charcoal" variety can be way too oily. The characteristic is that rather than grind to a powder it turns to "paste" in the lower chamber. This is obviously bad, because it then comes out in clumps or not at all.
- Clumpy grounds, for some reason tend to overshoot the portafilter and make a mess. I suspect this is because the large clump size has more mass, and comes out of the chute with too much momentum.
- If you pull the upper burr, and see what looks like a nice smooth black surface where the impeller would normally be, then that's your sign.
- The Fix: Clean the lower chamber, or at least break up the cake of grounds, and switch to a less oily roast.
