Milwaukee Impact Wrench 9070-20 Motor Field Winding Replacement

This guide will provide instructions on how to replace the motor field winding in your Milwaukee Impact Wrench 9070-20.

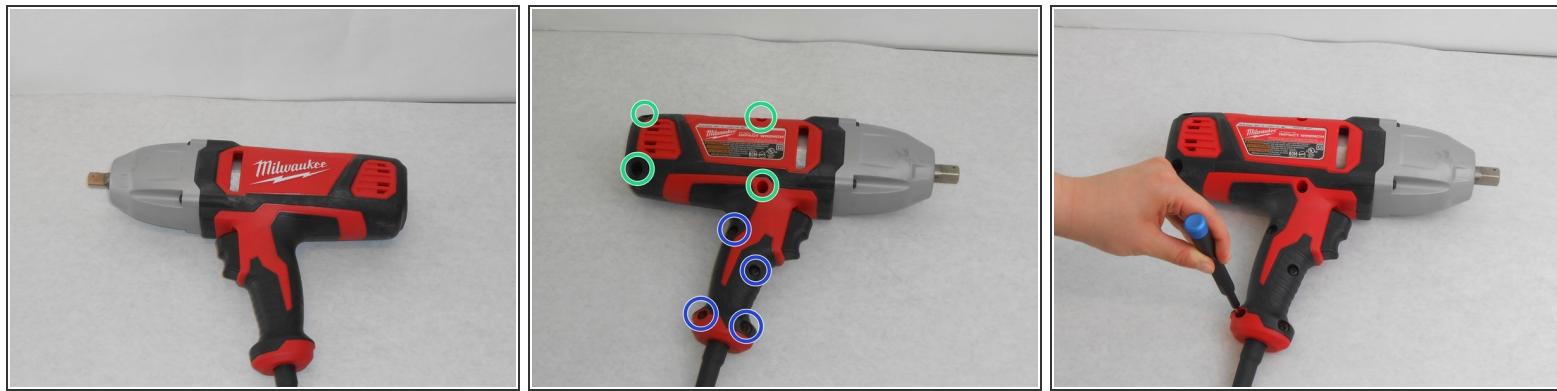
Step 1 — Motor Field Winding

⚠ Ensure that the device is unplugged from any power source to avoid electrical shock.

- Flip the device and remove four 18mm screws using a T20 Torx screwdriver.
- Remove four 14mm screws using a T20 Torx screwdriver.

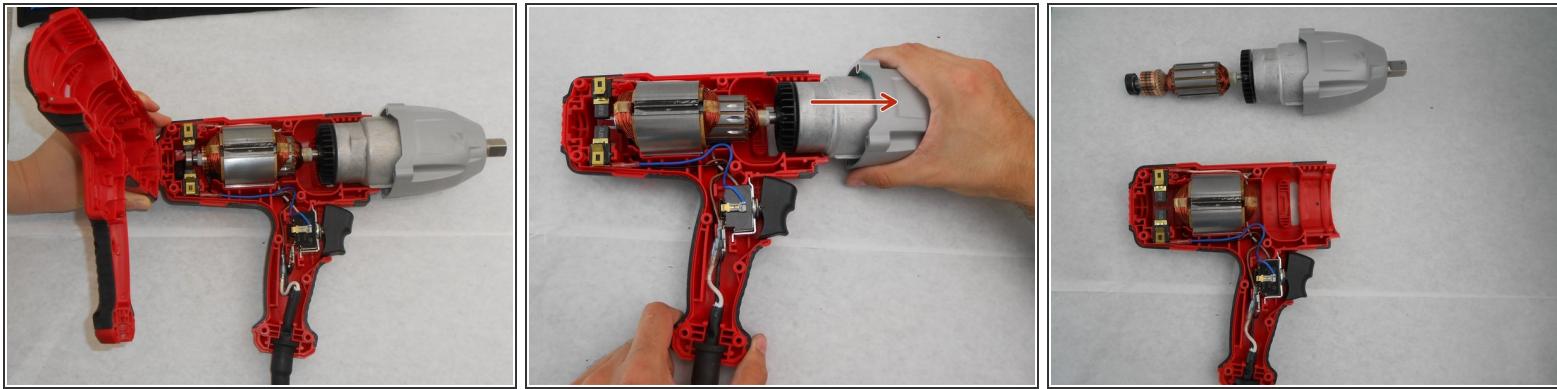
Step 3

⚠ Abrupt pulling may damage the motor brushes. Please remove it with caution.

ⓘ The motor brushes may need to be compressed to help with the removal of the gearbox assembly.

- Separate the top half of the clam shell from the tool.
- Remove the gearbox assembly by sliding it forward and set it aside.
