Panasonic KX-TGE233 TEL Port Replacement

This guide will give you instructions on how to replace a faulty TEL Port in your Panasonic KX-TGE233 docking station.

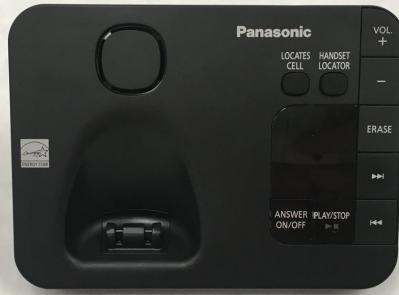
Step 1 — Base Front Panel Assembly

- To fix this component, we'll need to work with the main docking station. This is the one with the answering machine and the TEL line.

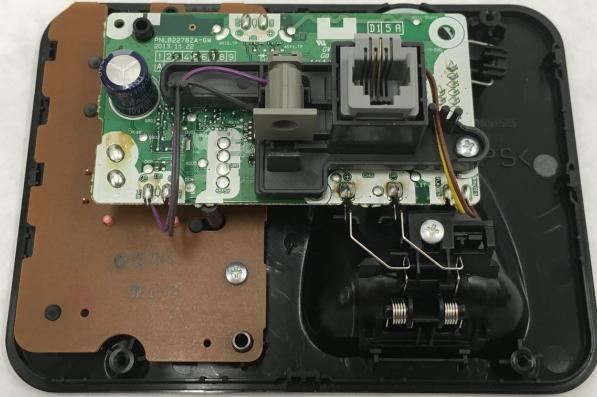
Step 5

- With the back removed, we now have direct access to all other components in the main docking station.
