LEAD-ACID BATTERY TROUBLE CONDITIONS (WITH COLOR PHOTOS)

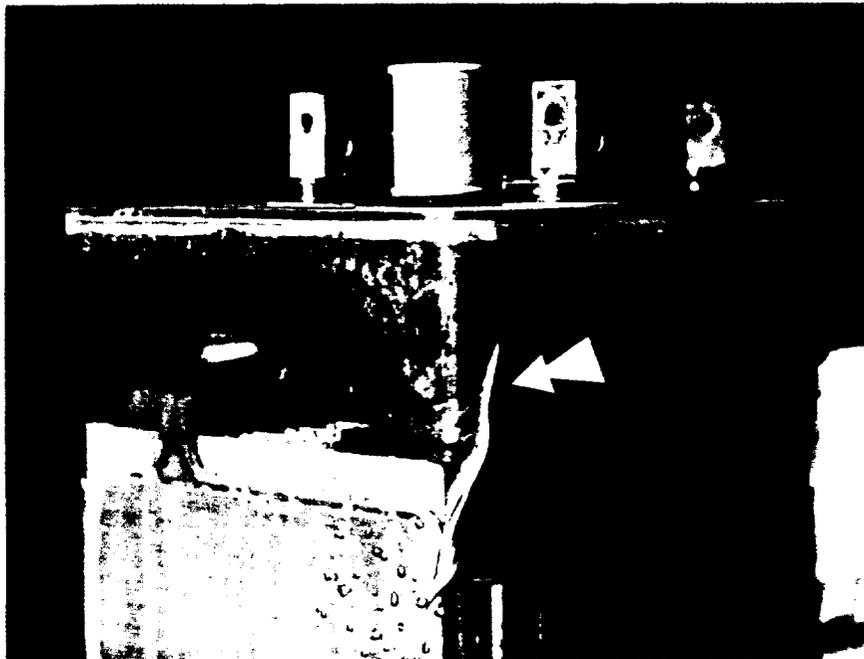
Fig. 10—Leaking Jar Crack in Strap Area—Typical With C&D Cells

2.05 *Crazes and Cracks:* Fig. 6 and 7 illustrate crazing. Fig. 8, 9, and 10 illustrate crack patterns typical of each supplier's product. Jar cracks are usually preceded by crazing of the jar at the plate or strap pressure point. Compare Fig. 6 with 9 and Fig. 7 with 10. Crazing is hard to see but shows up under a light beam as a group of hairline cracks. For safety, use a flashlight housed in a nonconducting material (plastic or rubber).
