## AT&T Practices

# Enhancement of Earthquake Safety in Existing Facilities

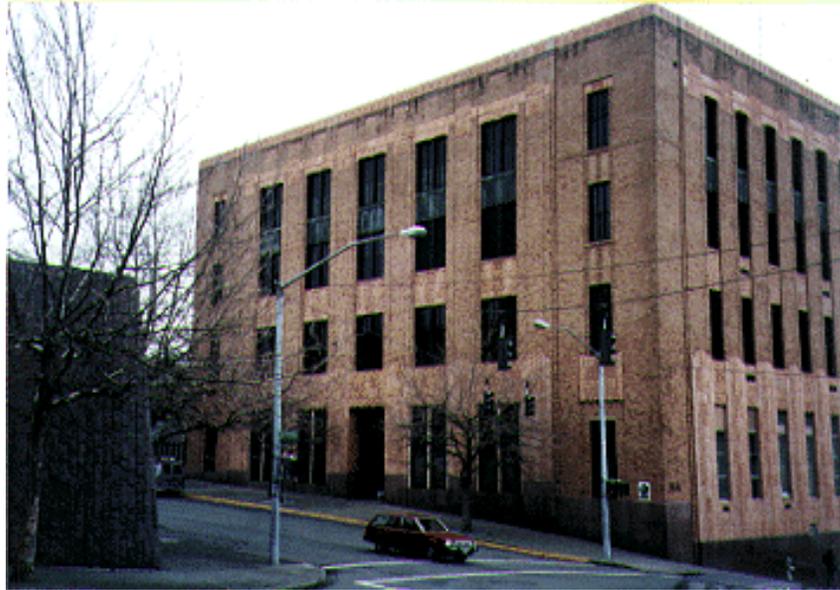
**Figure 1-1. Unreinforced Masonry Buildings often Perform Poorly in Earthquakes**

- **Deficient Materials** - Systems which consist of deficient materials often perform poorly in earthquakes. Deficient materials may include unreinforced masonry or lightweight concrete (Figure 1-1 and Figure 1-2).

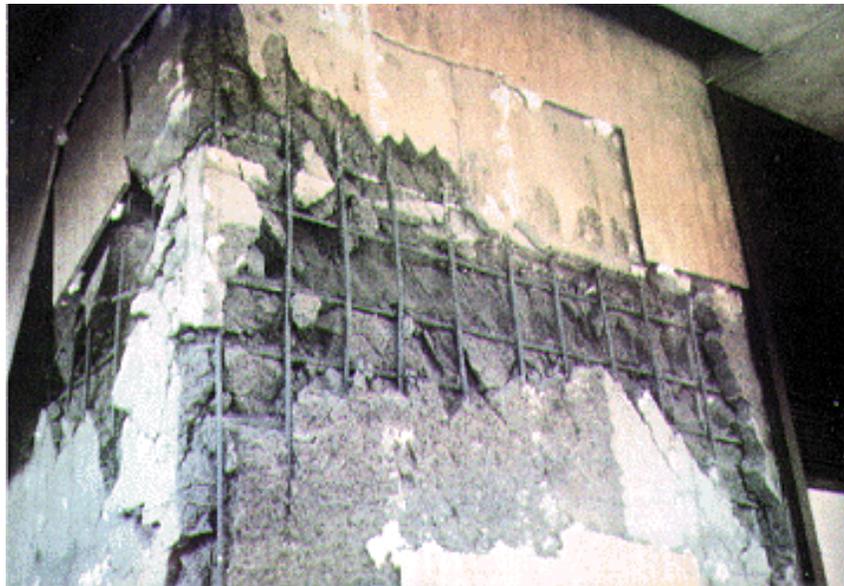
**Figure 1-2. Poor Performance of a Lightweight Concrete Wall in an Earthquake**

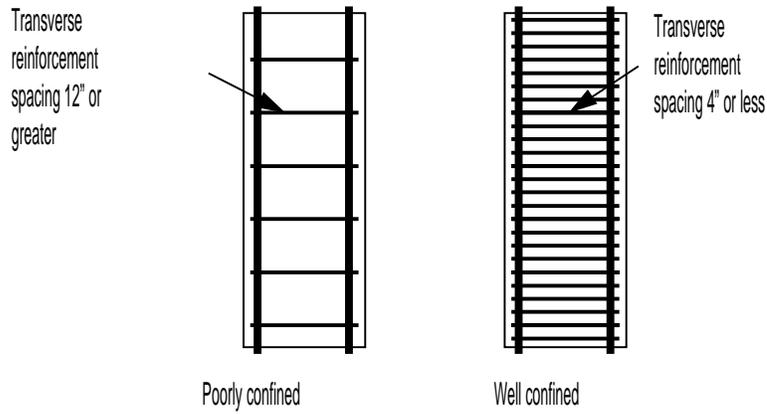
**Figure 1-3. Example of Adequate Detailing of a Later-load Resisting Concrete Member**

- **Deficient Members** - Structural members must be adequately detailed to ensure good seismic performance. Deficient members may include concrete columns with minimal transverse reinforcement (confinement), or slender steel columns or braces which are prone to buckling under load. Deficiencies may also be introduced into building systems, for example when large openings are cut in existing floor slabs or shear walls for new mechanical systems (Figure 1-3 and Figure 1-4).

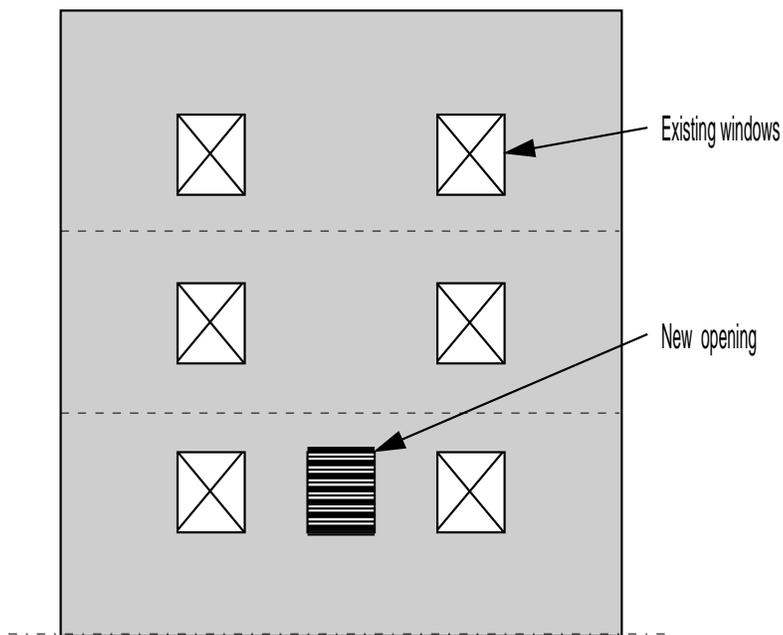
**Figure 1-4. Weakness Introduced into a Concrete Wall by Cutting a New Opening**

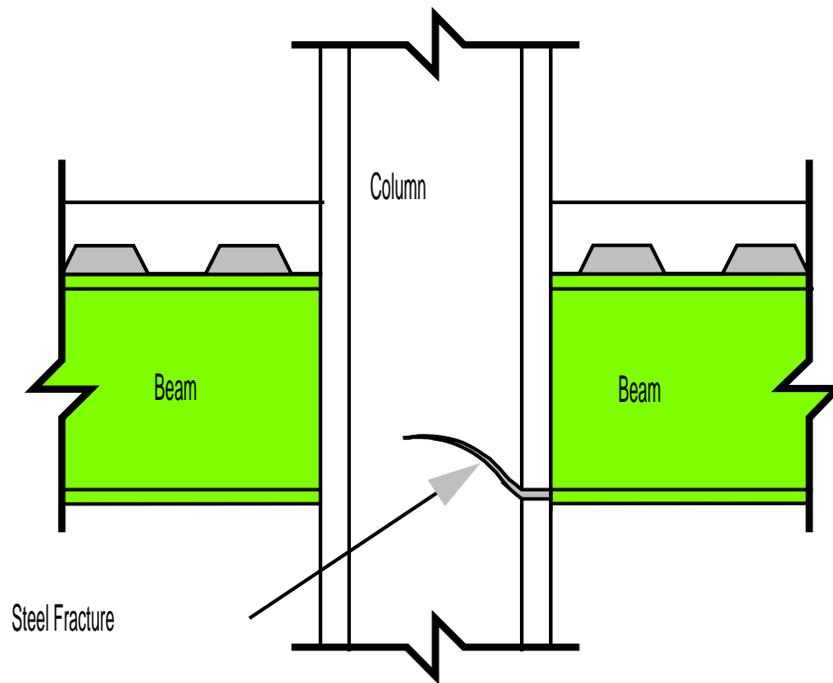
**Figure 1-5. Earthquake Fracture of a Steel Connection due to Inadequate Design and Construction Practices**

- **Deficient Connections** - Structural connections are often subjected to large forces during earthquakes. It is generally desirable for connections to be stronger than the adjoining members to ensure that the system remains tied together throughout the earthquake. Deficiencies may include inadequately detailed or deteriorated connections (Figure 1-5).

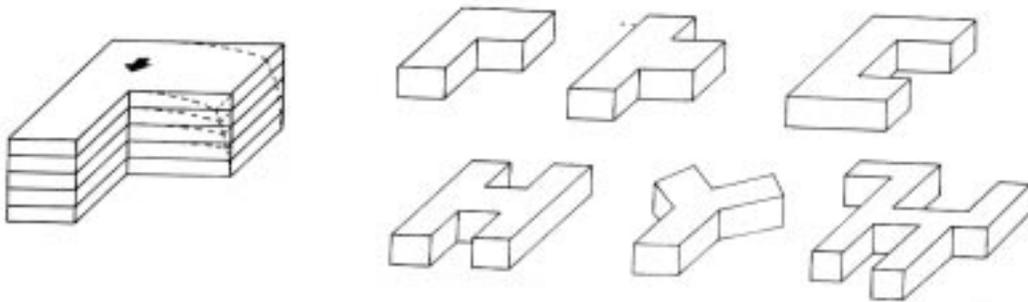
**Figure 1-6. Irregular Structural Configurations**

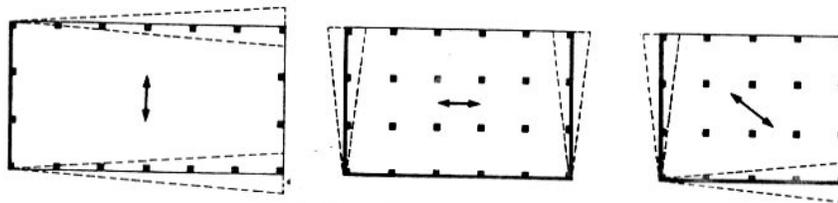
**Figure 1-7. Asymmetric Lateral Load Resistance**

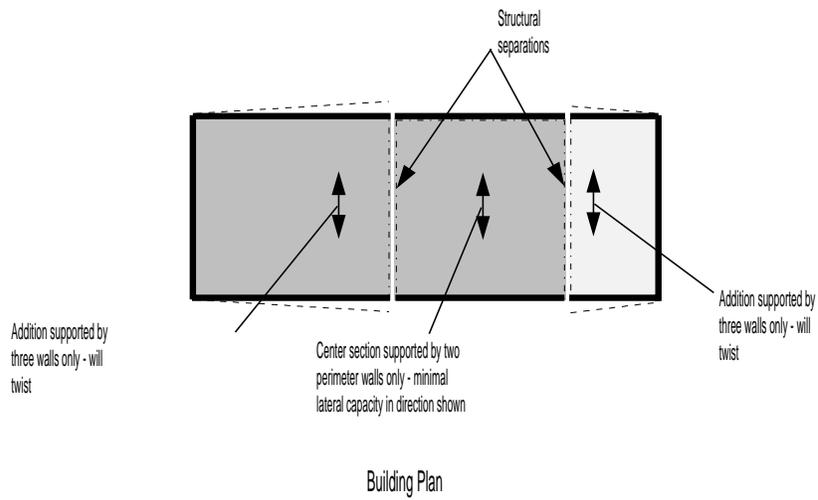
**Figure 1-8. Inadequate and Asymmetrical Lateral Load Resistance**

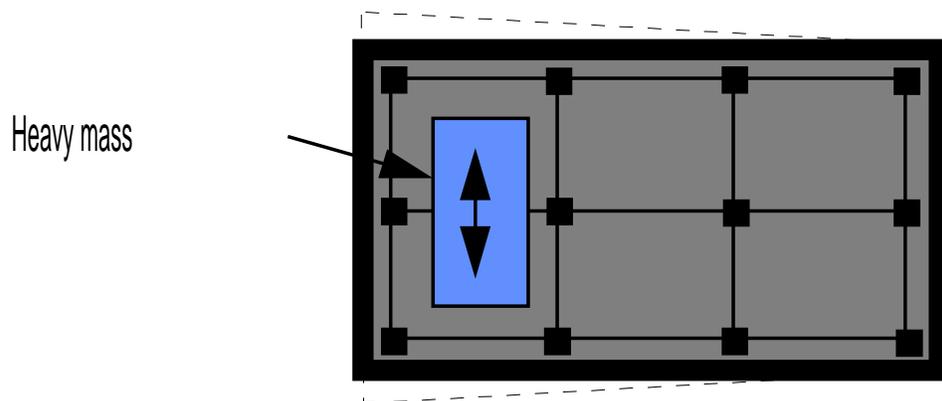
**Figure 1-9. Asymmetrical Mass Distribution**

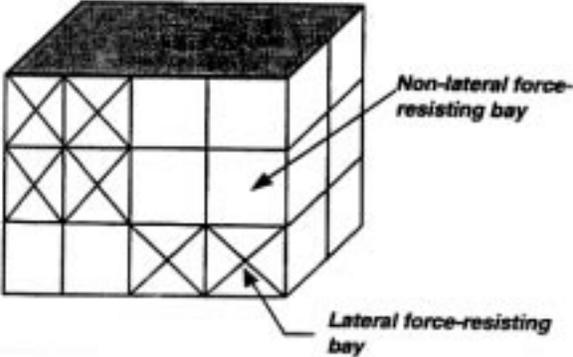
Figure 1-10. In-Plane Offsets in Lateral Load-Resisting Elements

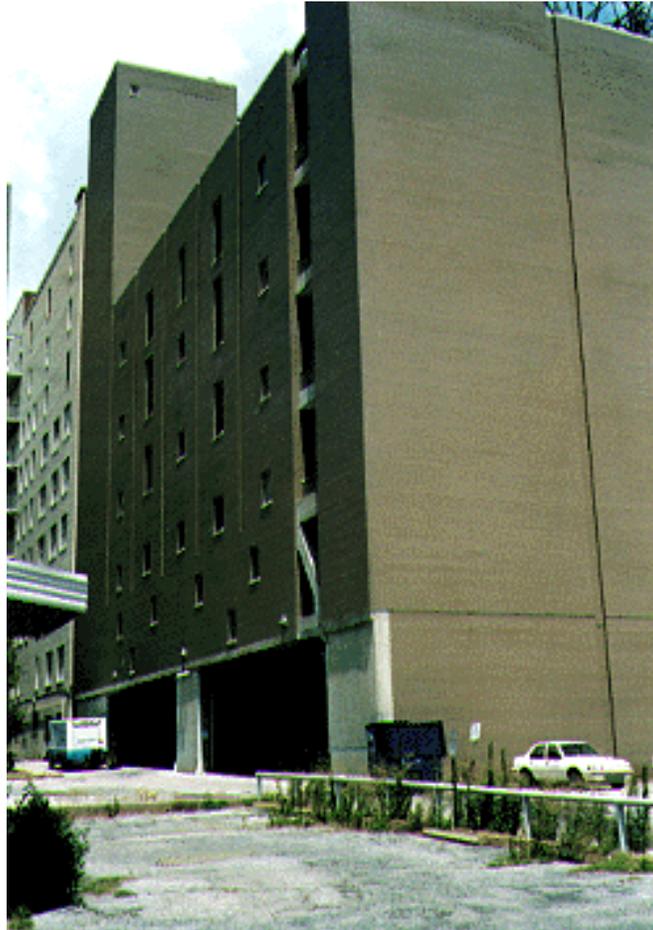
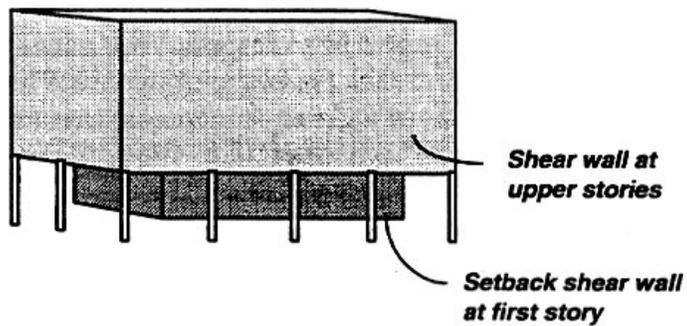
**Figure 1-11. Out-of-Plane Offsets in Lateral Load-Resisting Elements**

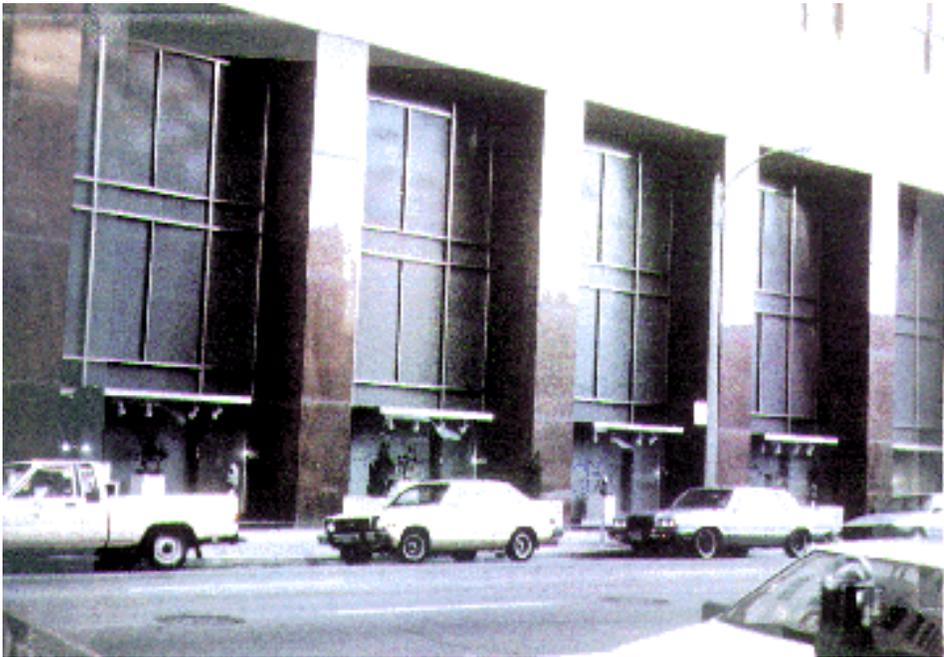
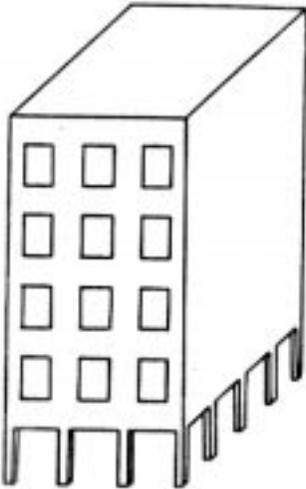
**Figure 1-12. Soft Story Condition created by Large Openings at First Floor**

- Significant changes in story stiffness or strengths (Figure 1-12)
- Large openings in walls or floors (Figure 1-13).

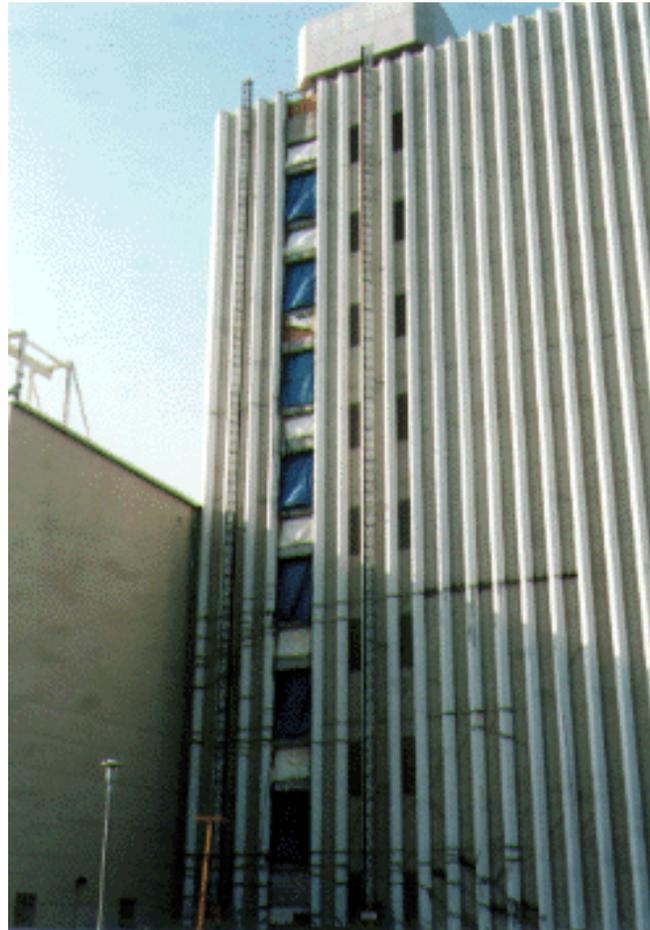
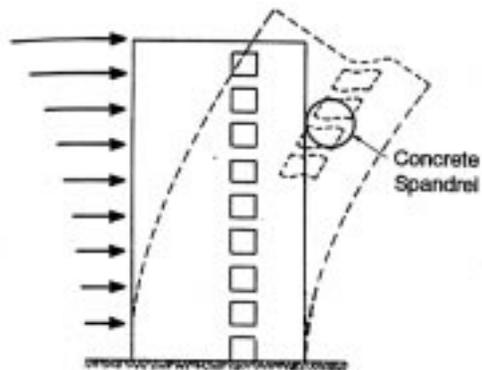
**Figure 1-13. Discontinuity and Source Damage created by Vertically Aligned Wall Openings**

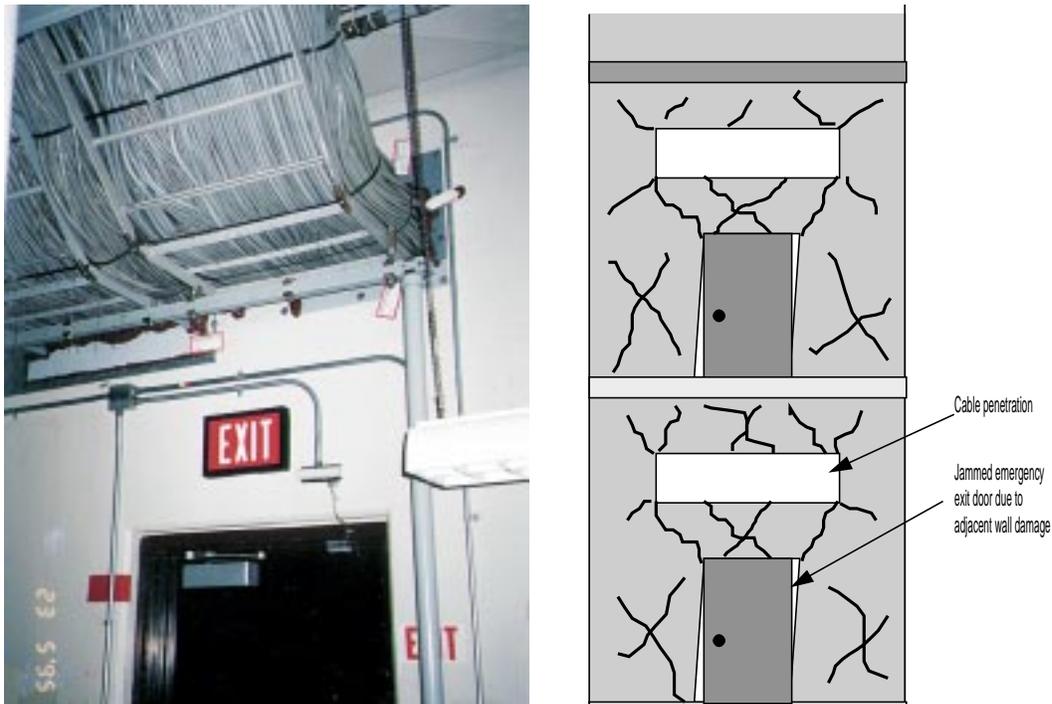
**Figure 1-14. Vertically Aligned Openings and Perforated Concrete Spandrels are prone to Damage and could affect Emergency Exit Doors (continued on next page)**

- **Exit door damage** - Exit doors may become dislodged due to excessive damage to wall elements (i.e. concrete spandrels) located directly above the doors (Figure 1-14).
- **Obstruction of exit paths** - Excessive damage to brittle materials, such as hollow clay tile, terra cotta, or glass in exit paths may obstruct safe exit (Figure 1-15).
- **Stair tower damage** - Detached stair towers may be inadequately connected to the building or lack adequate lateral resistance to enable emergency egress (Figure 1-16).

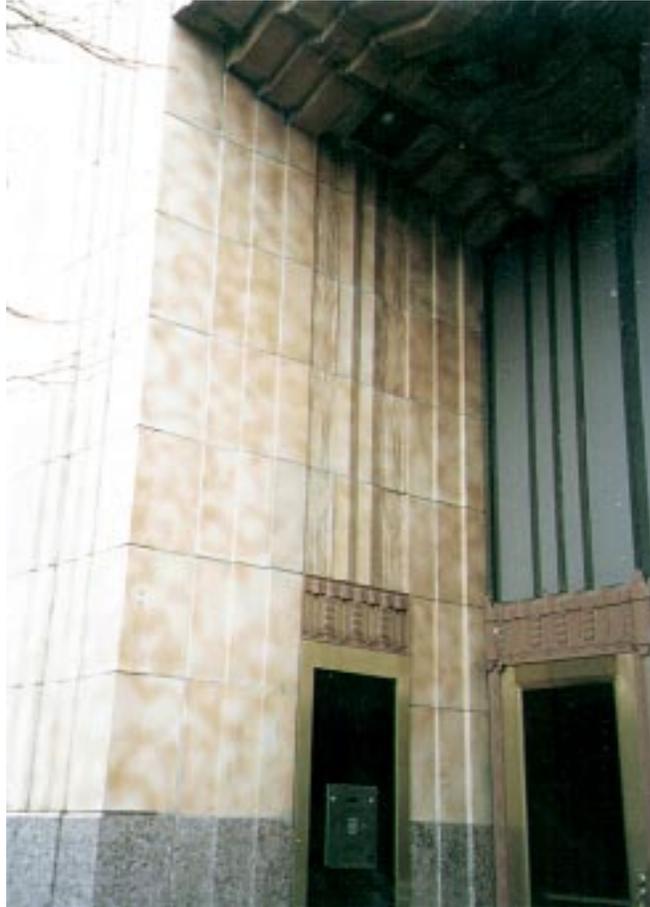
**Figure 1-15. Brittle Terra Cotta Adjacent to and above Emergency Exit Path**

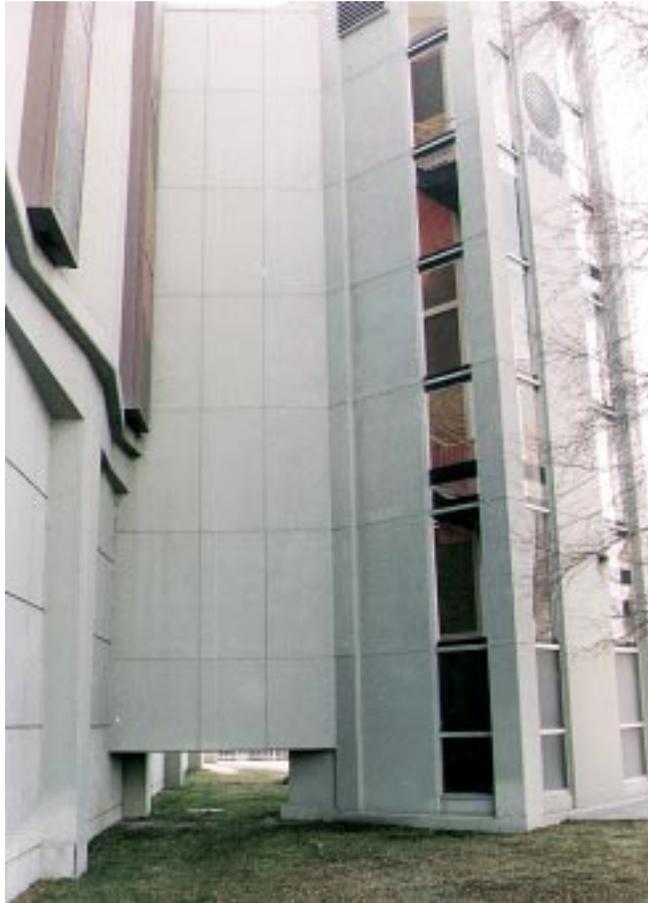
**Figure 1-16. Bridges and Stair Tower must have Adequate Seismic Resistance to Enable Emergency Egress**

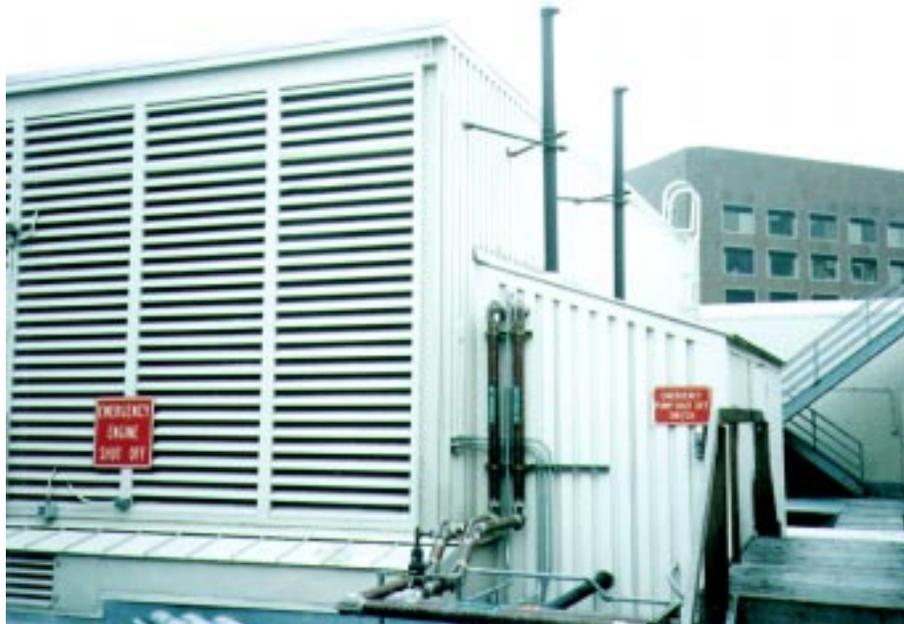
**Figure 1-17. Generator Penthouse with Inadequate Lateral Resistance**

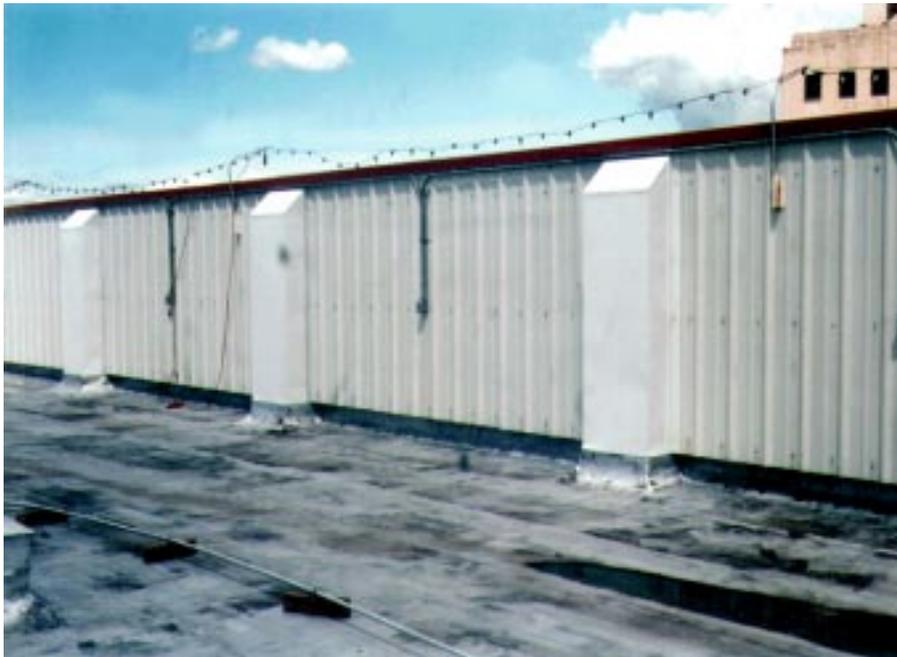
**Figure 1-18. Unreinforced Masonry Parapets often have Inadequate Out-of-Plane Support**

- **Parapets** - Experience has shown that inadequately braced building parapets are susceptible to earthquake damage, particularly when located atop multistory buildings. Failure is more likely to occur when parapets are constructed of unreinforced masonry or are relatively tall (Figure 1-18).

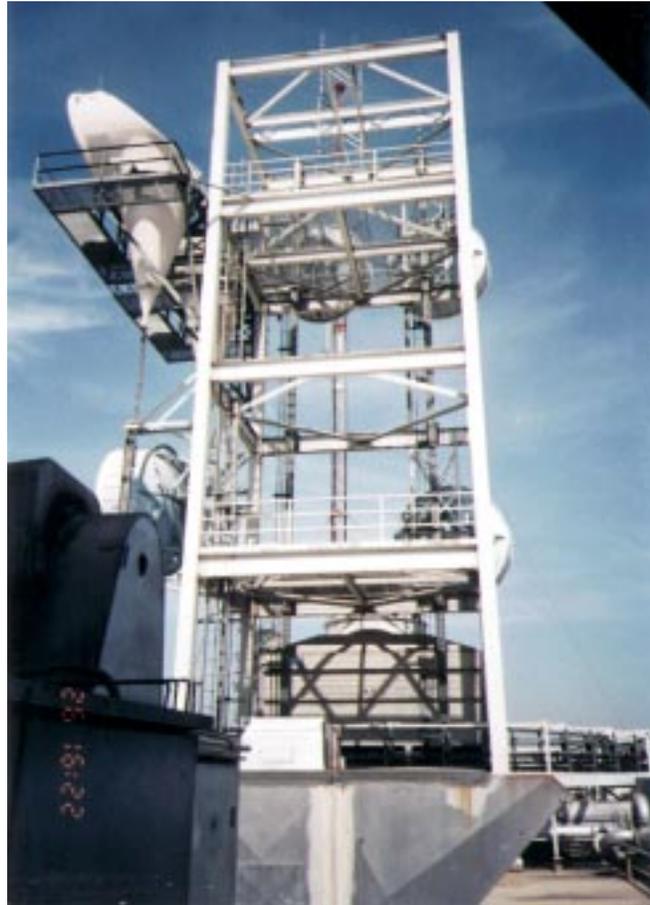
**Figure 1-19. Rooftop Microwave Towers may have Inadequate Framing to Resist Seismic Loads**

- **Towers** - Antenna towers for microwave or other radio telecommunication purposes are often placed atop network buildings. Proper attachment of the towers to the building structures are key to the performance of the towers during an earthquakes. Because towers are exposed to the elements, periodical maintenance is necessary to ensure adequate performance (Figure 1-19).

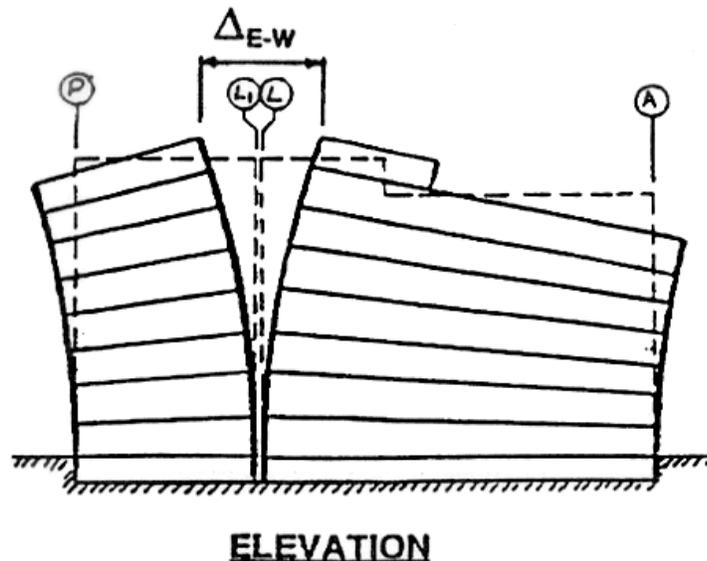
**Figure 1-20. Out-of-Plane Motion along Building Elevations can affect Systems and Result in Pounding of Buildings**

- **Out-of-phase along building elevation** - Out-of-phase motions along the building elevation (Figure 1-20) imply a condition in which adjacent buildings are either pulling apart from, or pound at each other. Damage to the systems traversing the gap between the buildings is likely to occur as the buildings are pulling apart while damage to the structure is likely to occur as the buildings are pounding at each other. The latter is of particular concern when adjacent floor diaphragms do not line up (Figure 1-21).

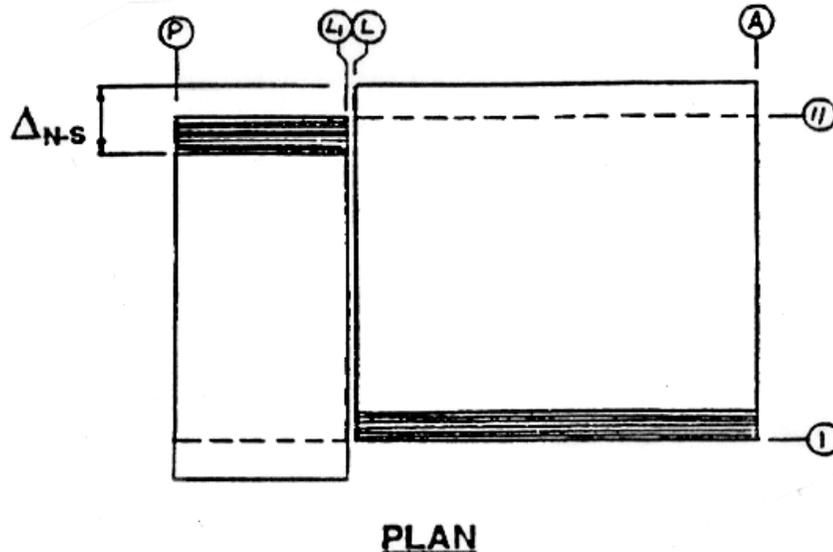
Figure 1-23. Out-of-Phase Motion along Building Plans can affect Systems

- **Out-of-phase along building plans** - Out-of-phase motions along the building plans (Figure 1-23) may result in excessive horizontal differential displacements between adjacent floor diaphragms. This condition is likely to cause damage to relatively rigid conduits and ducts fixed to the structures at close proximity on both sides of the inter-building gap.

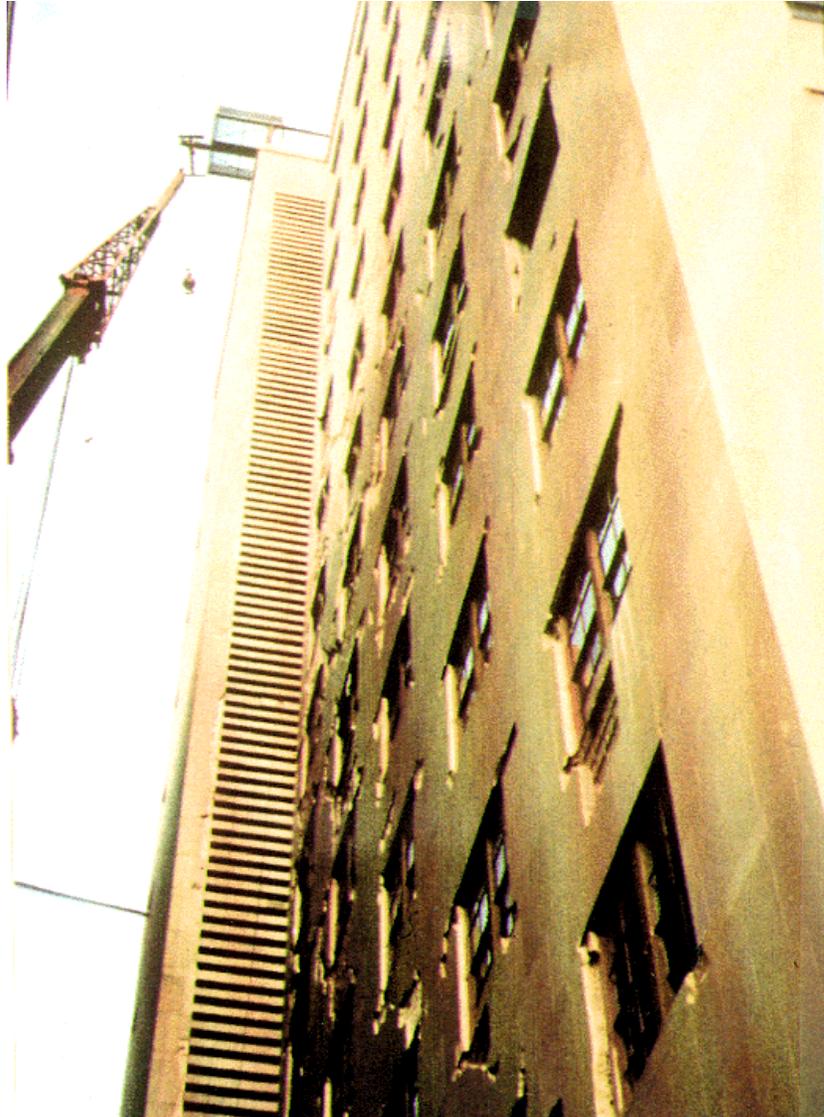
**Figure 1-24. Damaged Terr Cotta Facade following an Earthquake**

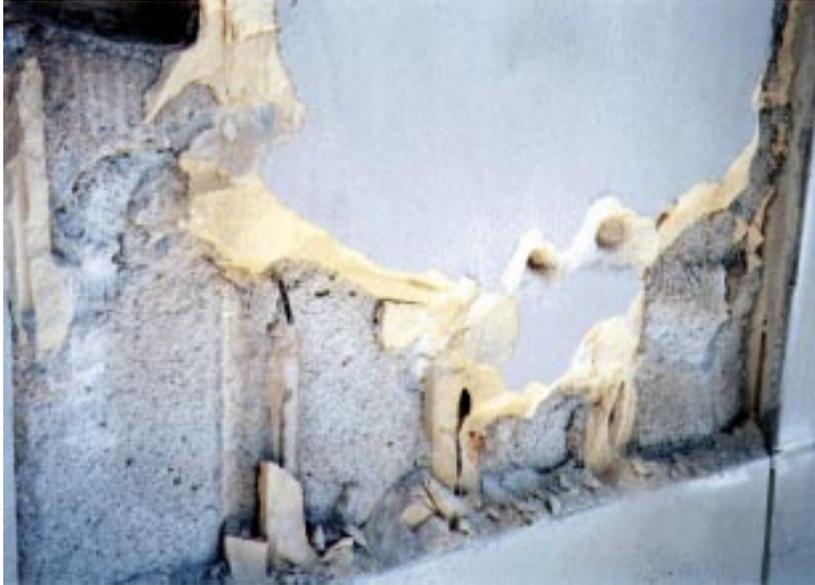
**Figure 1-25. Limited Destructive Testing to verify the Presence of Mechanical Anchorage and to determine the Adequacy of the Mortar Bond**

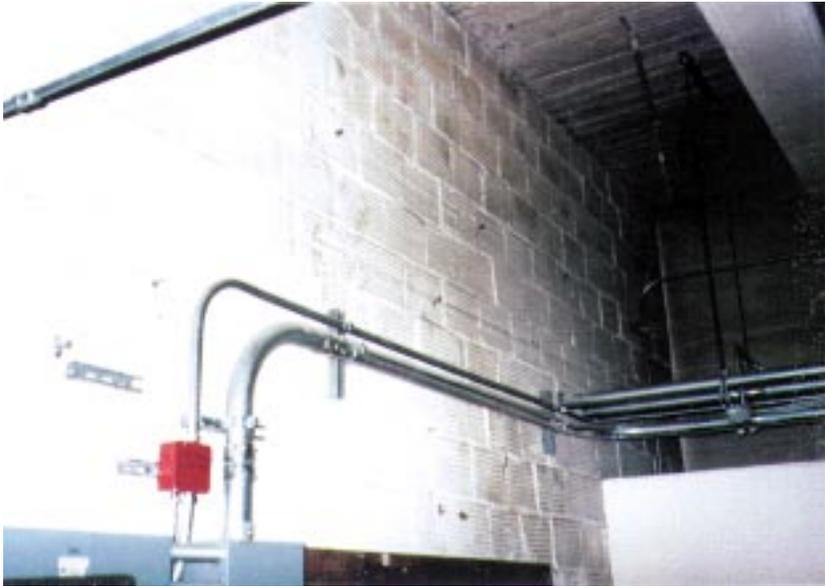
**Figure 1-26. Typical Hollow Clay Tile Partition**

- **Partitions** - In some older buildings partition walls were constructed of hollow clay tiles which tend to fail in a brittle manner when subjected to earthquake loads. Brittle failure may involve the dispersion of fragments in the vicinity of the wall, potentially jeopardizing adjacent network operations (Figure 1-26).

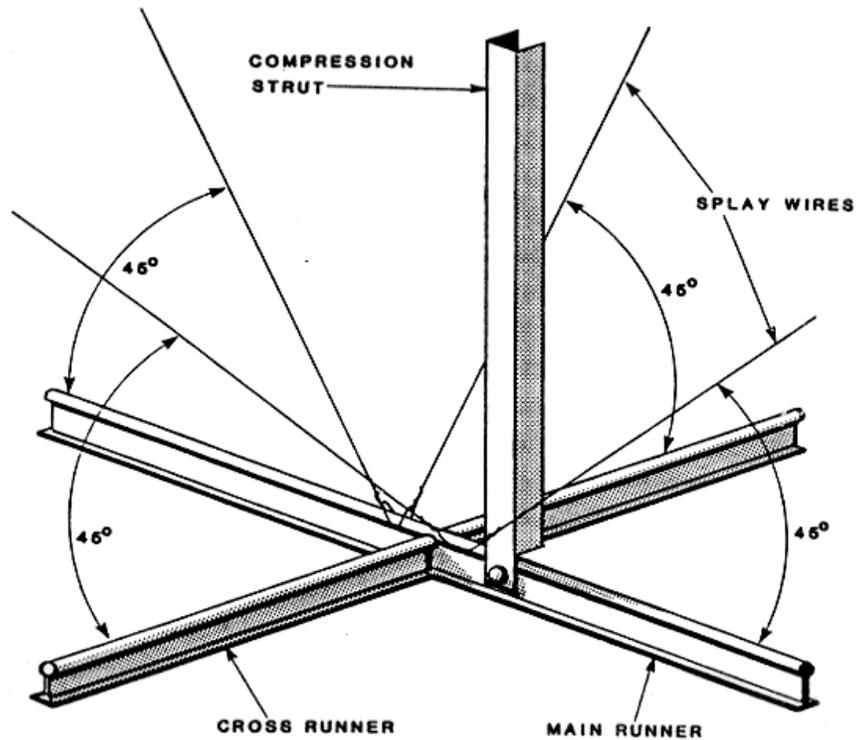
Figure 1-27. Seismic Bracing of a Suspended Ceiling

- *Ceilings* - Inadequately braced suspended ceilings often collapse during earthquakes. This vulnerability is of concern particularly in heavily populated buildings (Figure 1-27).

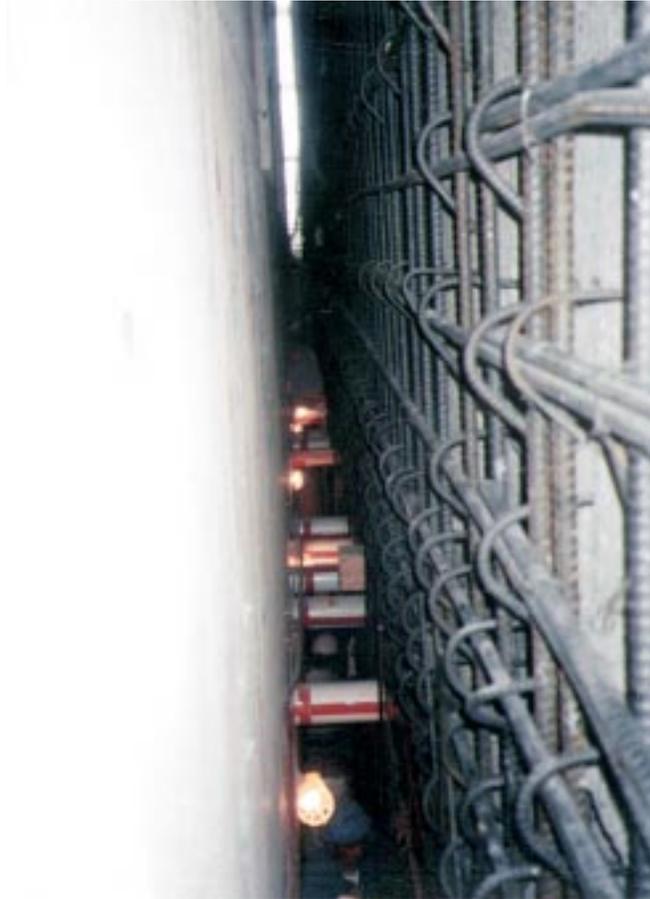
**Figure 1-28. Reinforcement and Dowels installed for New Wall Thickening**

achieved through the use of epoxy bonded reinforcement dowels (Figure 1-28). The capacity of steel construction can be augmented by the introduction of new braces (Figure 1-29) or by improving the capacity of existing connections (Figure 1-30).

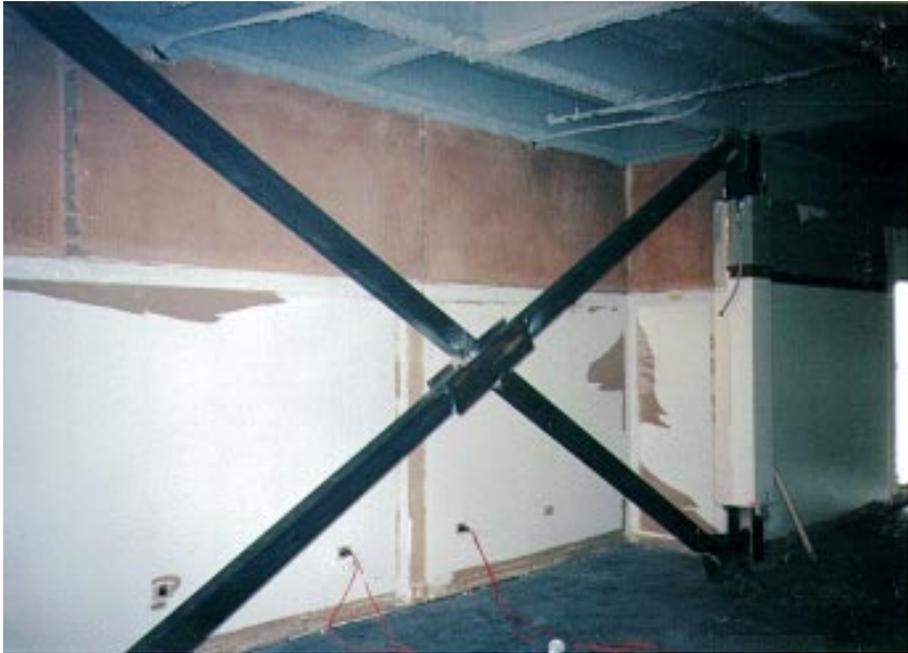
**Figure 1-29. New Steel Braces installed for Seismic Resistance**

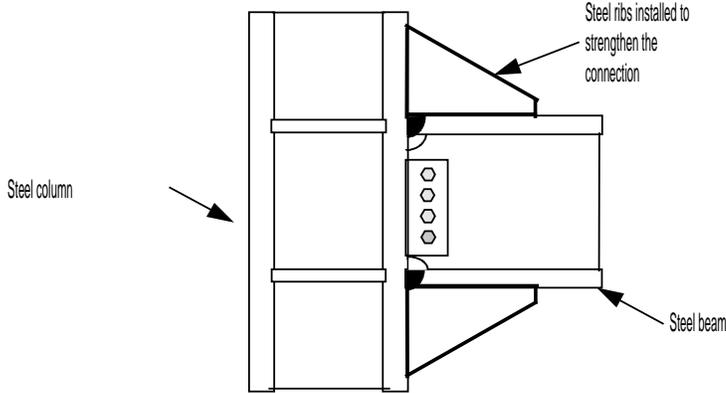
**Figure 1-30. Strengthening a Steel Moment Frame Connection by installing Vertical Steel Ribs**

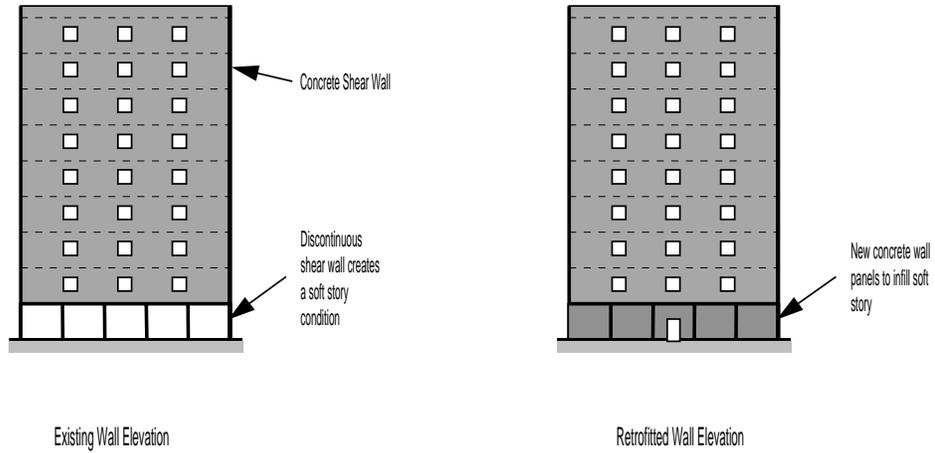
**Figure 1-31. New Infill Wall Panels installed to remove a Soft Story Condition (see Figure 1-12 for comparison)**

Removal of structural irregularities is the preferred retrofit approach. Vertical structural irregularities due to abrupt changes in story stiffness or strength can be removed through the use of infill wall panels (Figure 1-31). In certain situations where it may not be possible to remove undesired irregularities other mitigating solutions should be implemented (Figure 1-32).

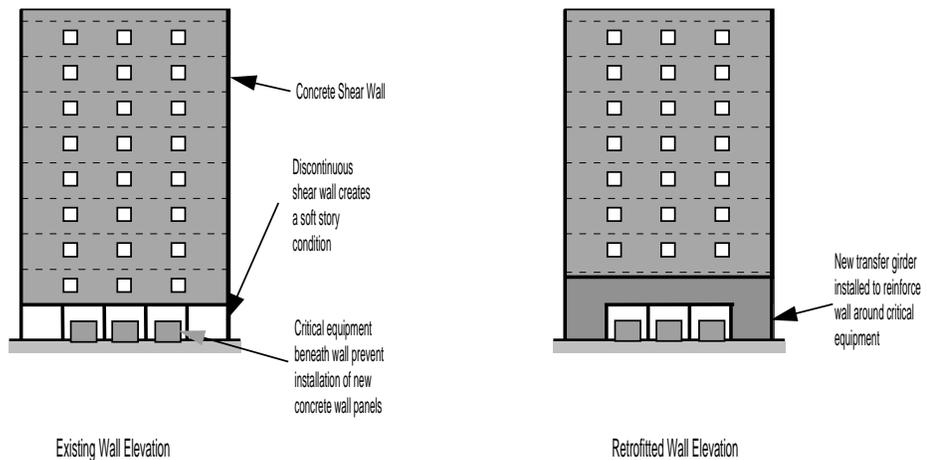
**Figure 1-32. Transfer Girder installed to Bridge over a Soft Story which could not be filled**

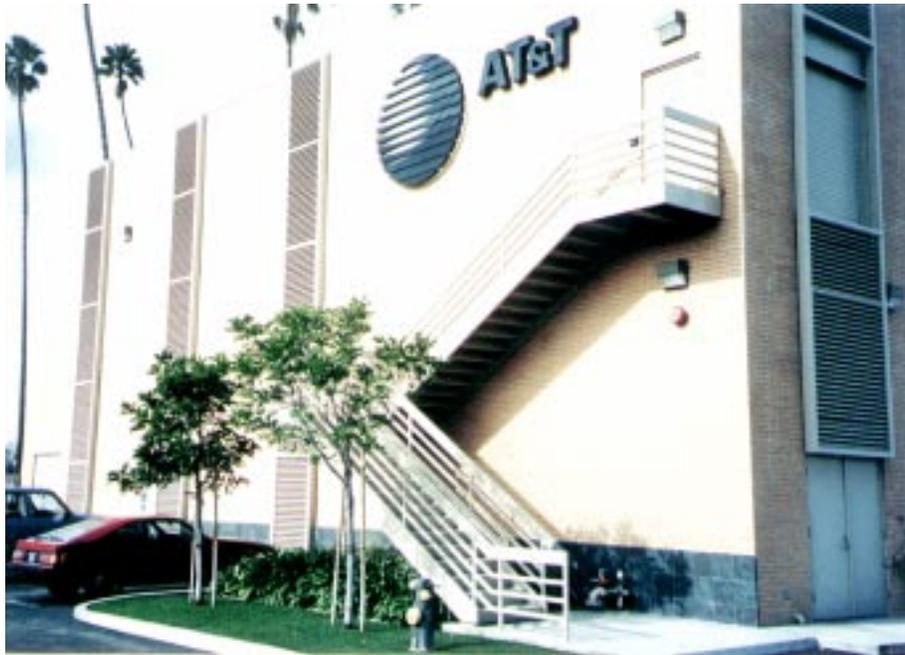
**Figure 1-33. To Ensure Adequate Lateral Support of the Emergency Egress Stair, Additional Anchorage was installed to Tie the Stair Landings to the Building**

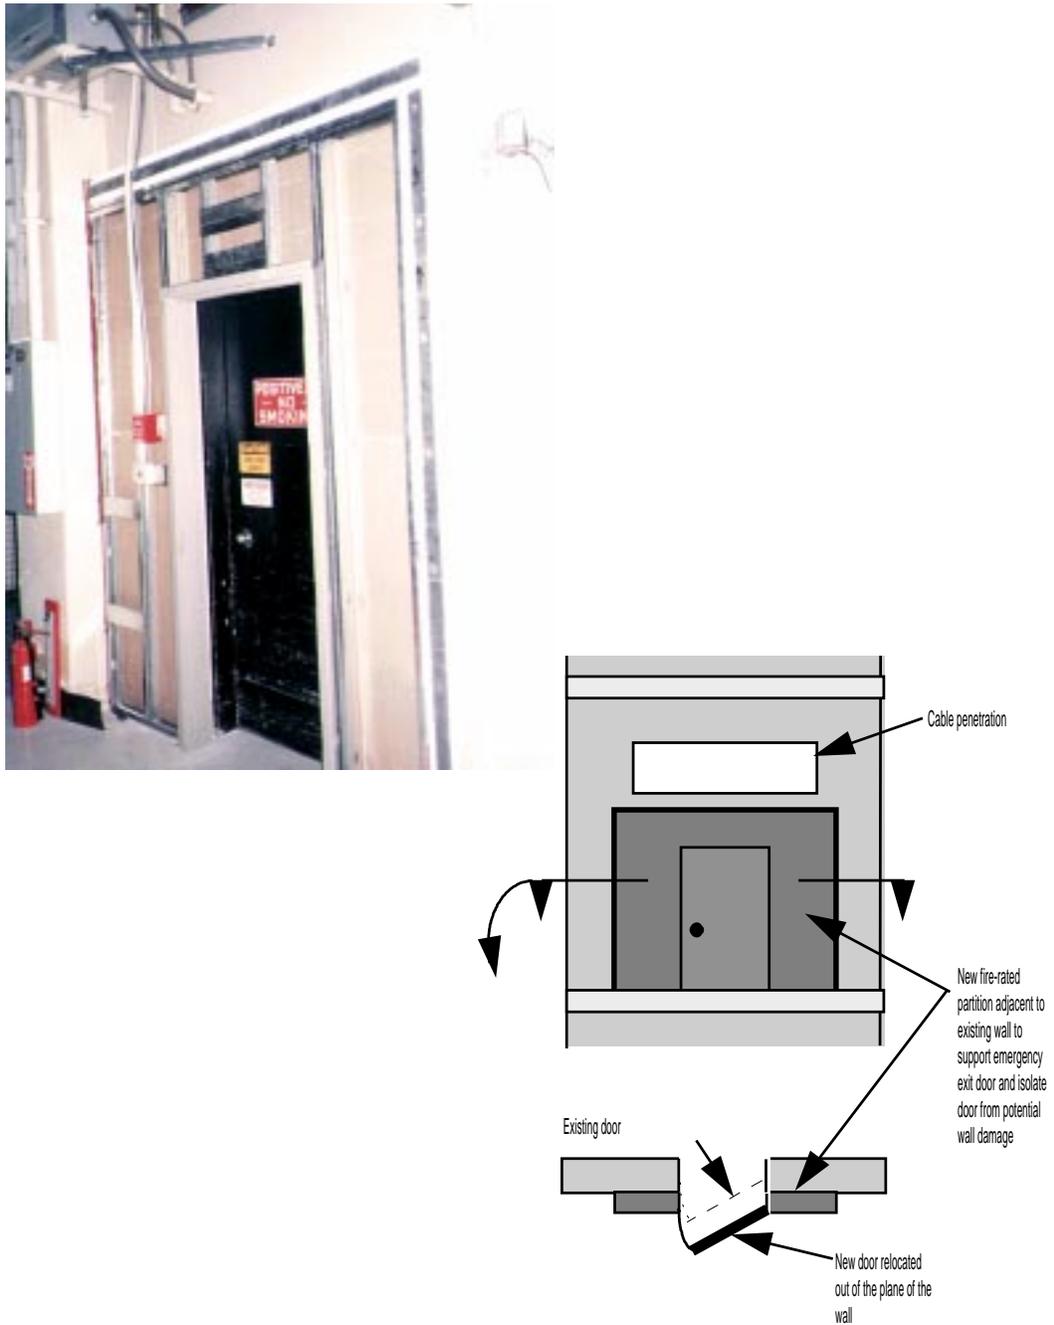
**Figure 1-34. Vertically Aligned Wall Openings created a Local Discontinuity and Source of Damage (see Figure 1-13). Emergency Exit Door Frames were isolated from the Wall to enable Egress despite Wall Damage**

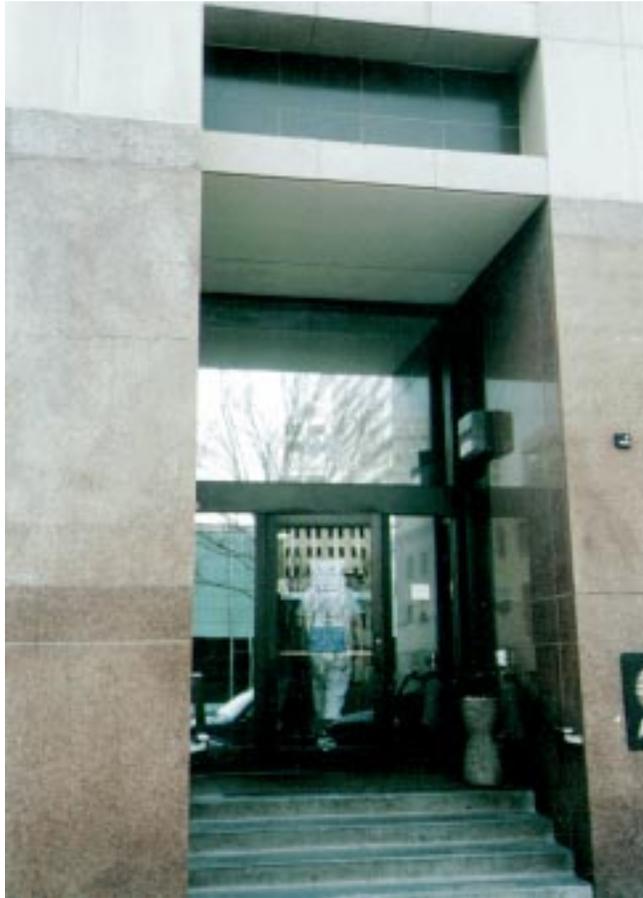
**Figure 1-35. Glass Panels above Emergency Exit were replaced with Tempered Safety Glass to Reduce Egress Hazards**

Assurance of safe emergency egress requires verification of the overall stability of the egress system, provisions for unhindered access and removal of potential obstructions along the path. In certain situations where the egress system is exterior to the building adequate stability can be ensured by properly securing the egress system to the structure such that physical separation is prevented (Figure 1-16 and Figure 1-33). Unhindered access often involves the need prevent fire doors at entrances to emergency egress from becoming dislodged. Emergency exits likely to be dislodged by adjacent wall damage can be isolated from the damage by offsetting the door outside the plane of the wall (Figure 1-34). Obstructions to emergency egress due to failure of brittle materials should be minimized by means of containment or removal (Figure 1-35).

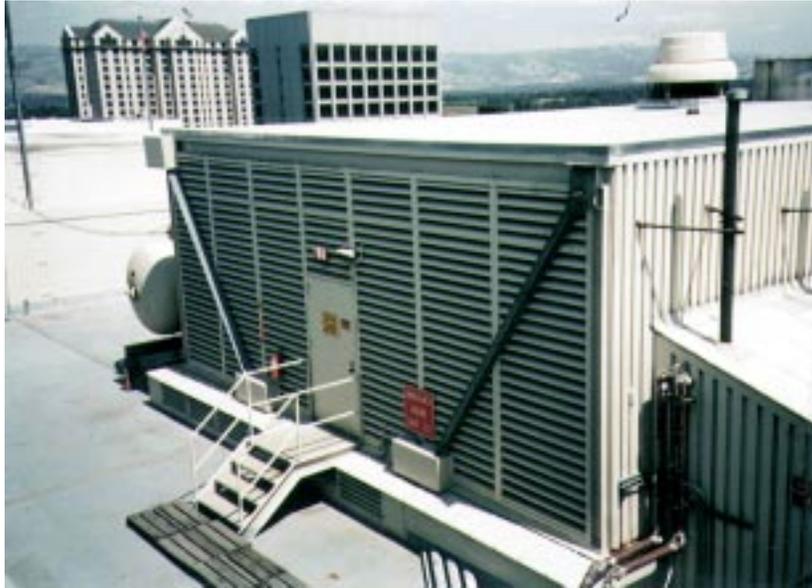
**Figure 1-36. Generator Penthouse with New Steel Bracing for Seismic Resistance (see Figure 1-17 for comparison)**

Building appendages including penthouses, parapets, canopies and towers should be retrofitted to ensure their stability. Appendages are often mounted at upper levels of buildings and thus may be subject to motion amplifications (see AT&T Standard 760-200-024, *Earthquake Resistant Design Guidelines for New Buildings*, which must be considered in providing the appropriate retrofits. Retrofits to achieve adequate structural stability of appendages typically involve the installation of bracing (Figure 1-36 and Figure 1-37).

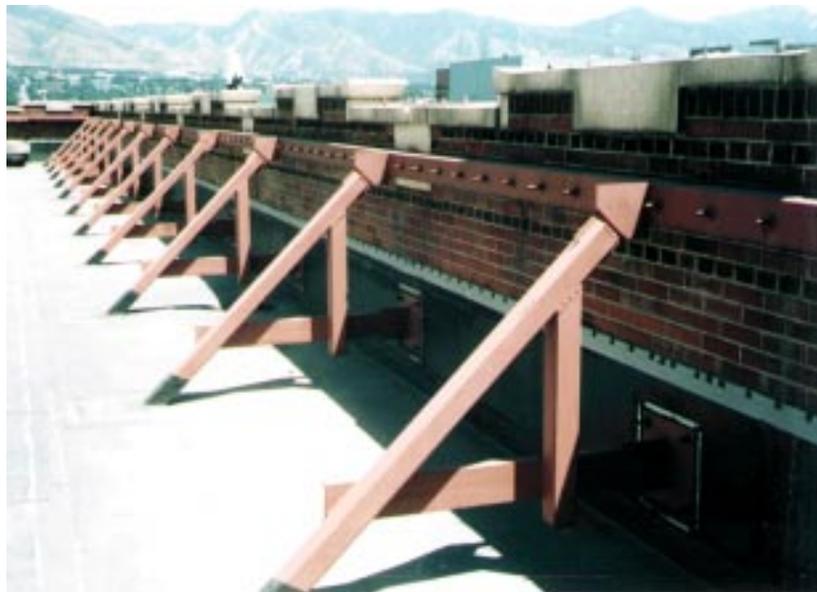
**Figure 1-37. Unreinforced Masonry Parapet with New Seismic Bracing (see Figure 1-18 for comparison)**

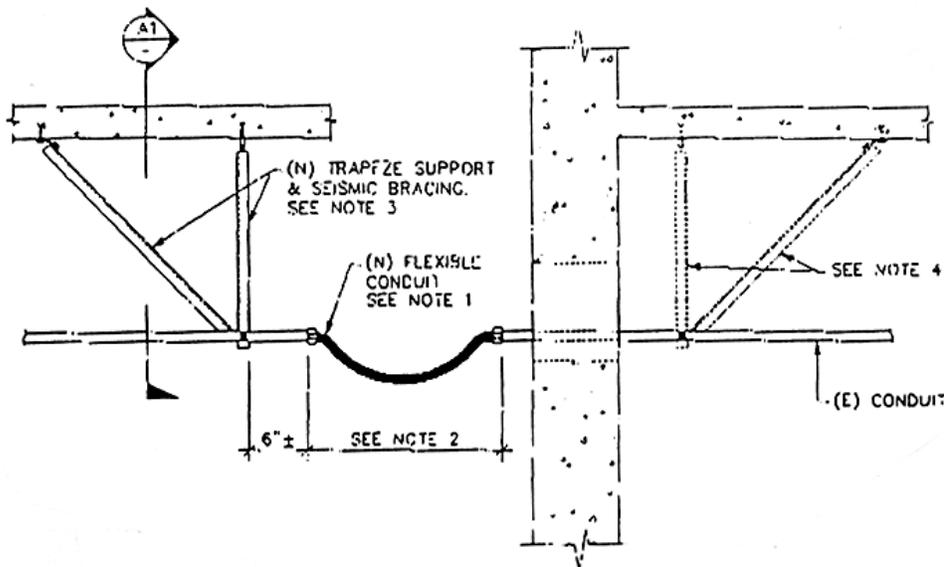
Figure 1-38. Cables Retrofitted to provide Adequate Flexibility across a Structural Separation
