## AT&T Practices

# Enhancement of Earthquake Safety in Existing Facilities

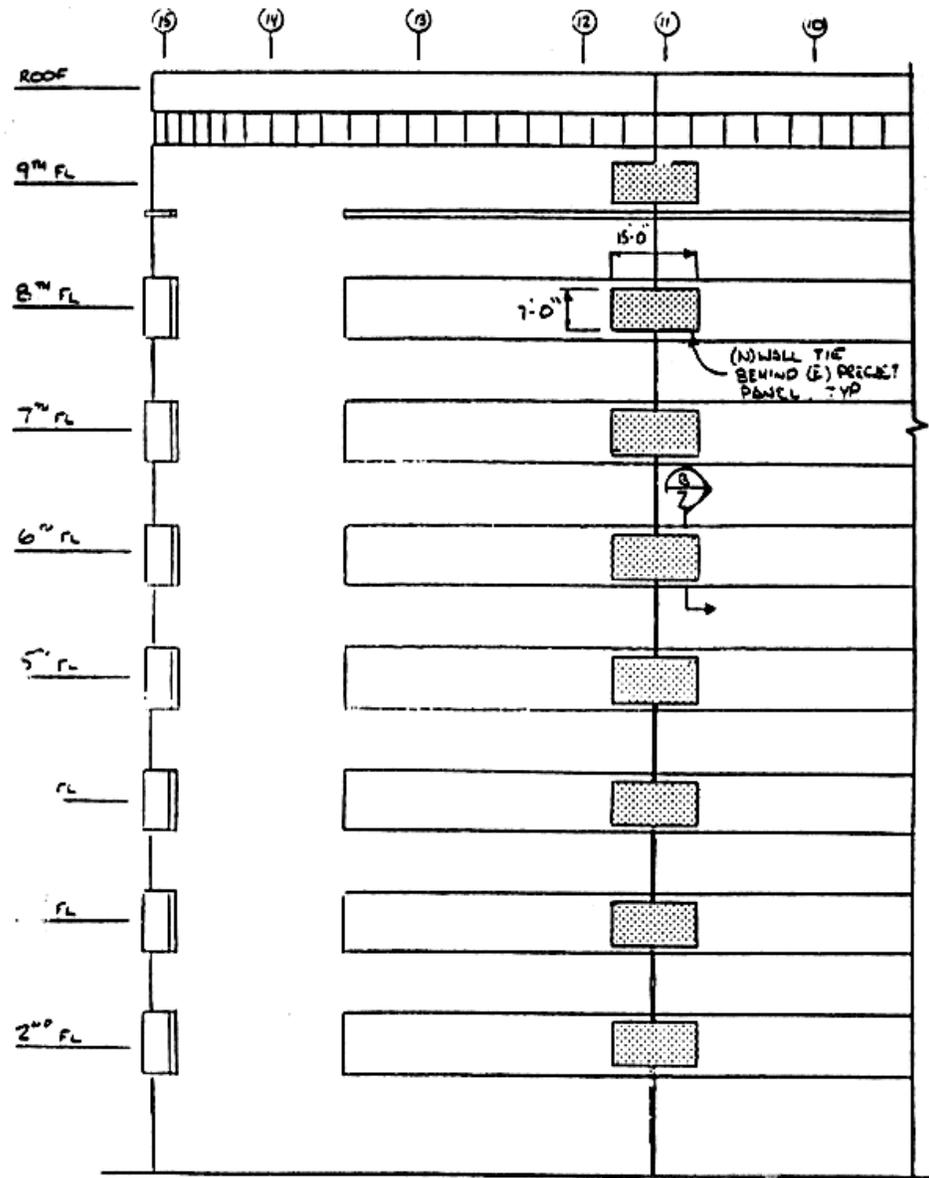
Figure 1-39. Structural Tie between Adjacent Buildings to prevent Relative Movement during an Earthquake
