# 1986-1993 Volvo 240 Distributor Cap Replacement

Replace the distributor cap in your Volvo 240.

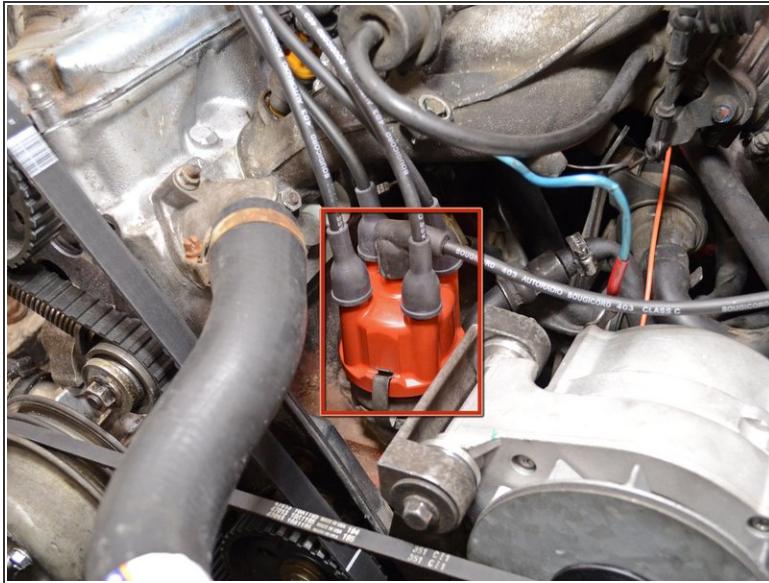
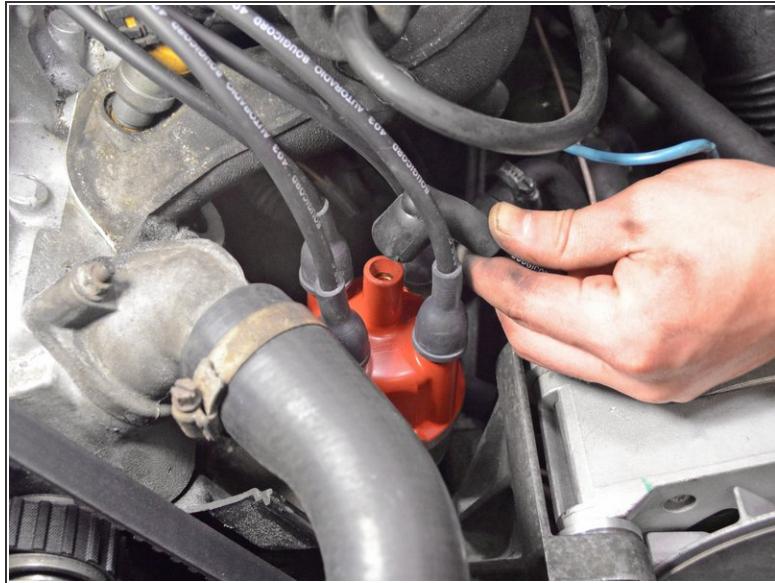
## Step 1 — Distributor Cap

- ⓘ The distributor cap is located next to the engine and has all of the spark plug wires connecting to it.
- Pull straight up on the ignition coil wire in the center of the distributor cap to disconnect it.

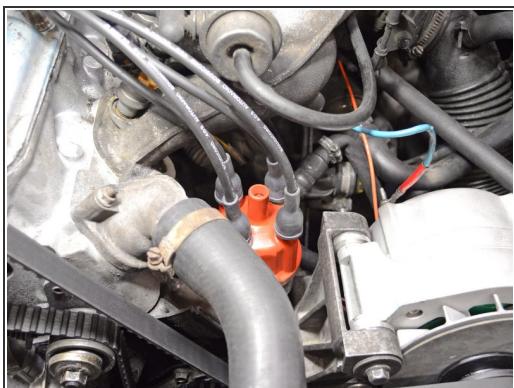
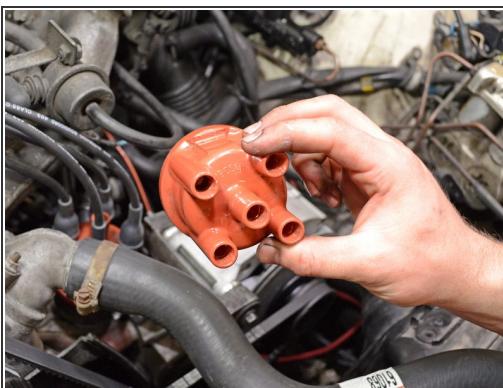
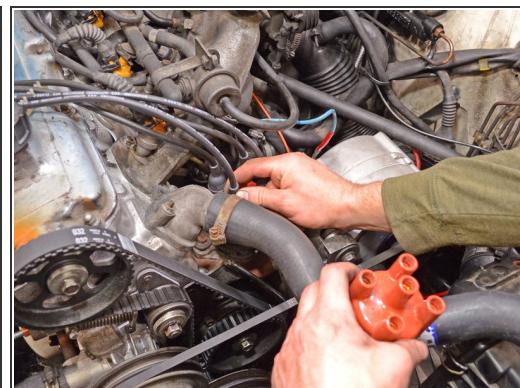
## Step 2

- ⓘ Connect the spark plug wires to the new distributor cap one at a time. Mixing up the order will result in the engine not firing properly or at all.
- Pull straight up on the boot of the first spark plug wire to disconnect it from the distributor cap.

**⚠** Be sure to pull on the boot and not the wire itself. Spark plug wires are quite fragile and may break easily.

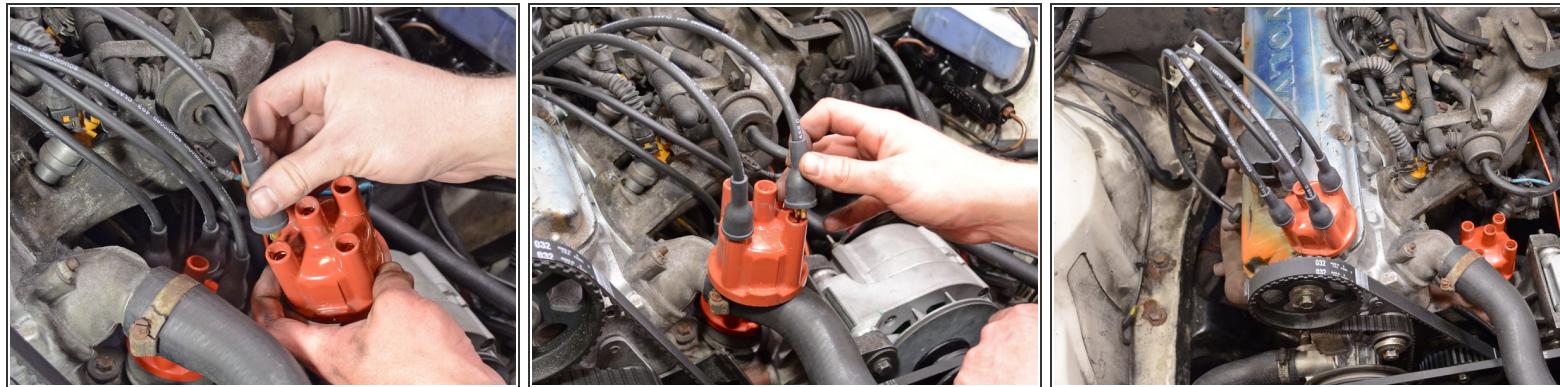
## Step 3

- Install the spark plug wire onto the new distributor cap and make sure it is seated properly.
- Continue to transfer each spark plug wire to the new distributor cap, maintaining the same arrangement of wires on the cap.
- Once all of the spark plug wires have been installed on the new distributor cap, set the cap aside.

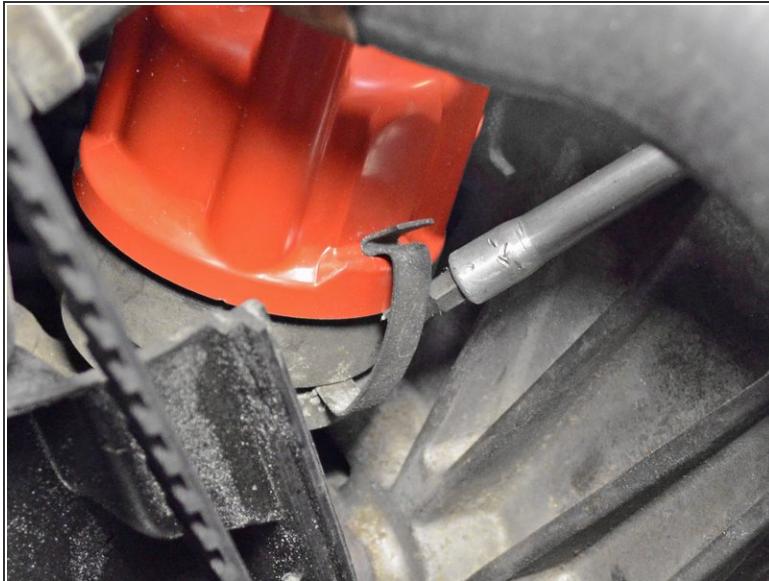
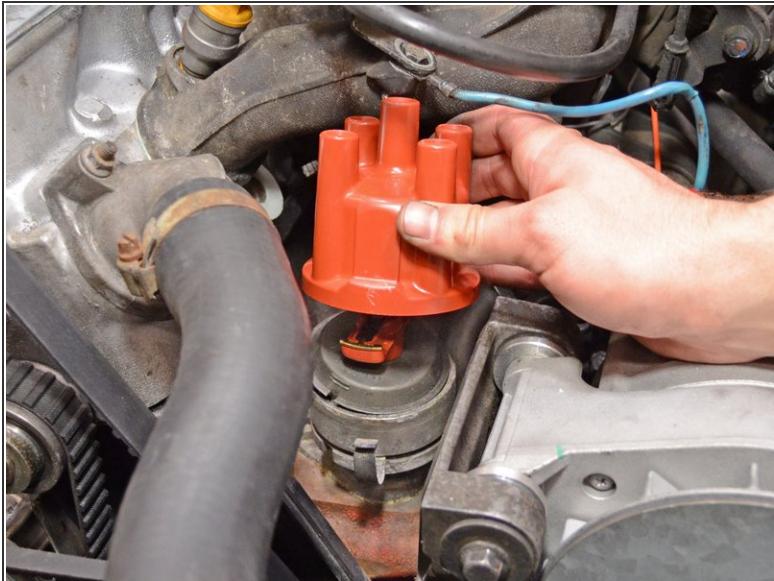
## Step 4

- Use a flathead screwdriver to release the clip securing the distributor cap.
- Only one side of the distributor cap has a spot for the clip to rest. The new cap must be installed in the same orientation.
- Remove the old distributor cap.

When installing the new distributor cap, don't forget to reconnect the center ignition coil wire.
