# 1999 GMC Sierra Radio Replacement Radio Replacement

Replacing a radio in a 1999 GMC Sierra SLE. Based off replacing a stock radio with a XO Vision XD107BT radio.

This guide will show the steps of replacing a radio in a 1999 GMC Sierra SLE. The radio that is being replaced is a stock radio, and the new radio is a XO Vision XD107BT.

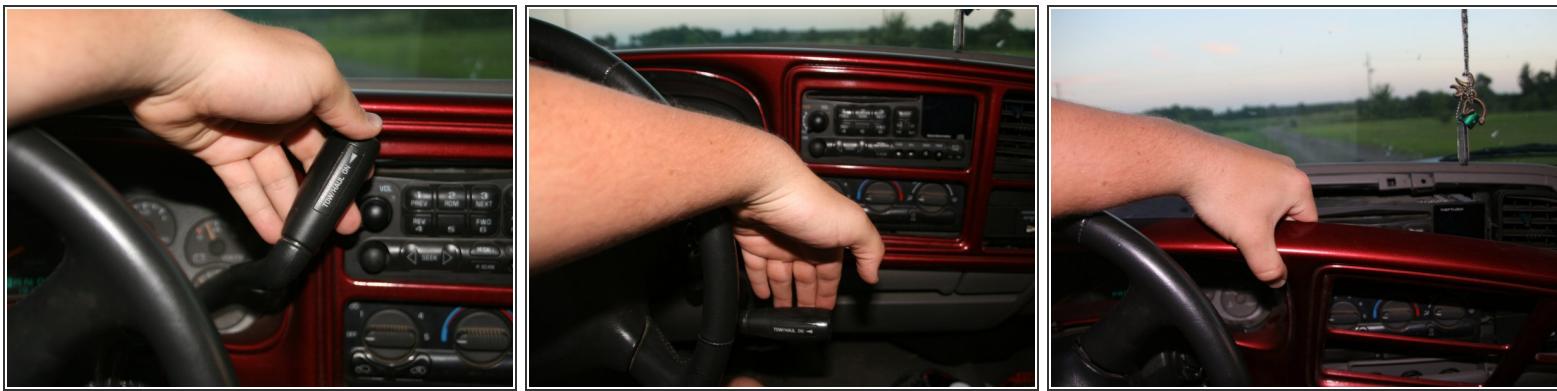
## Step 1 — Radio

- Use the gear shift to shift the truck from 'Park' to '1st Gear' so that the dash face is easily accessible.
- Pop the dash face off, and place it to the side until the radio has been replaced

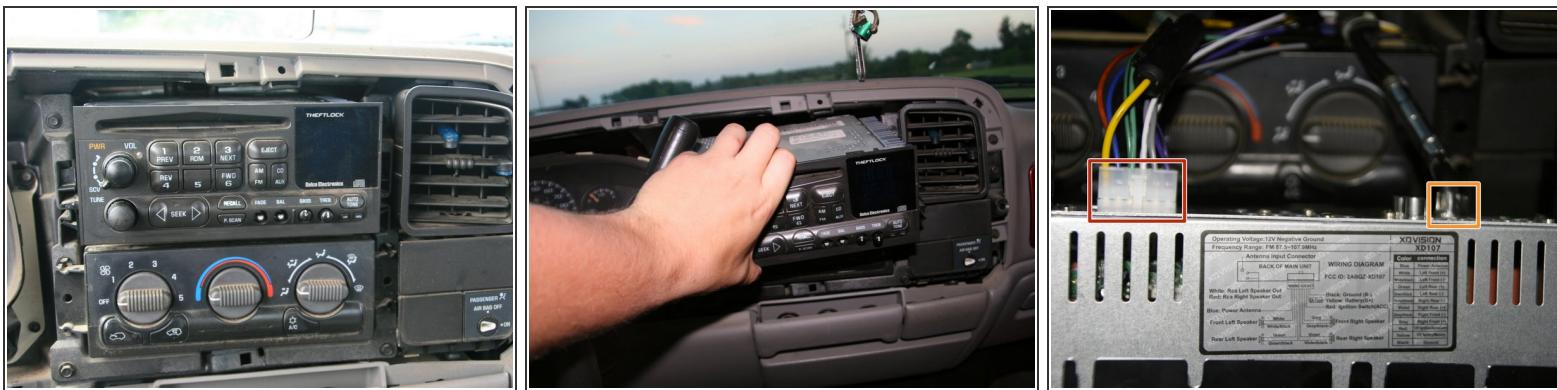
## Step 2

- Remove the radio from its place.
- Remove the bundled cable connector from the back of the radio unit.
- Remove the antenna plug from the back of the radio unit.

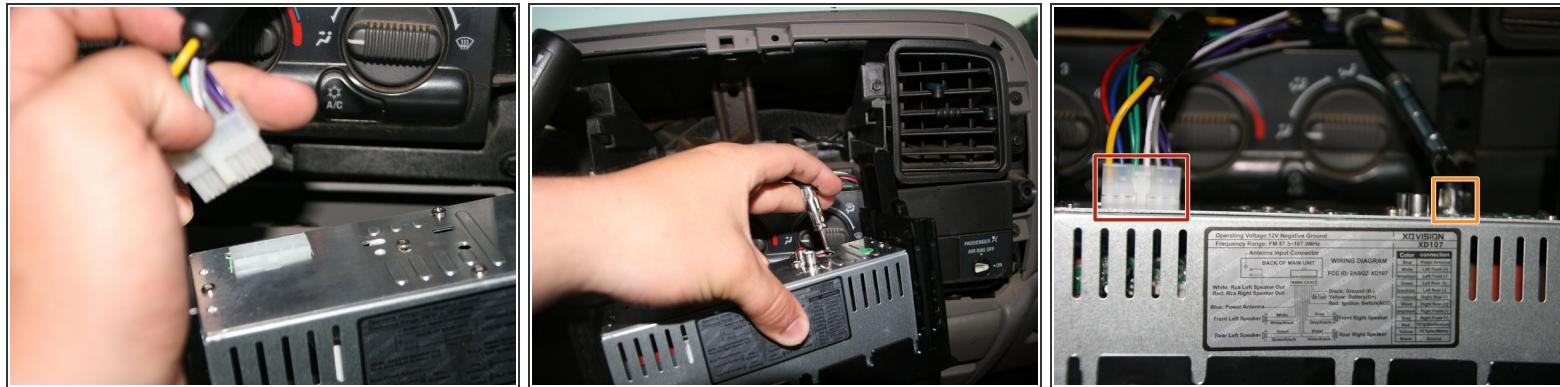
## Step 3

- Attach the radio plug to the back of the new radio.
- Also, attach the antenna chord to the back of the new radio.

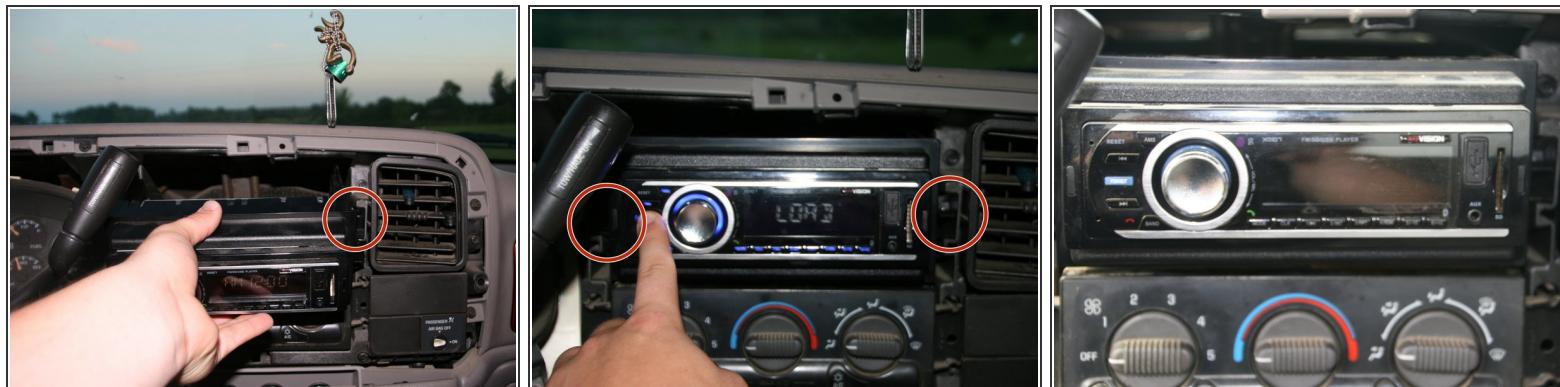
## Step 4

- Align the slots along the sides of the new radio with the ones in the dash.
- Push new radio in until you hear a 'pop' sound, telling you the new radio is in place.
- Press the power button on new radio to insure that it works properly.

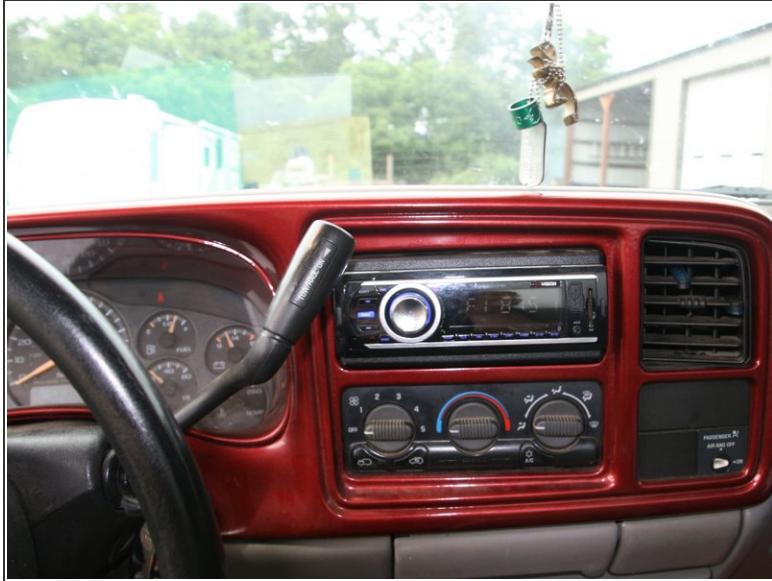
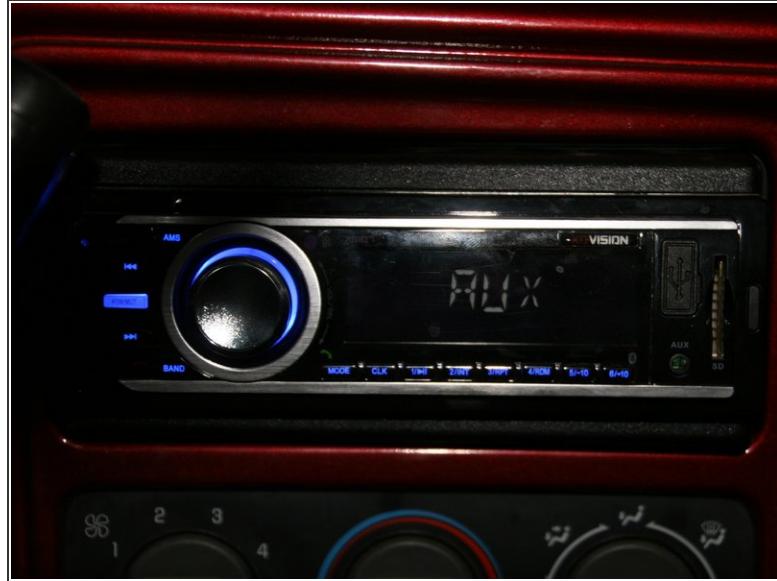
## Step 5

- Replace dash face! Then you are finished!
