2003 Ford F150 Driveshaft U-joint rear Replacement

I did the replacement of the U-joint with the simplest tools I could use.

Here is a recent repair on an F-150 drive shaft. It started by making some loud clanking noise on acceleration and when slowing down. As with any repair under a vehicle, make sure that proper safety steps are followed. Use proper jack stands and wheel chock's for the front wheels. The drive shaft is not very heavy, but it's a bit cumbersome to hold. An assistant can be of great help to remove the driveshaft from under the vehicle. For the replacement of the U-joint itself, I chose to not use any special tools. I felt that it might be beneficial to show how this repair can be done with some basic tools in a drive way somewhere. Yes, the right tools might make it easier, even so I did not have any issues using what I did.

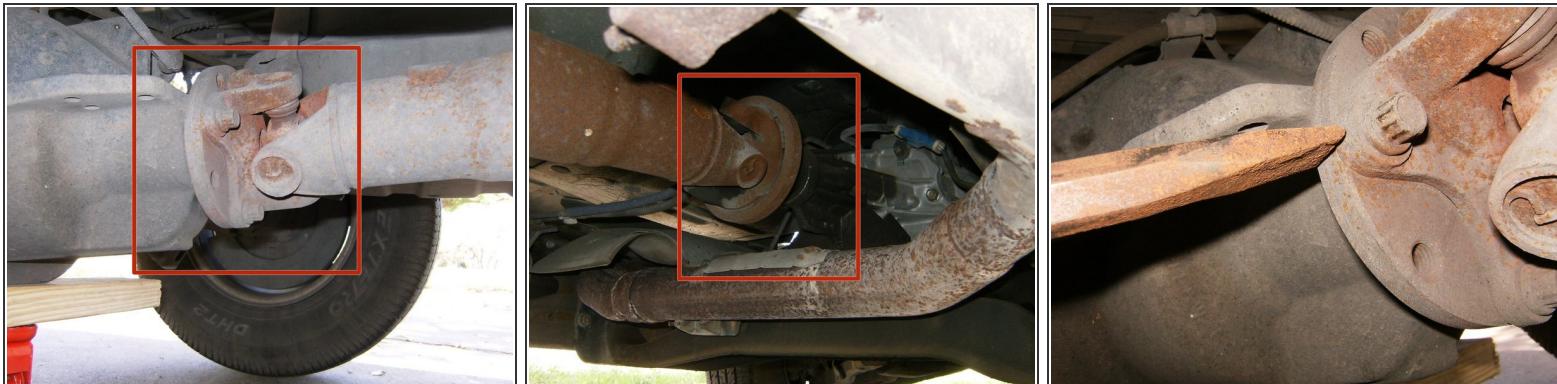
Step 1 — Driveshaft rear U-joint

- Here is a view of the rear U-joint assembly. It is connected to the driveshaft via the flange yoke. It is bolted to the rear axle at the drive pinion flange
- The front U-joint assembly connects the drive shaft and the slip yoke. The slip yoke just slides into the transmission and meshes onto the gear with its internal splines.
- Use a chisel, or similar instrument, to index the flange yoke and the pinion flange. All that does, it makes a mark across those two pieces. This will assure that the drive shaft will be mounted in the same way once the repair is done.

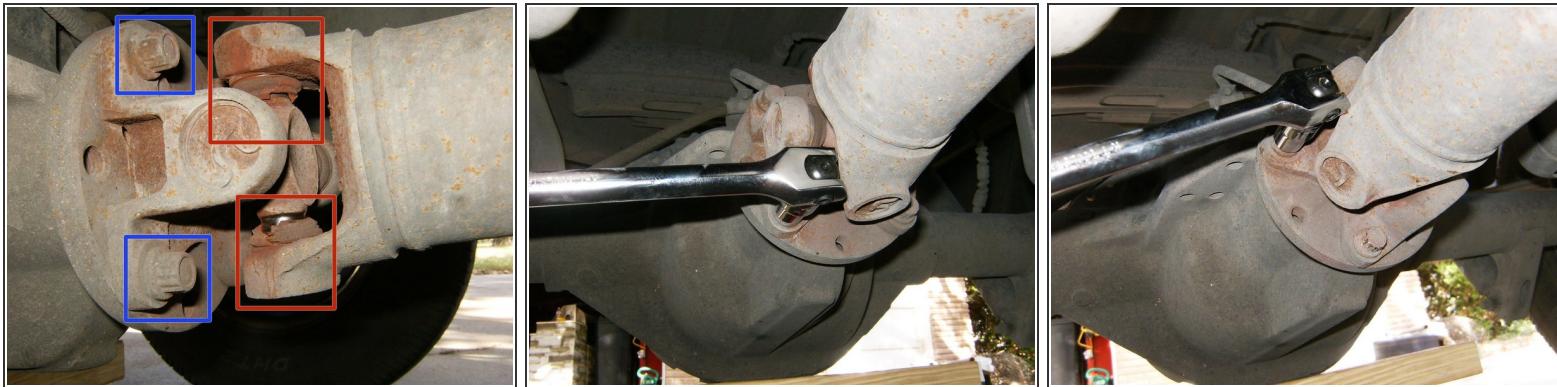
Step 2

- The damaged U-joint is clearly visible.
- There are four bolts that connect the flange to the yoke. The bolt heads require a 12mm 12point socket. A 6 point socket will not fit, and a box end wrench will not generate enough torque.
- Use a 12mm 12 point socket and a 16 inch breaker bar will generate enough torque to remove the bolt. Here a 1/2" drive socket set is used. 3/8" socket set may work as well, but the larger drive set will tolerate a bit more torquing.
- Loosen all four bolts in a criss-cross pattern.

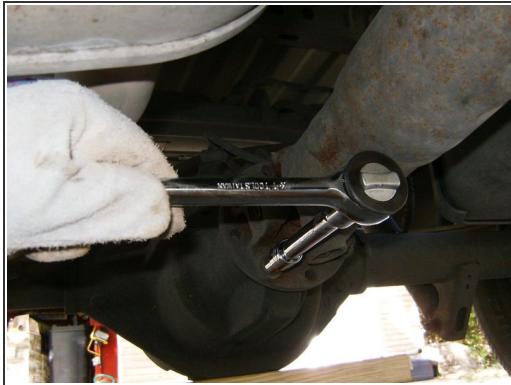
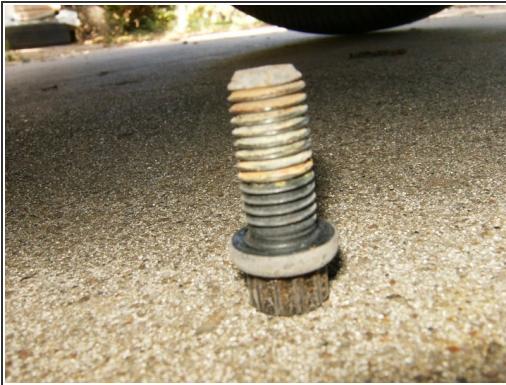
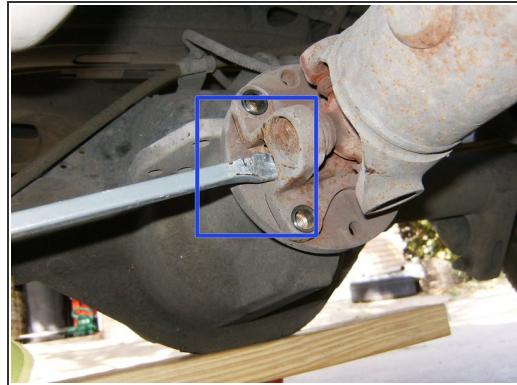
Step 3

- Use a socket and small extension to remove the bolts.
- Here is a view of the actual size of the bolt.
- The driveshaft flange yoke fits tightly on the rear axle pinion flange pilot. Do not hammer on the driveshaft or any of its components to disconnect the yoke from the flange. Pry only in the area shown, to disconnect the yoke from the flange.

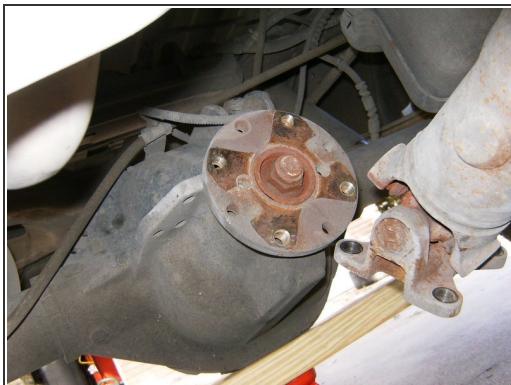
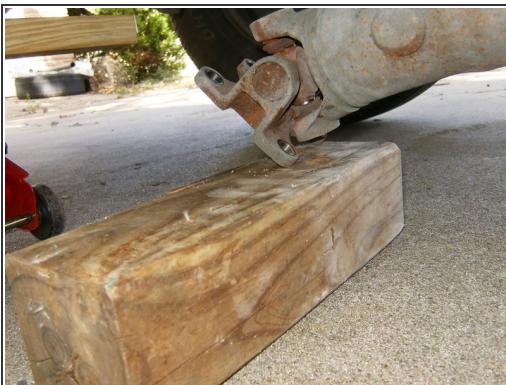
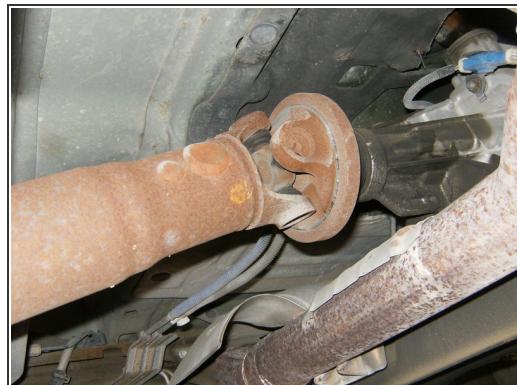
Step 4

- Driveshaft removed from the pinion flange.
- It is not very heavy, but do not let it hit the ground. Use a wooden block to set it down
- The front slip yoke still in place.

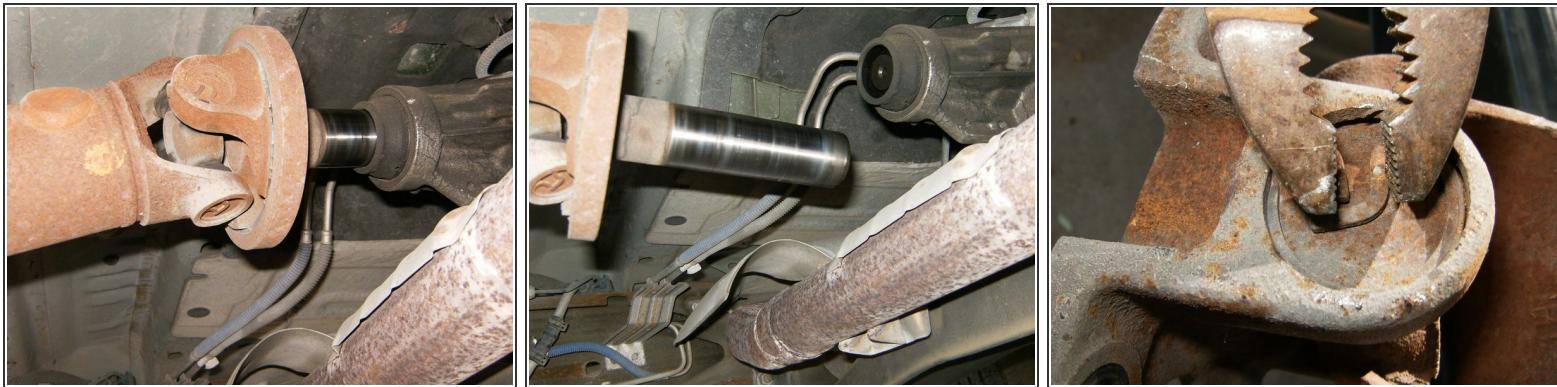
Step 5

- Lift the driveshaft of the wooden block and gently slide it to the back of the vehicle.
- The driveshaft slip yoke will simply slide out.
- Remove the driveshaft from under the vehicle and place it on a suitable place (large workbench or even the ground)
- Remove the snap ring that secure the bearings. Use a pair of pliers and squeeze the angled ends of the snap ring together. this will compress the ring.

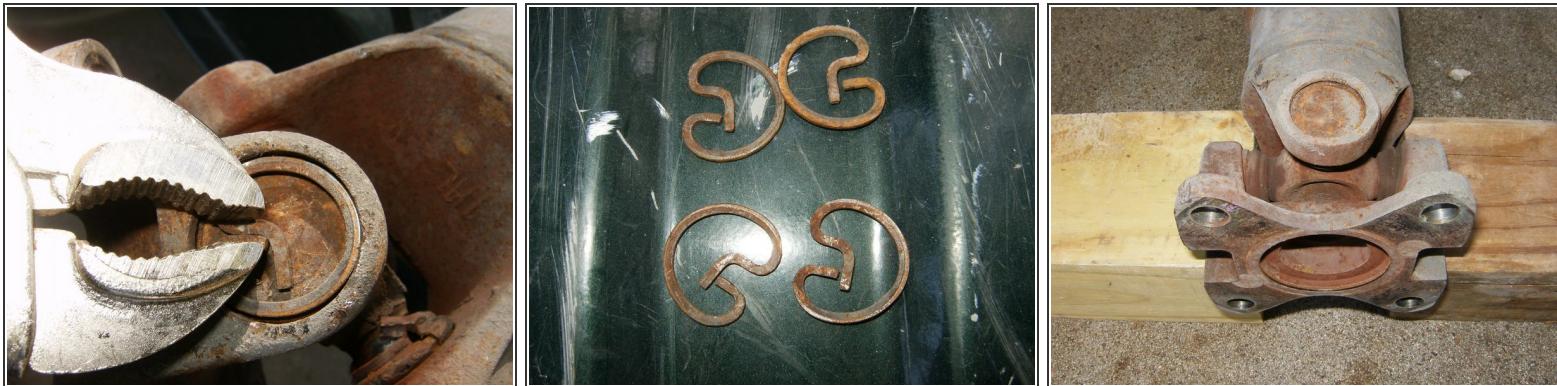
Step 6

- When the ends are properly compressed the ring will clear the inside of the groove and can be removed.
- Here are the four old snap rings. Discard those, do not reuse.
- All snap rings removed. Place the driveshaft over a block of wood so that the flange yoke will clear it.

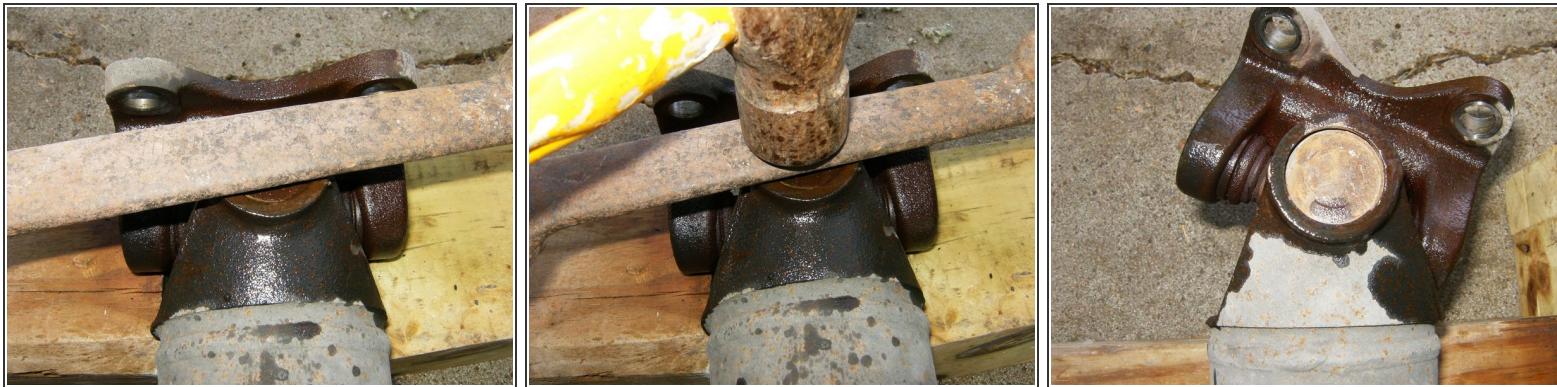
Step 7

- Application of some lubricant may assist in loosening some of the rust and debris that may have collect between the bearing cup and the bearing hole itself. Place a piece of flat metal stock across the bearing cup.
- Use a hammer and strike the flat stock
- This will slide the yoke and subsequently the bearing up through the bearing opening in the driveshaft.

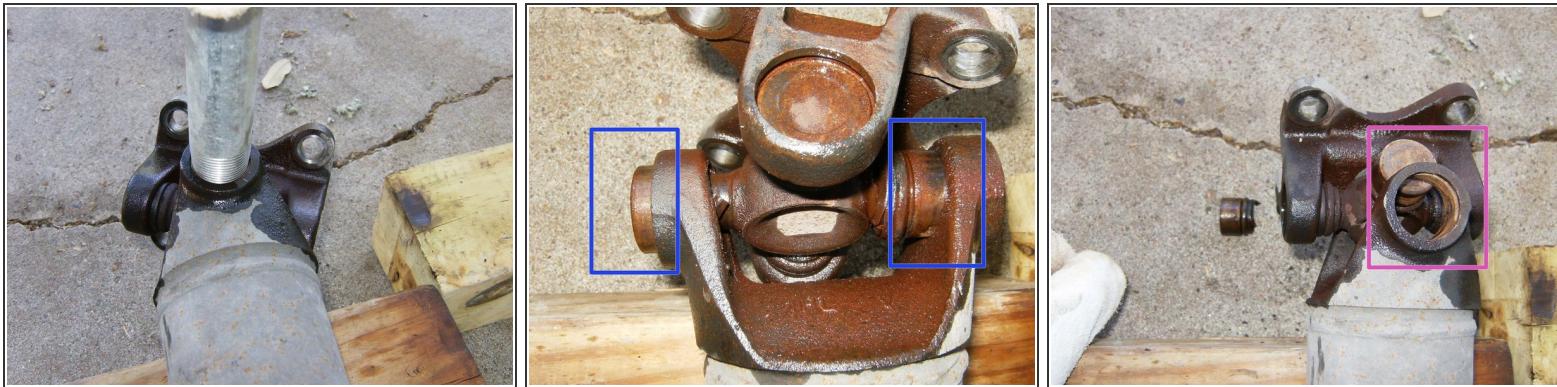
Step 8

- Turn the driveshaft 180degrees and use a tool that will fit inside the bearing hole of the drive shaft
- Strike the tool with a hammer. This will move the U-joint and yoke further out of the drive shaft
- It should only take 2-3 hammer strikes to move the yoke and U-joint out of the driveshaft bearing holes. The bearing cup most likely will may simply fall out.

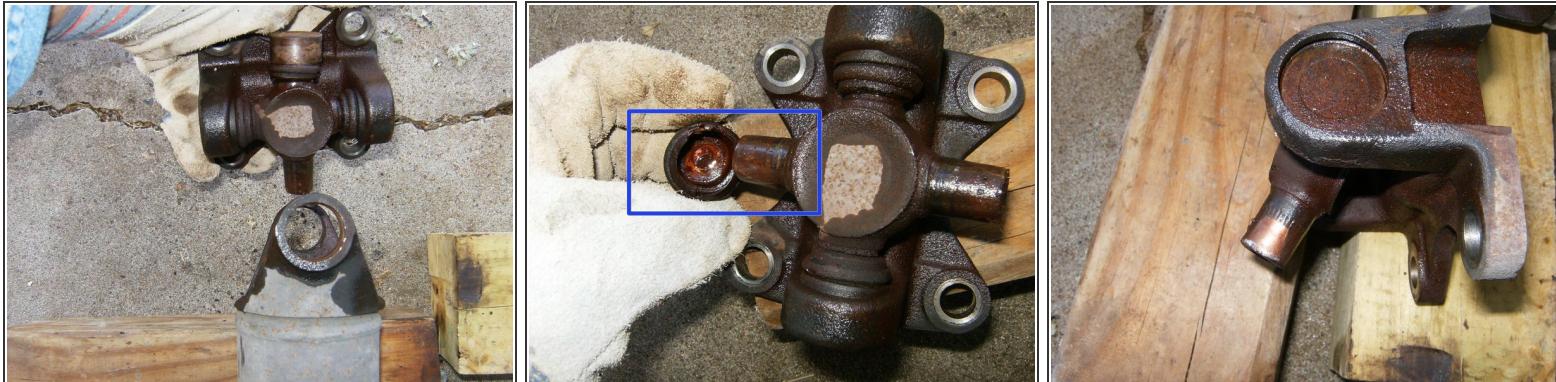
Step 9

- Remove the yoke from the driveshaft by angling it so it will clear the bearing surface.
- Here is the flange yoke with the U-joint still attached.
- Here is the damage. Missing needles out of the bearing cup, worn trunions on the joint cross.
- Place the flange yoke between two blocks of wood. Leave enough space between the blocks to clear the bearing cup.

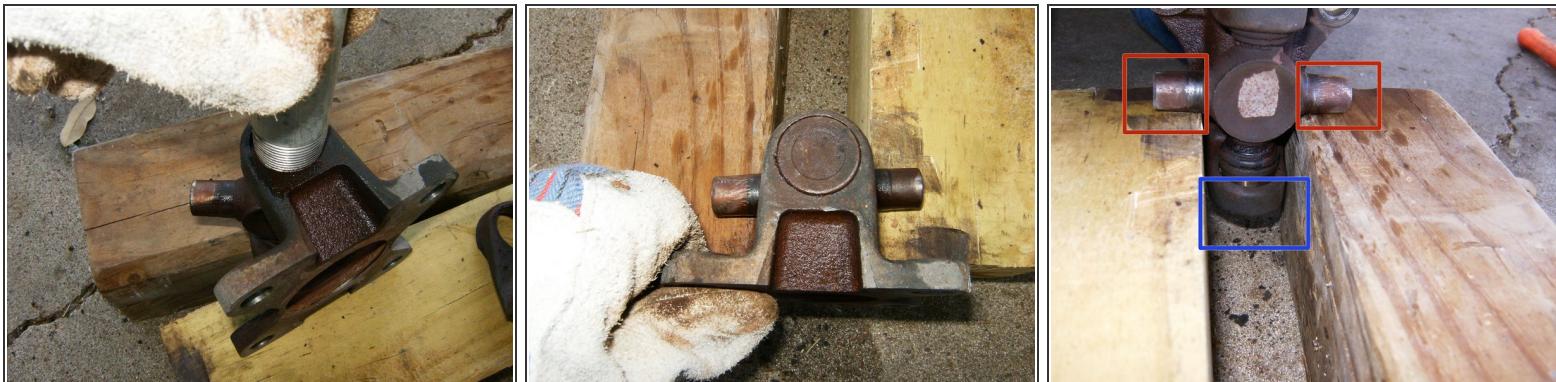
Step 10

- Use a tool that fits inside the bearing hole in the flange yoke. Strike that tool with a hammer to drive the U-joint down the opening.
- Shown here is the opposite end of the yoke. The U-joint is now flush with the yoke bearing hole.
- Position the yoke between two wooden blocks, let it rest on the trunions
- provide clearance to the bottom

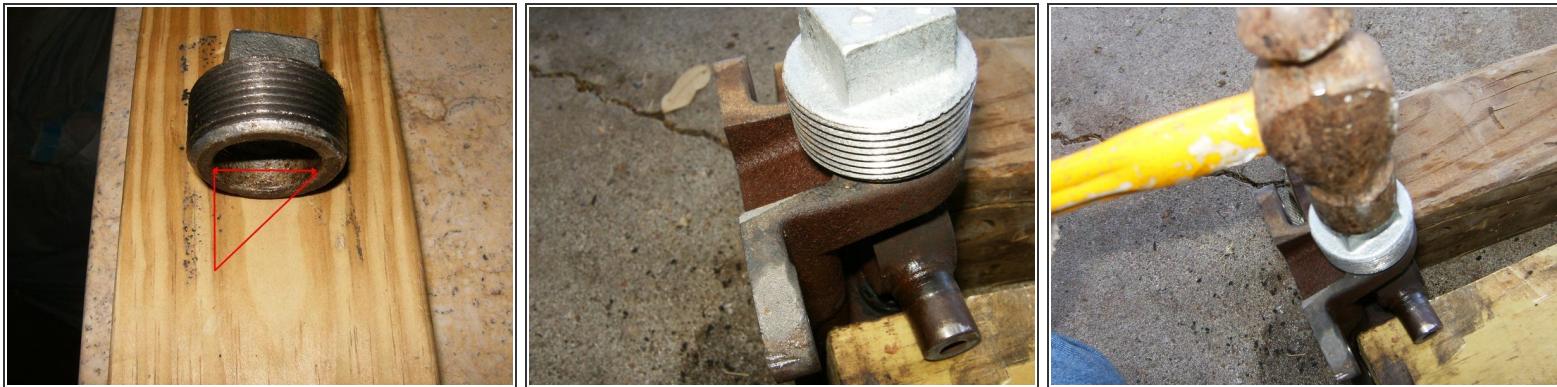
Step 11

- Here is the next tool I am using. It is a 1 1/4 galvanized plumbing plug. It has enough clearance to fit over the bearing cap.
- Place the tool over the bearing cup and rest it on the flange yoke.
- Strike that tool with a hammer

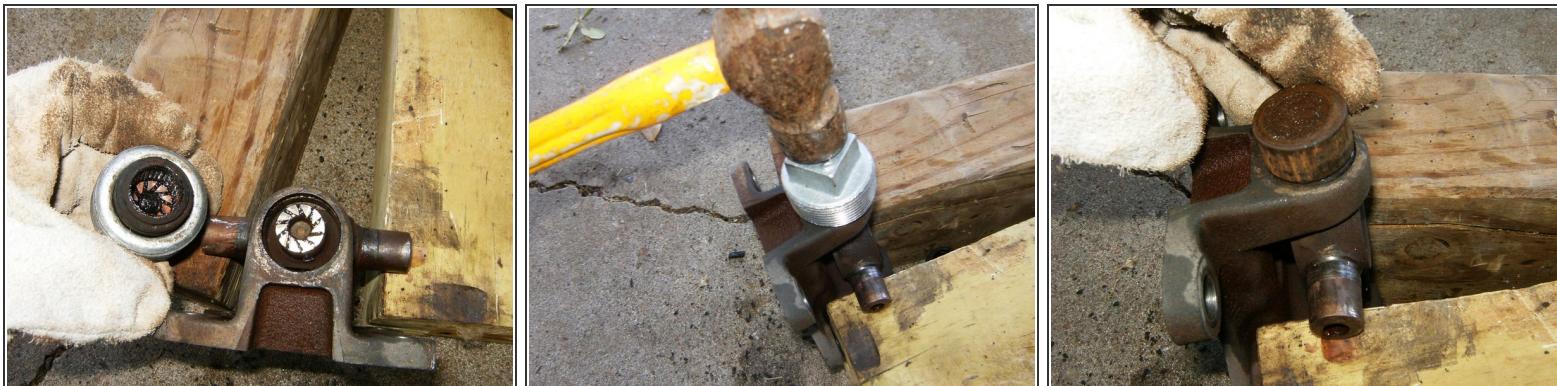
Step 12

- The yoke will move down, clearing the bearing cup. The cup may now rest inside the tool. It will be easily removed.
- Turn the yoke 180 degrees and position it between the two blocks of wood. Let the trunions rest on the wood. Place the tool over the bearing cup opening and strike it with a hammer
- The yoke will move down, clearing the last bearing cup.

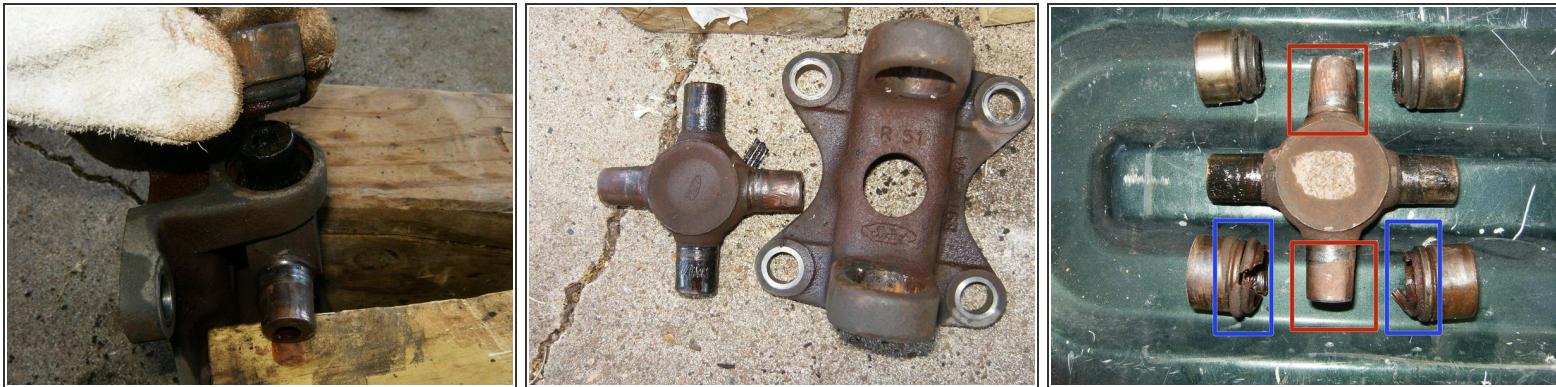
Step 13

- Remove the bearing cup.
- Remove the U-joint cross from the flange yoke.
- Show here is the damage to the trunions
 - as well as the bearing cups

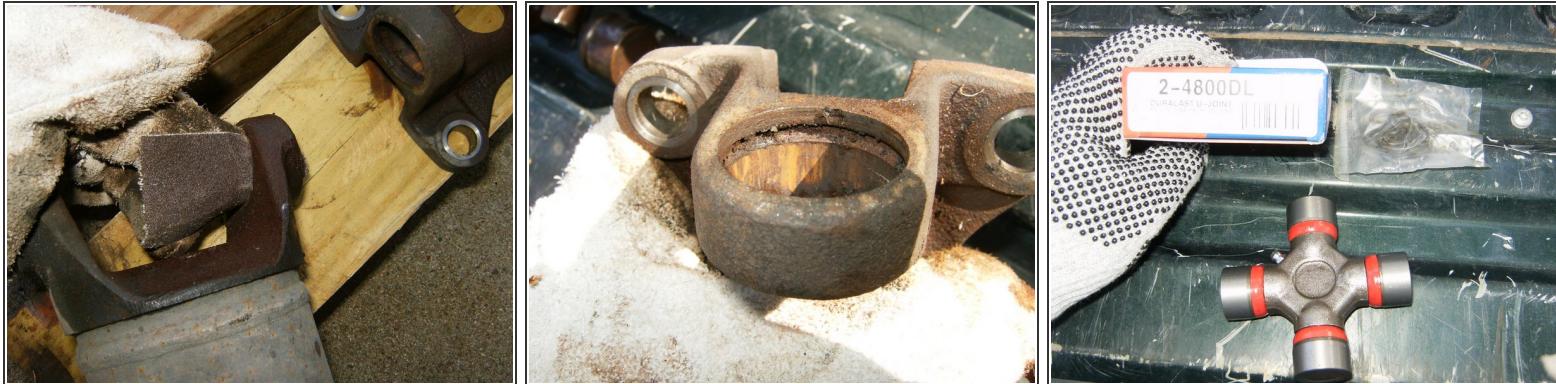
Step 14

- Clean the bearing openings with either a piece of emery cloth or a file. Deburr all the edges
- Clean the groove for the snap rings of any debris. It is imperative that these are clean to properly seat the snap rings
- Here is the new U-joint assembly for this truck. Purchased at Autozone for around \$9. This has a grease fitting that the original did not have.

To reassemble your device, follow these instructions in reverse order. Ensure the needle bearings are seated straight in the bearing cup. Do not force the trunion all the way into the bearing. If it does not butt flush against it, disassemble and check for dislodged needles.
