# 2008-2010 Mitsubishi Lancer Radio/CD Player Replacement

Learn how to replace the radio/CD player unit for 2008-2010 Mitsubishi Lancers.

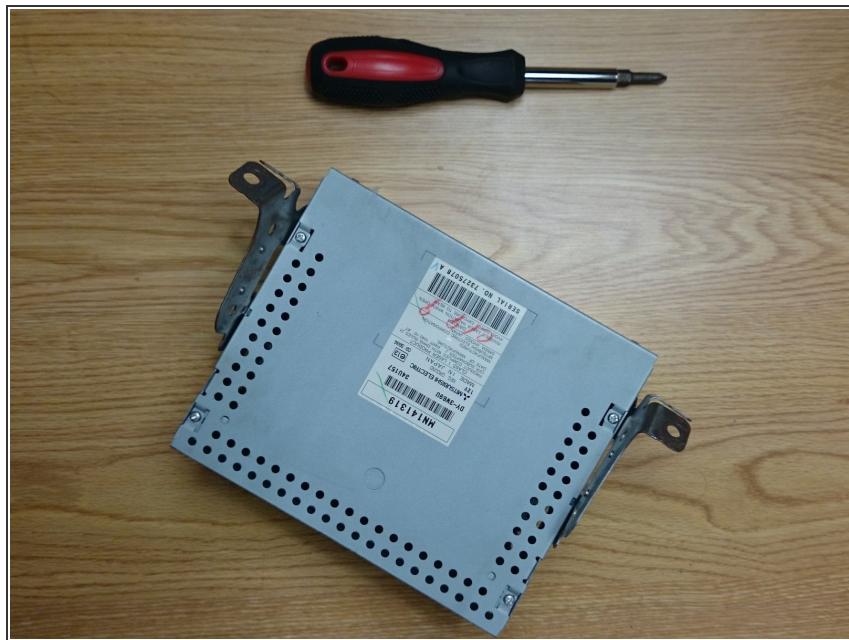
## Step 1 — 2008-2010 Mitsubishi Lancer Radio/CD Player Replacement

- The only tool required for this install is a Phillips #2 screwdriver. Of course, you will also need the new replacement radio/CD player unit that you will be installing.

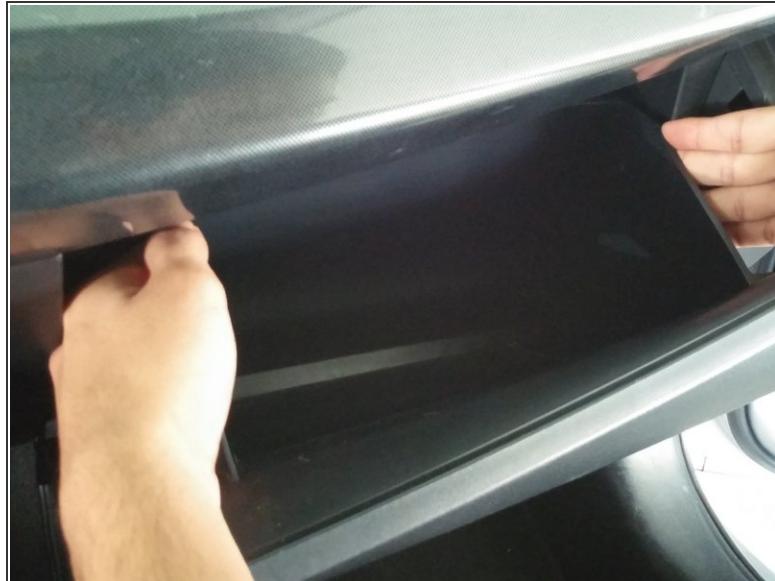
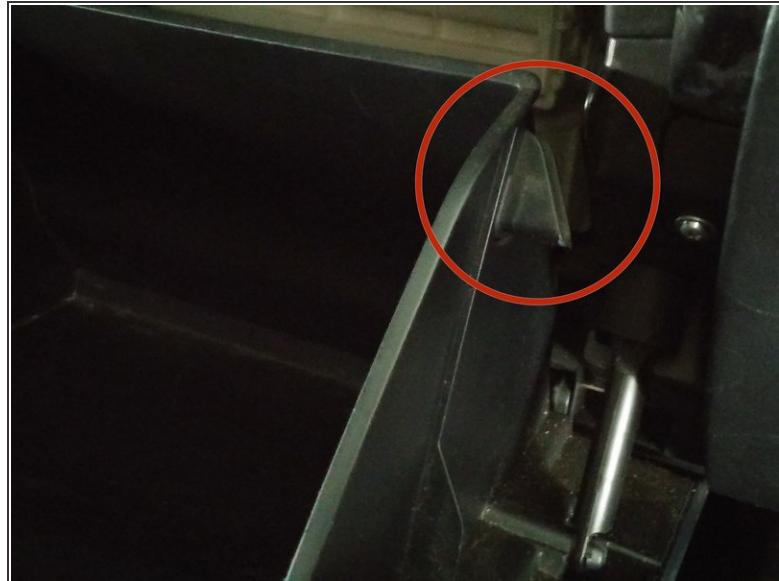
## Step 2

- Using both hands, apply inward pressure to the sides of the glove compartment until the compartment is free to slide out.
- The clips on the side of the glove compartment must be freed.

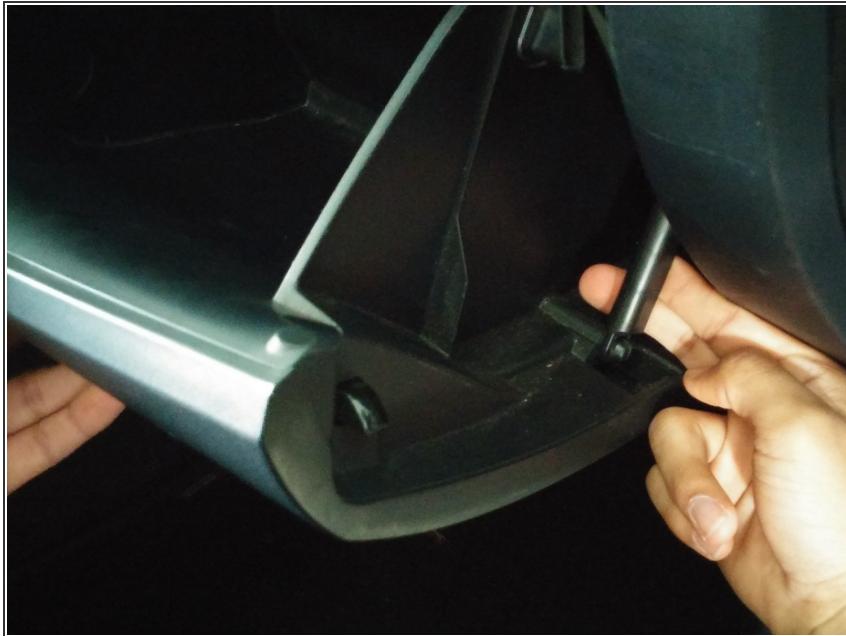
## Step 3

- Remove the attached plastic arm by simply pulling outward so that the arm snaps out of its socket.

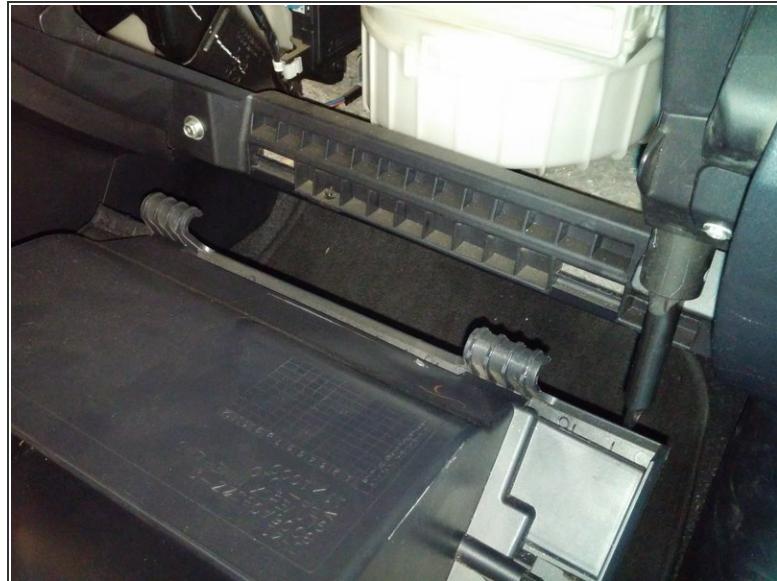
## Step 4

- The glove compartment can now be removed completely by raising it off its hinges.

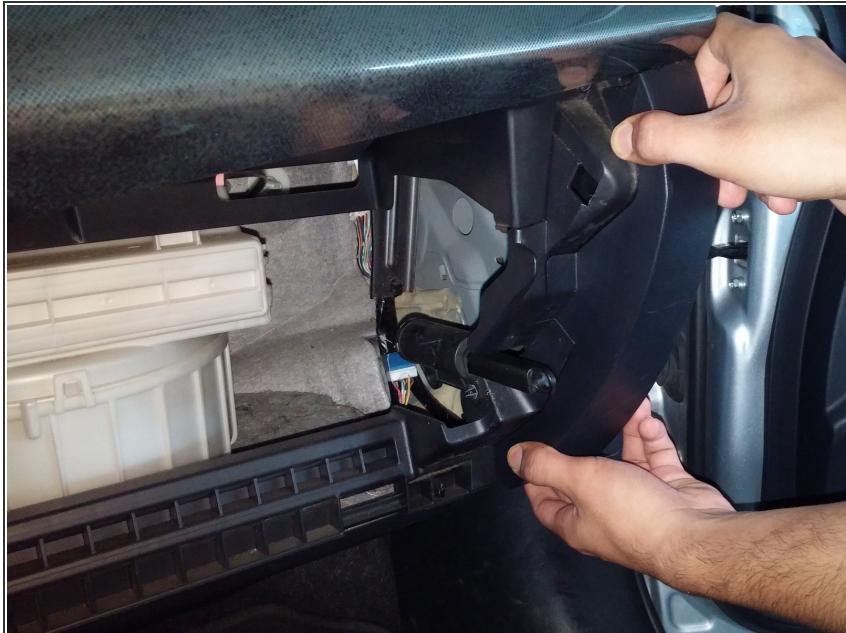
## Step 6

- Carefully remove the plastic trim by pulling outwards.

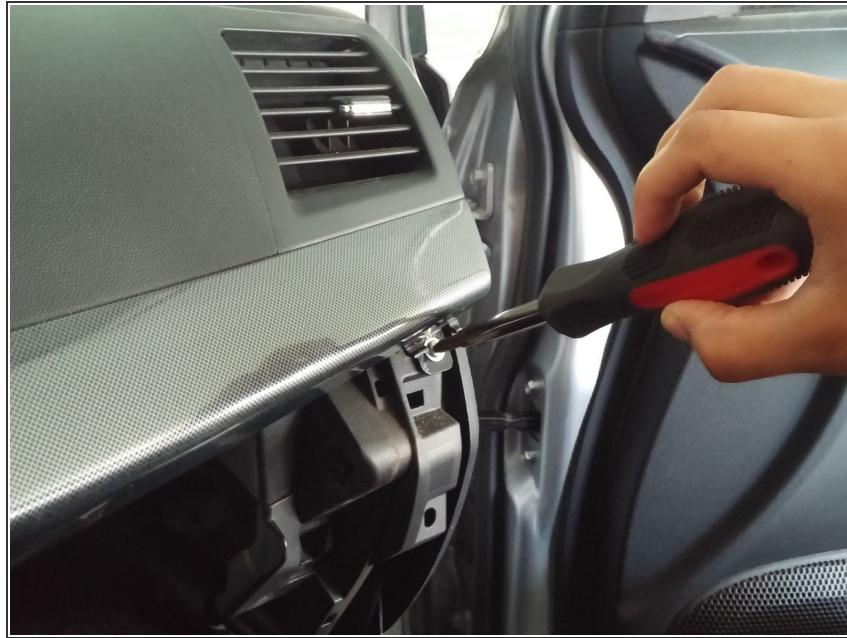
## Step 7

- Using a Philips #2 screwdriver remove a 15 mm screw from the trim piece.

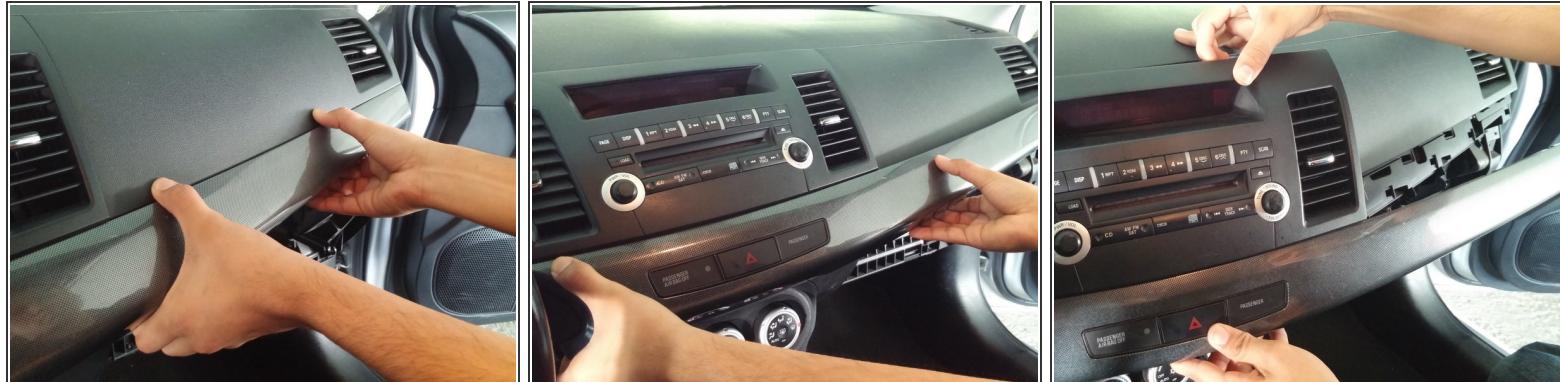
## Step 8

- Using both hands, carefully pull the trim outward section by section.

*(i)* The dashboard and decorative trim are attached to each other, so they will come out as one unit.

**⚠** When pulling out the trim start from the right and work your way toward the center console.
