2018 Ford Focus ST Positive Crankcase Ventilation Plate Gasket Replacement

How to fix a Positive Crankcase Ventilation (PCV) plate that has a faulty gasket creating an oil leak for a 2018 Ford Focus ST.

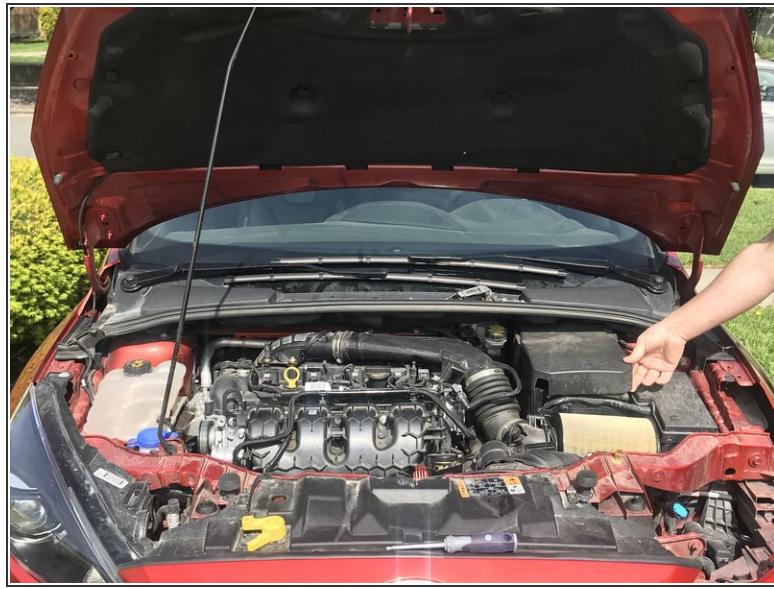
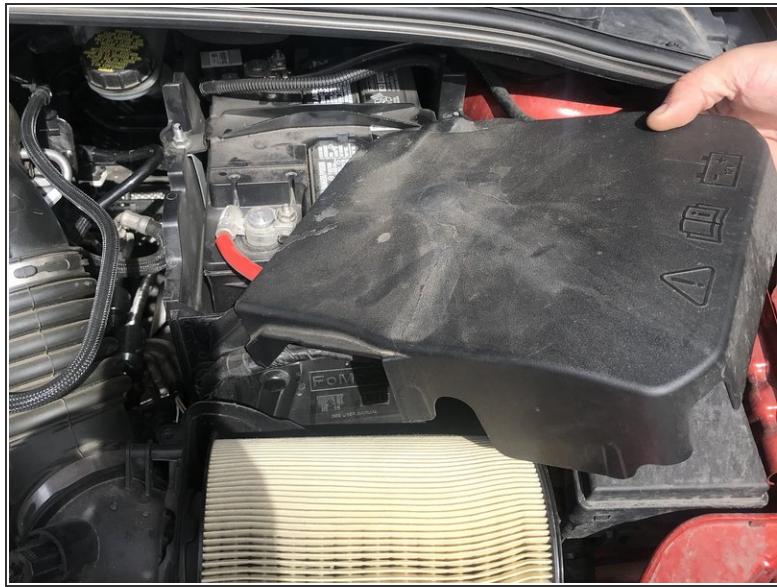
Step 1 — Gasket Replacement

- Pop the hood and remove the plastic battery cover.

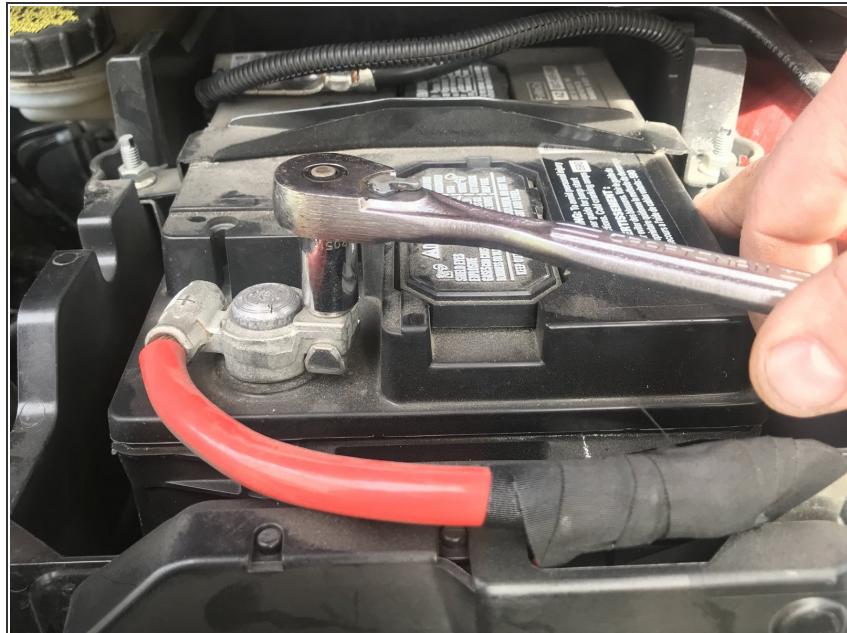
Step 2

- Using a 1/4 inch flex head ratchet and a 1/4 inch shallow 10mm socket, loosen the battery cable tightening nut.

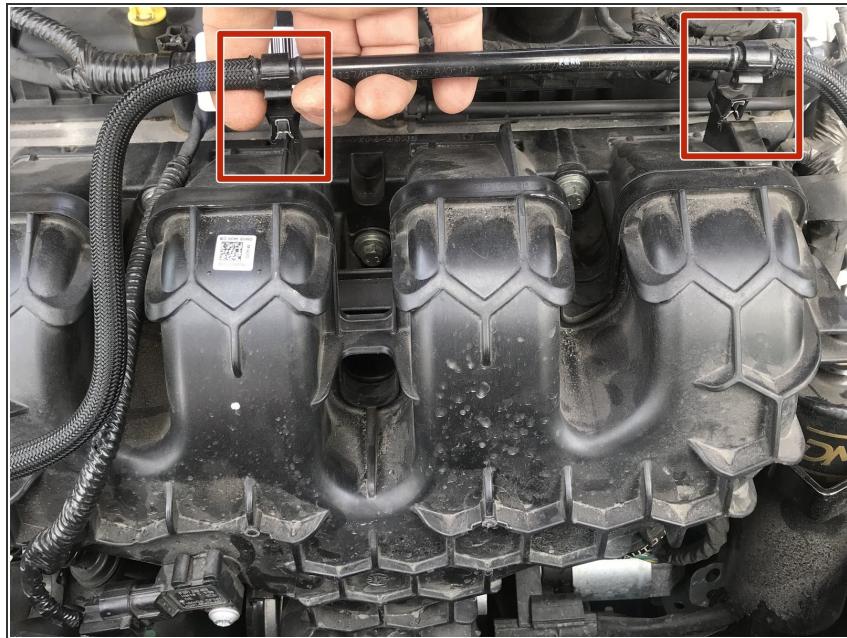
Step 3

- Remove the vacuum line from the front of the intake by gently pulling up on the line releasing it from the clamps.

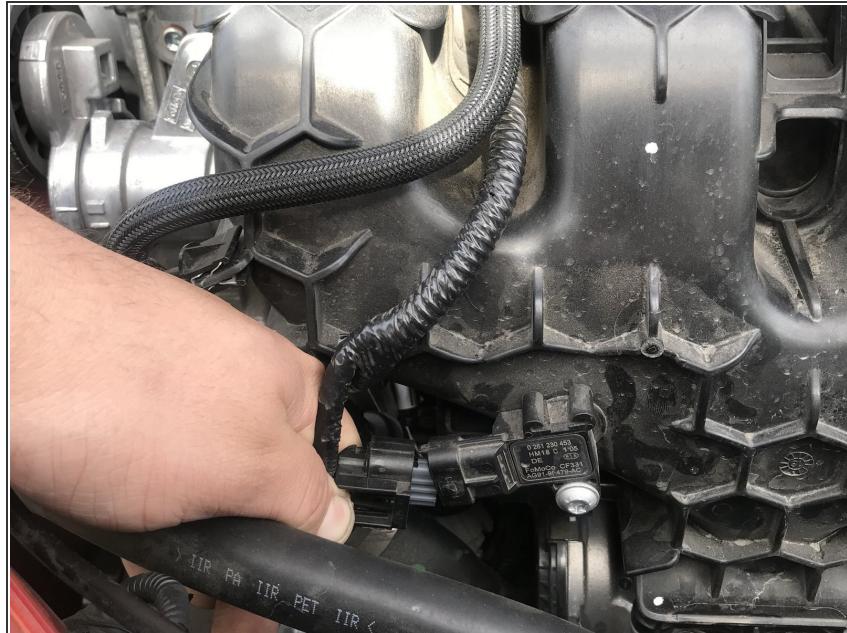
Step 4

- Disconnect the MAP sensor.

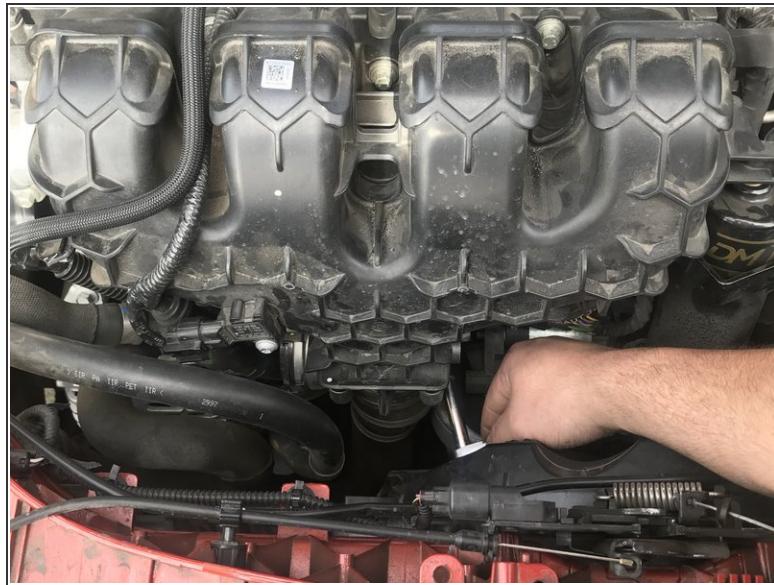
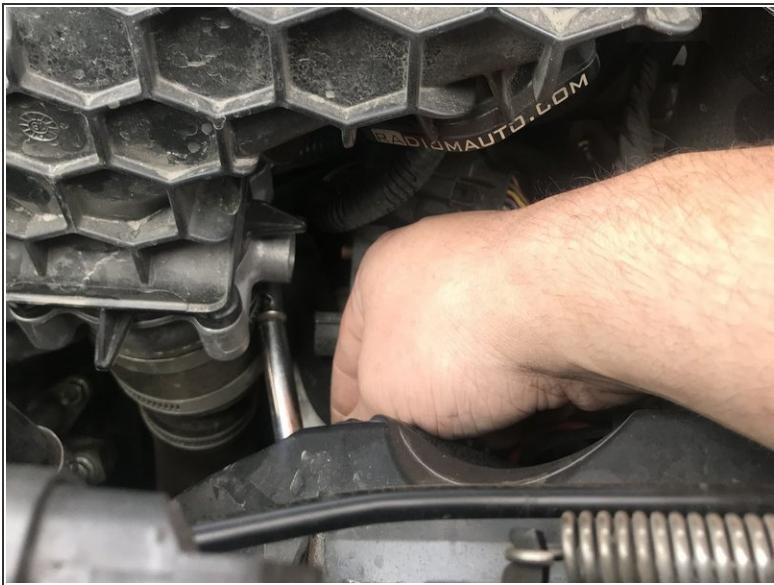
Step 5

- Using a 1/4 inch 7mm deep socket and 1/4 inch flex head wrench, loosen the worm clamp on the cold air intercooler pipe.

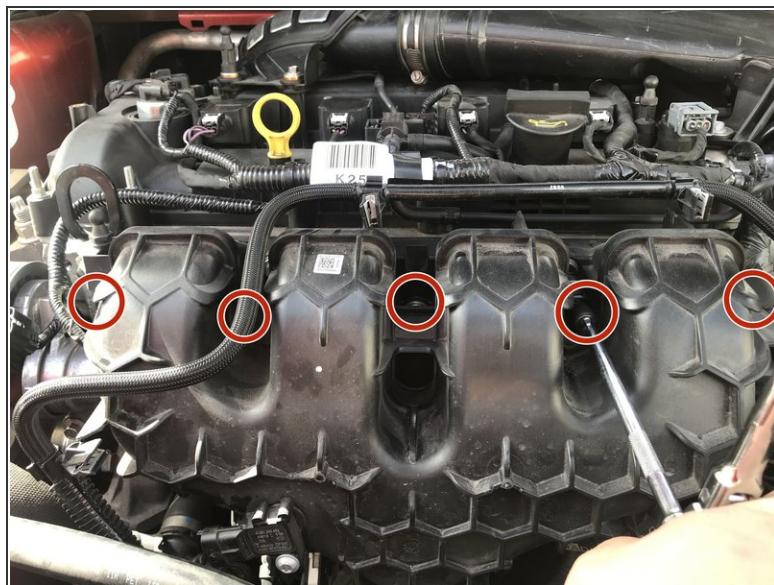
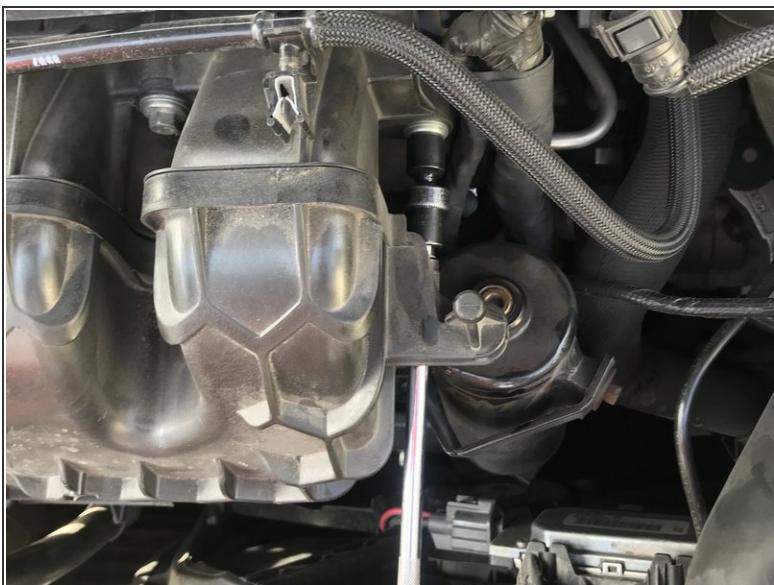
Step 6

- Using a 1/4 inch 10mm wobbly socket, 1/4 inch 8 inch extension, and 1/4 inch ratchet, remove all 5 of the cap screws holding the intake to the cylinder head.

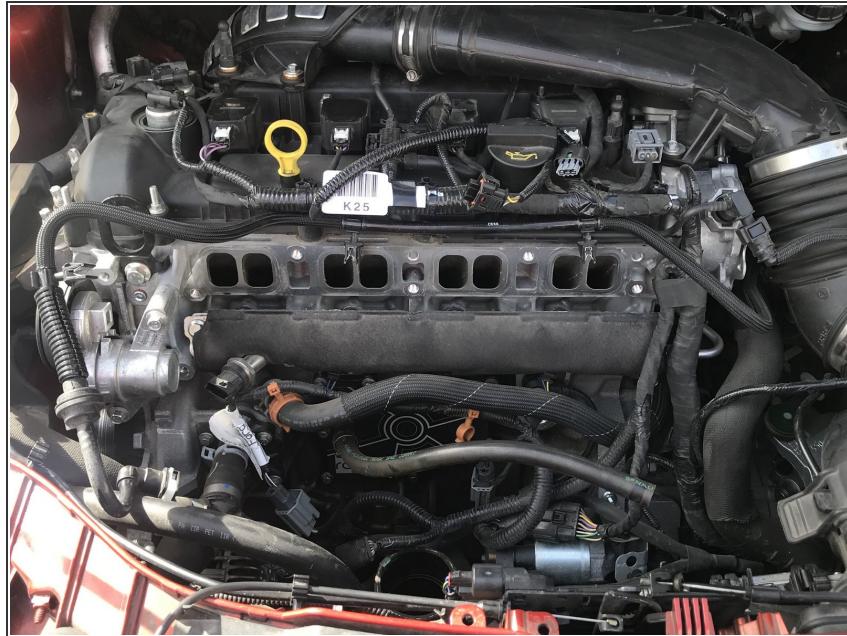
Step 7

- Remove the intake out of the engine bay by lifting and pulling the intake towards you.

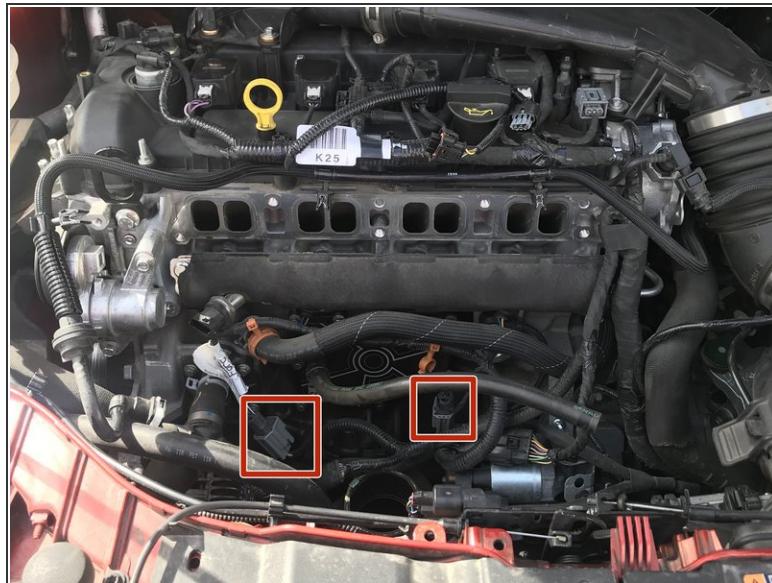
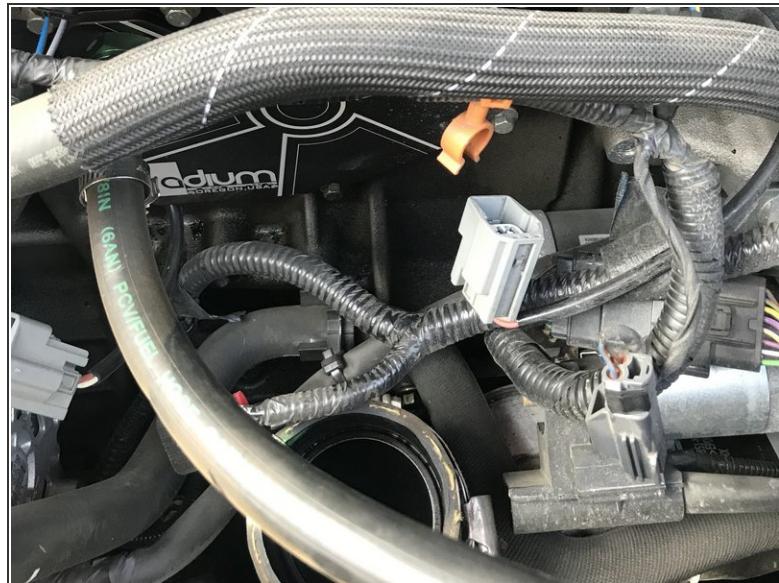
Step 8

- Unplug both left and right engine ground strap connections.

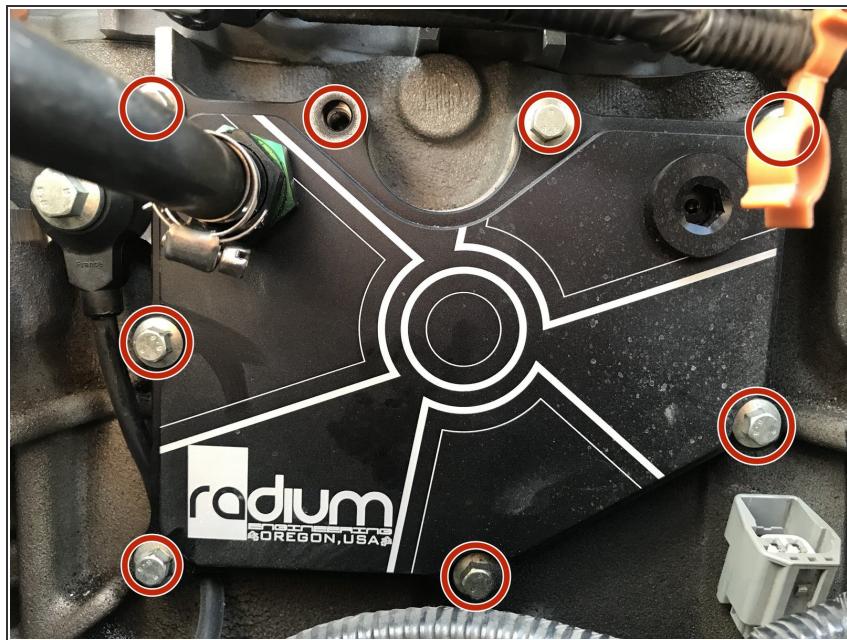
Step 9

- Using a 1/4 inch 8mm deep socket, remove the 8 PCV plate mounting bolts.

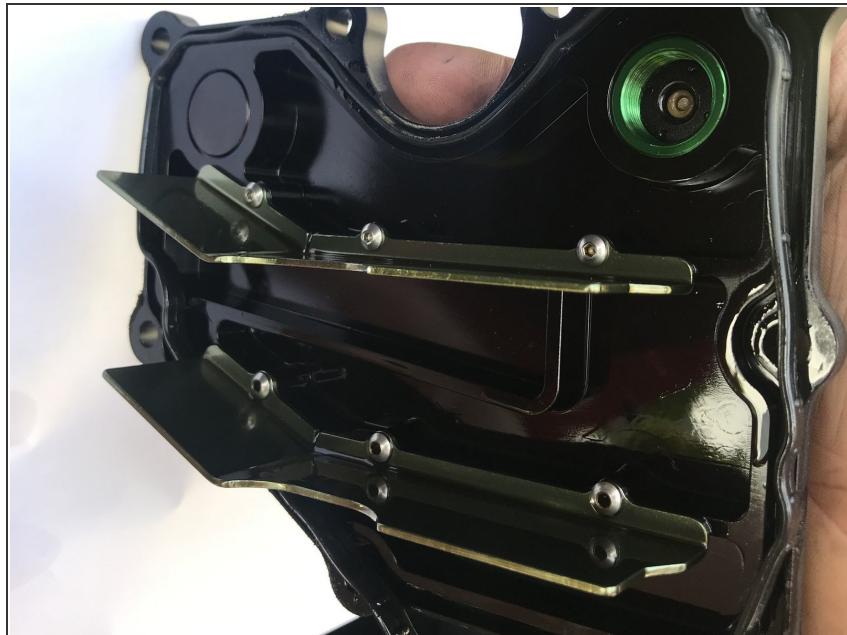
Step 10

- Remove the PCV plate and the old PCV plate gasket.

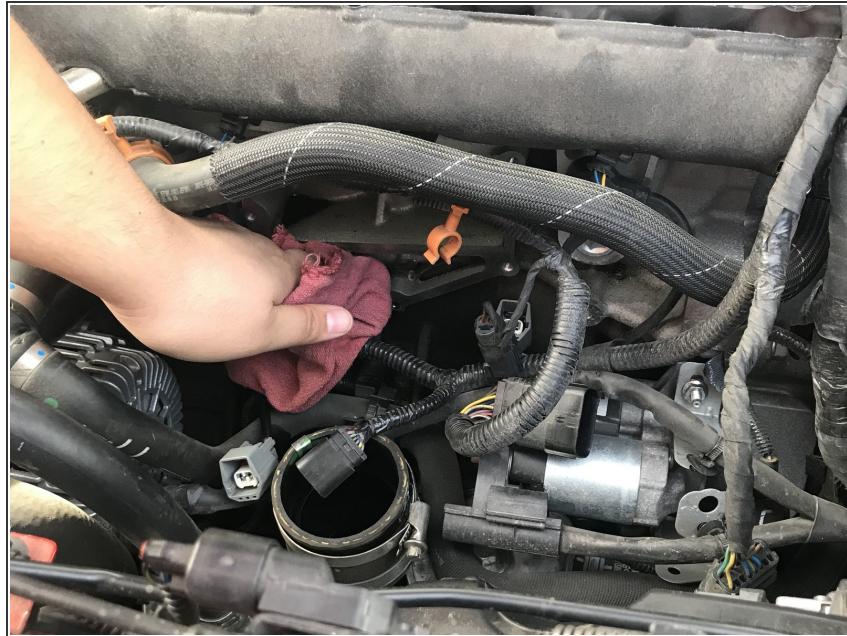
Step 11

- Wipe down the mounting surface and the inside of the PCV plate with a shop rag.

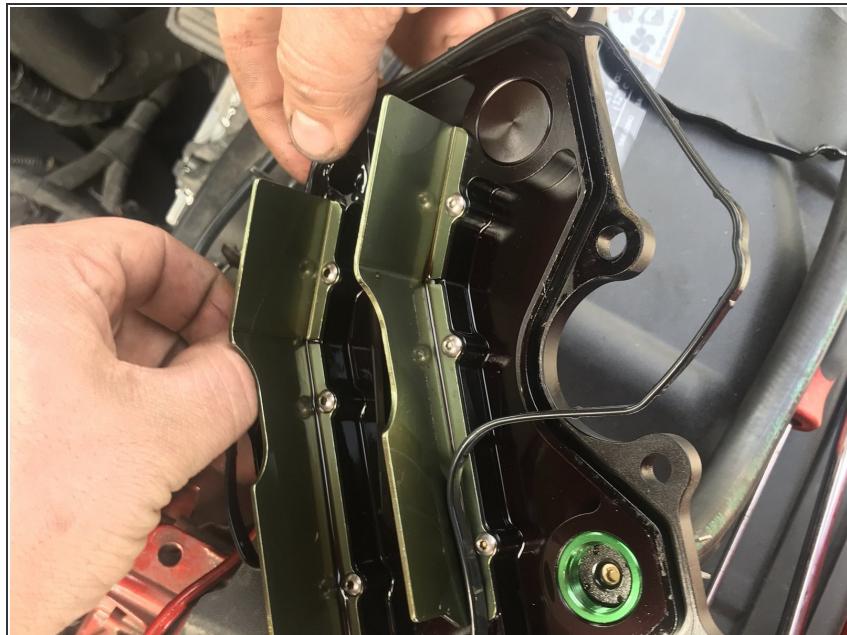
Step 12

- Install the new PCV plate gasket.

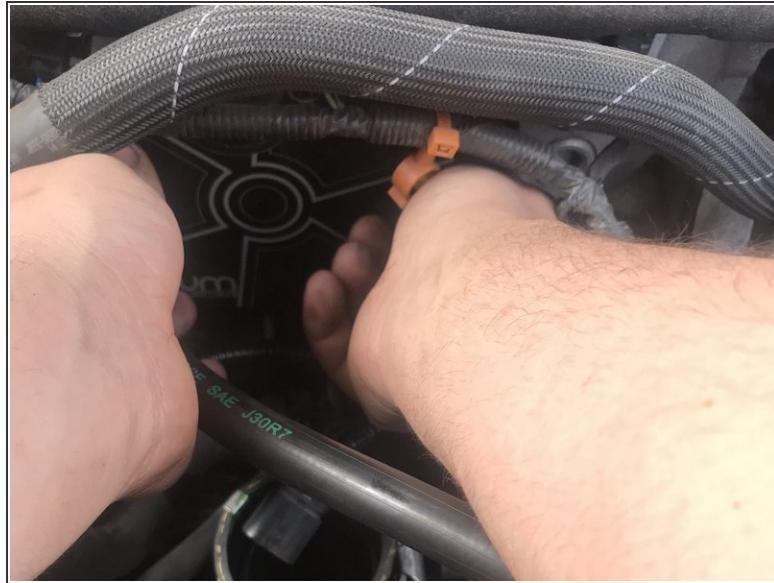
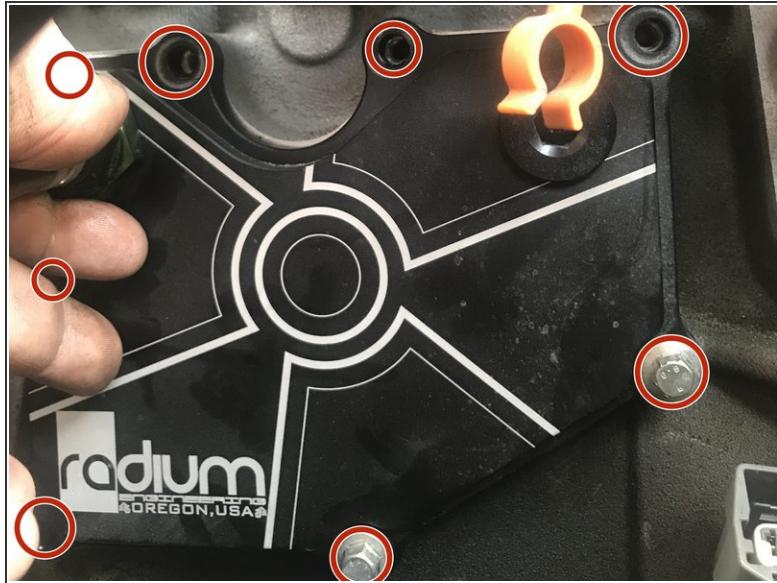
Step 13

- Reinstall the PCV plate on the side of the engine block.
- Torque the PCV plate mounting bolts to 89 inch pounds.
