ASUS X552LAV-BBI5N08 CD Drive Replacement

This guide will show you how to replace the CD drive for a ASUS X552LAV-BBI5N08 laptop.

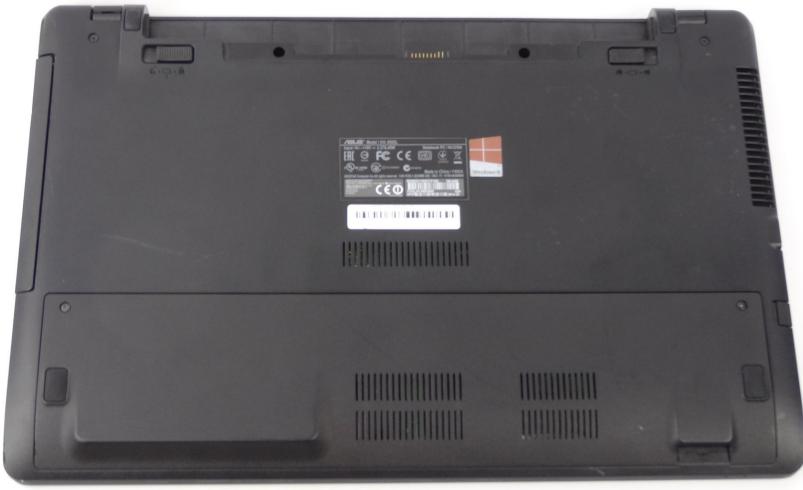
Step 1 — Battery

***i* Battery is not showed in pictures.**

- Flip the laptop face down.

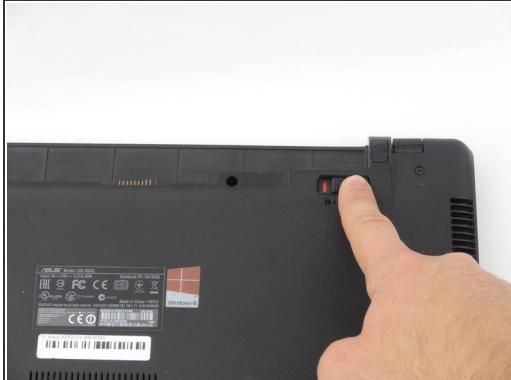
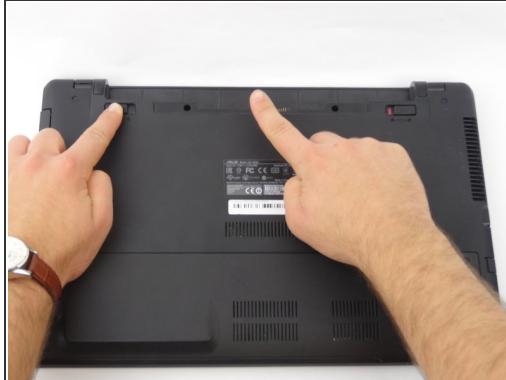
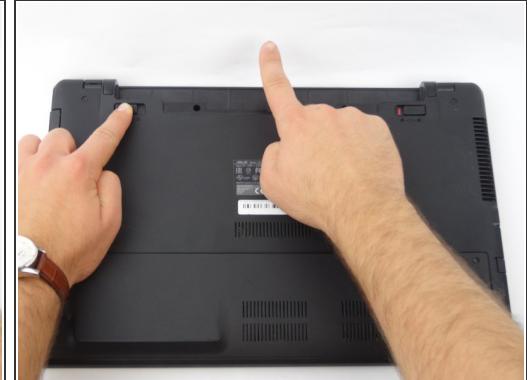
Step 2

- Slide the right button to the left.
- Hold the left button to the right.
- While you hold the left button in position, slide the battery out by pushing it away from you.

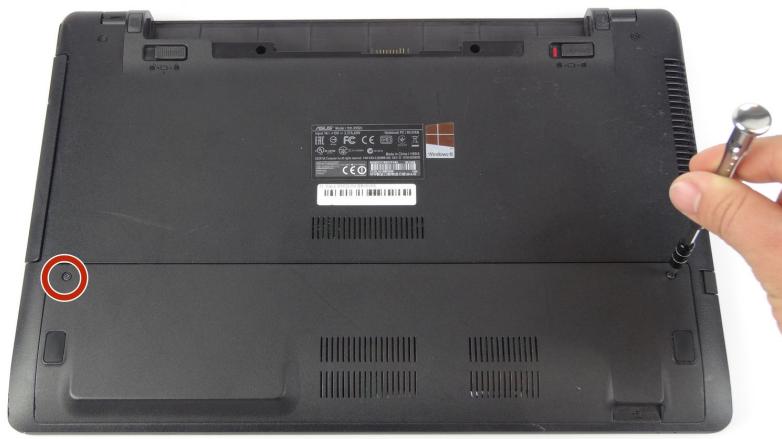
Step 3 — CD Drive

- Locate the bottom panel. It is at the opposite end of the battery.
- Remove the two 12mm screws at the bottom panel with a Tri-wing Y1 screwdriver.

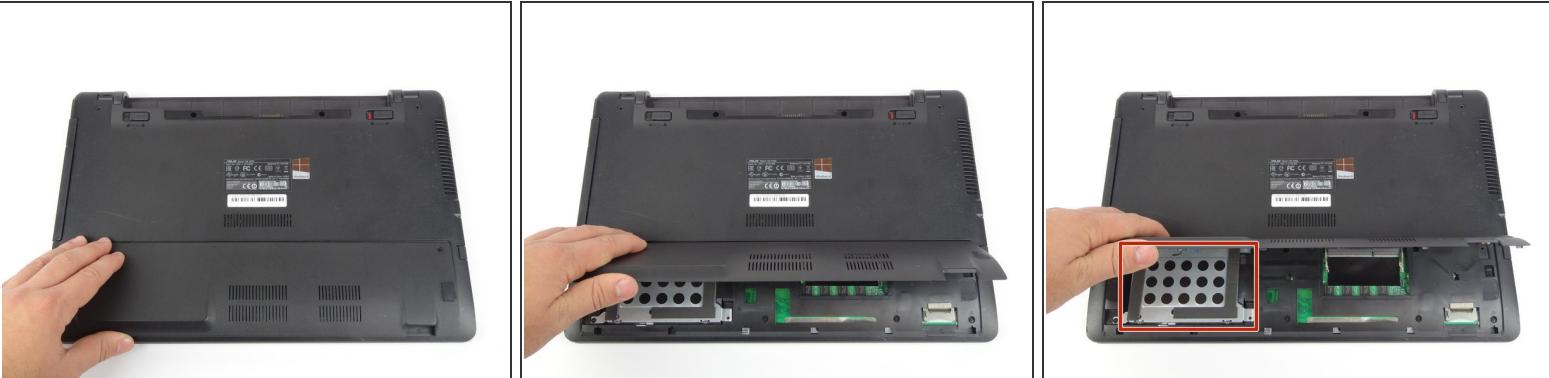
Step 4

- Remove bottom panel by lifting it up.
- Locate the hard drive.
- It is located in the bottom left corner.

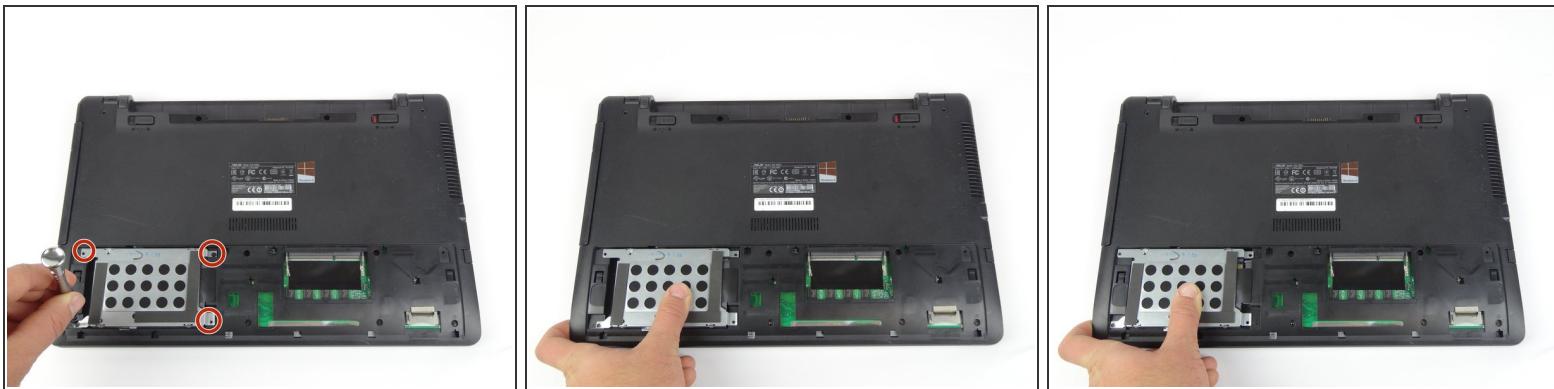
Step 5

- Remove the four 5.5mm screws located on the hard drive case using a Tri-wing Y1 screwdriver.
- Slide the hard drive out to the left.

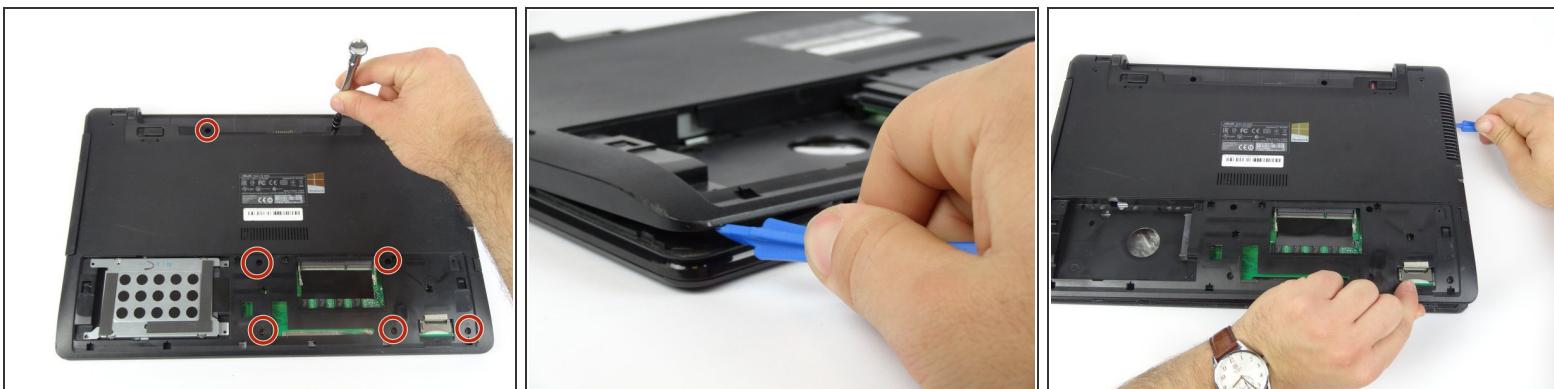
Step 6

- Use Tri-wing Y1 screwdriver to remove seven 4mm screws from battery area.
- Use opening tool to split keyboard from base of the laptop.
- Make sure to start from one end and go around the edges.

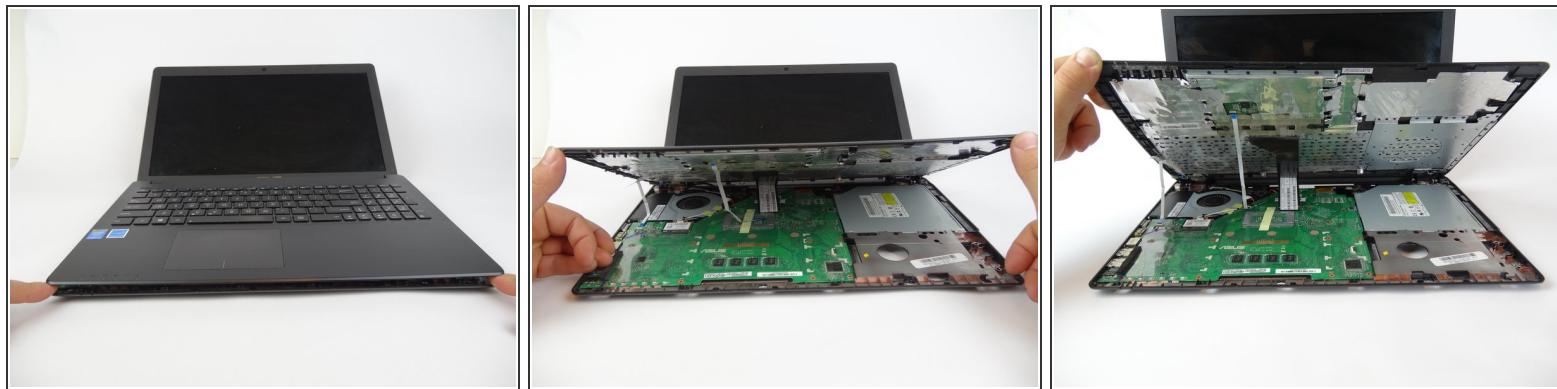
Step 7

- Flip laptop to sit on its bottom.
- Lift keyboard up by the front edge

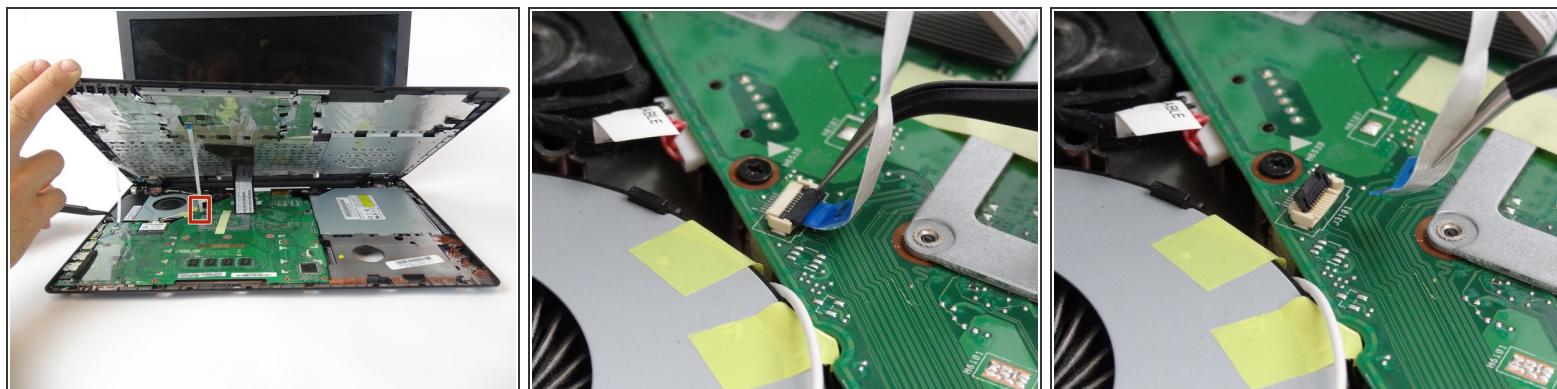
Step 8

- Flip up the small locking flap for the two ZIF connectors.
- Unplug the connectors that are keeping the keyboard connected.

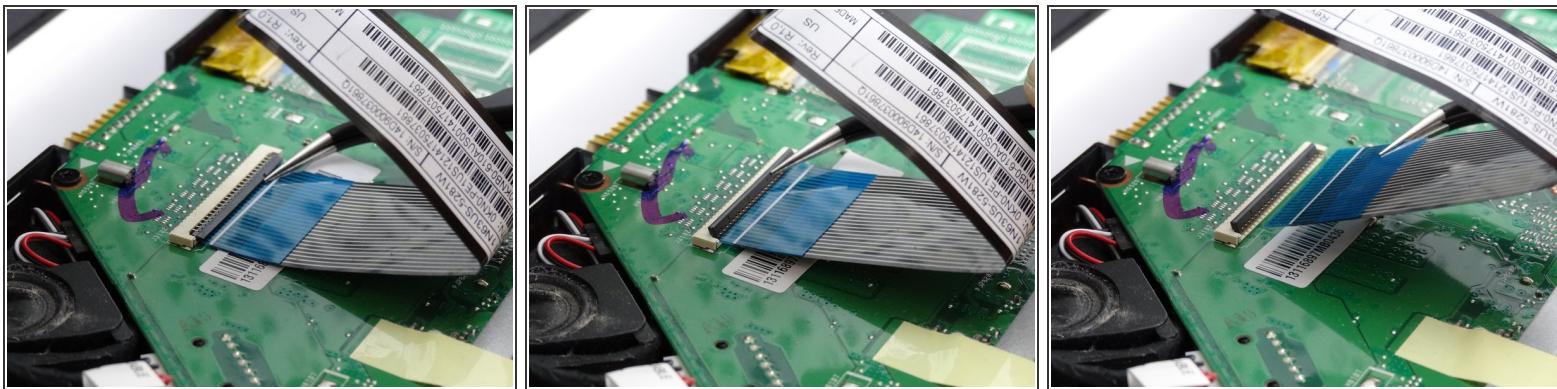
Step 9

- Flip up the locking flap for the ZIF connector.
- Unplug the connector that is keeping the keyboard connected.

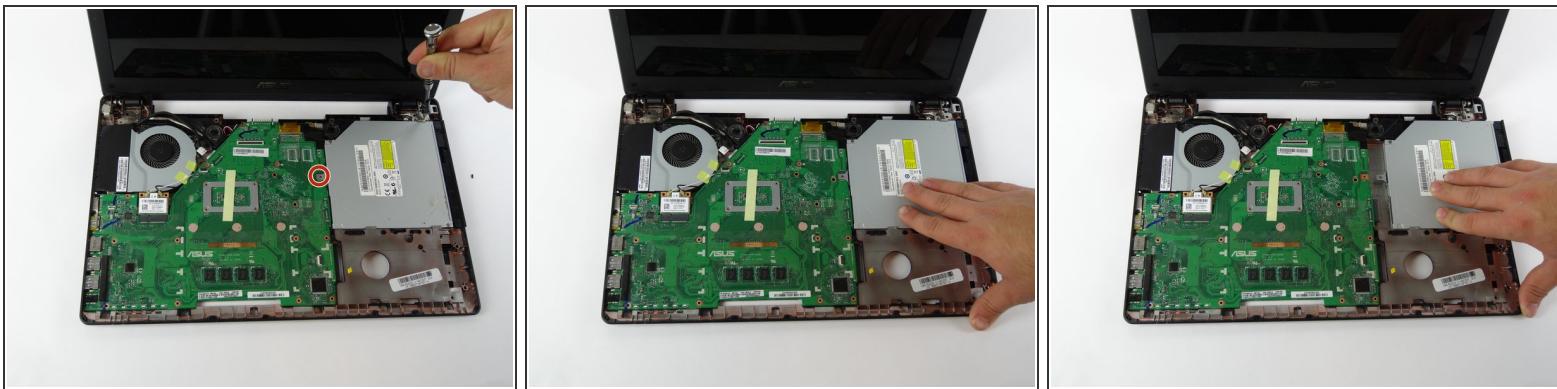
Step 10

- Remove keyboard from laptop.
- Remove two 4mm screws around CD drive
- Slide the CD drive out to the right to remove it.

To reassemble your device, follow these instructions in reverse order.
