Amazon Echo 2nd Generation AMP Board Replacement

How to replace the AMP Board in the Amazon Echo 2nd Generation.

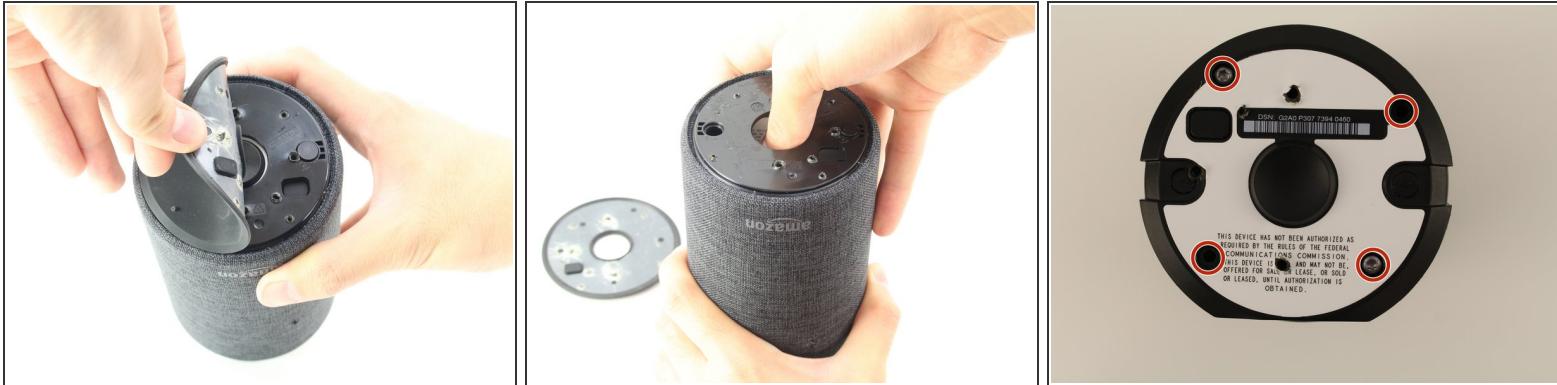
Step 1 — AMP Board

- Remove the rubber layer beneath the device.
- Look for the crater beneath the rubber layer and place your thumb on it. Hold down and lift off the cover with your other hand.
- Remove the four 8.0 mm T8 Torx screws on the lid.
- Remove the lid from the device.

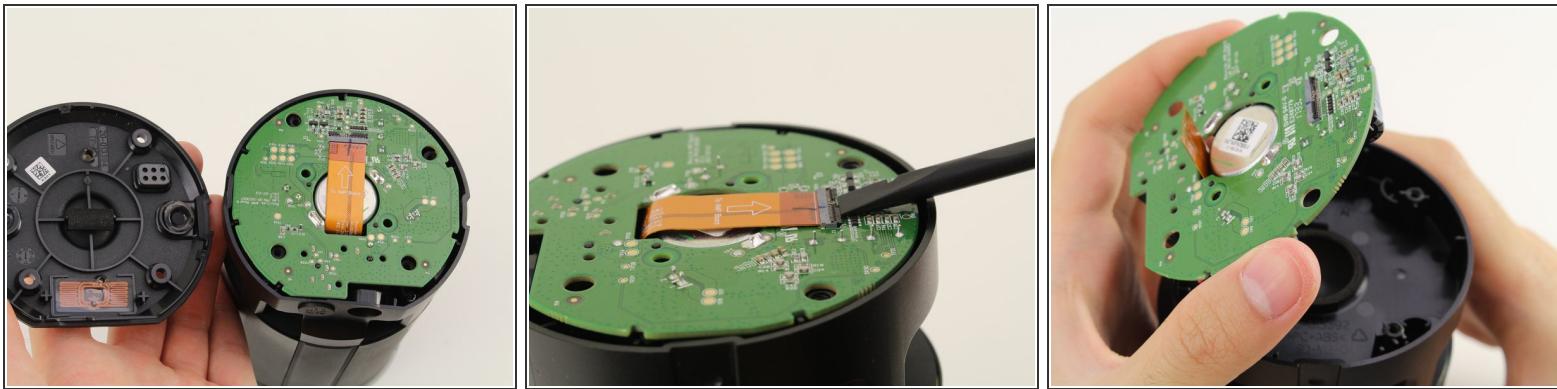
Step 2

- Use a spudger to flip up the small flap on the ZIF connector.
- Gently pull the ribbon cable out of the ZIF connector.
- Lift the AMP Board gently while sliding the ribbon cable out through the center hole to reveal another set of wires underneath the board.

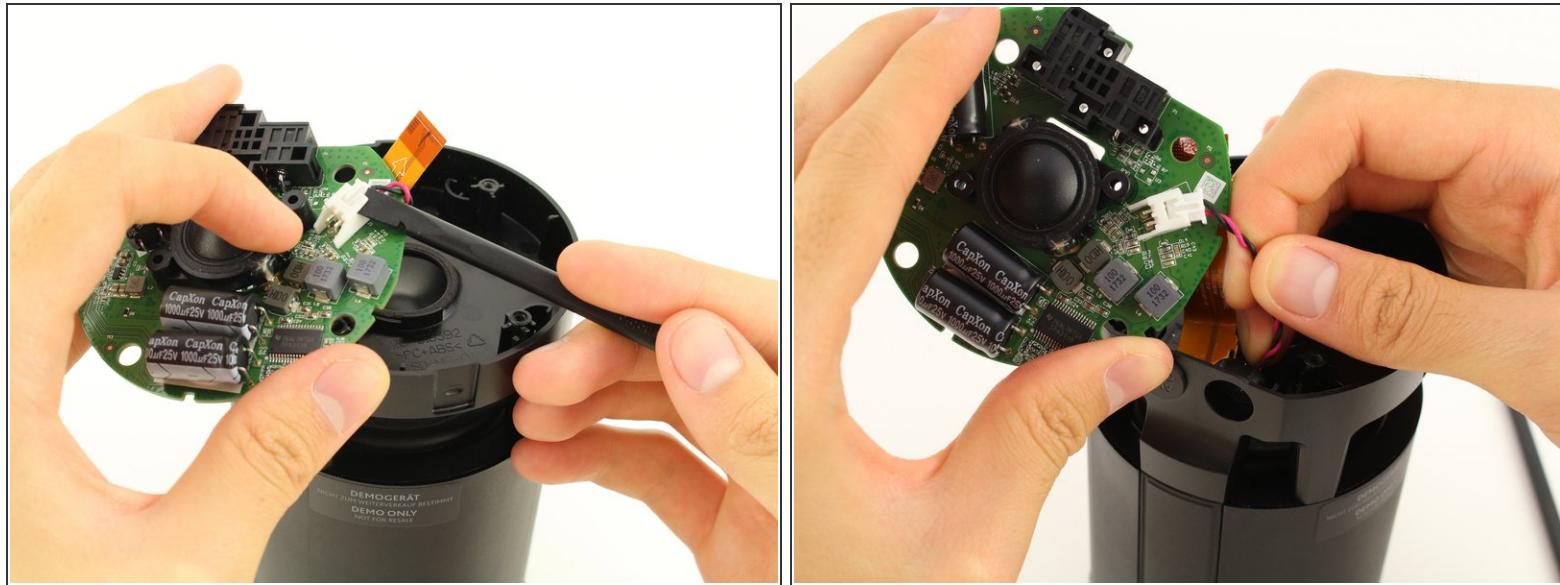
Step 3

- Use a spudger to lift up one of the small flaps on only one side of the female connector.
- Pull on the wire toward the lifted side until the male connector is disconnected.
- Remove the AMP Board.
