Aspen A720 Back Cover Replacement

How to replace an Aspen A720 back cover.

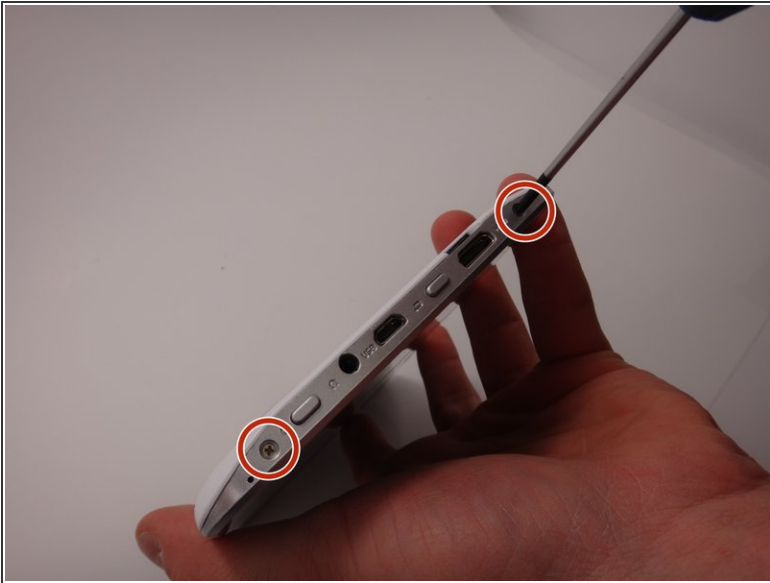
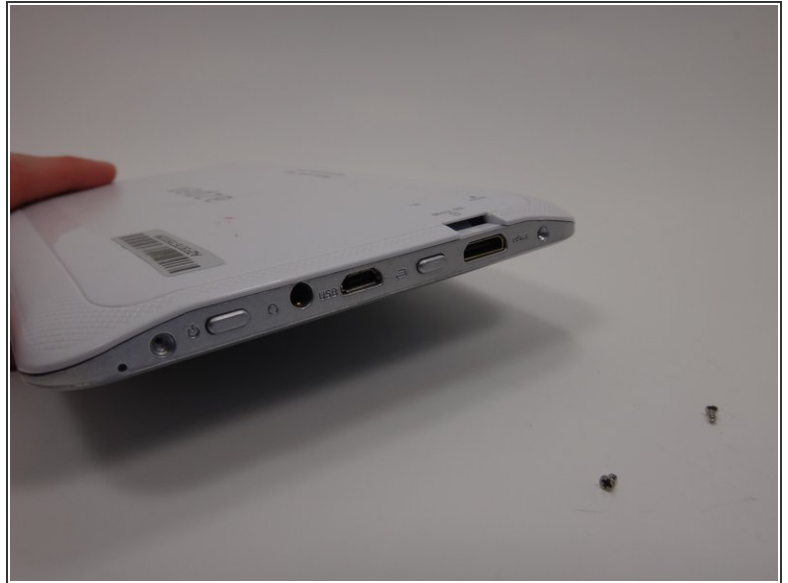
Step 1 — Aspen A720 Back Cover Replacement

- Use the Phillips # 00 screwdriver to remove the two 4mm screws found on the top edge of the tablet near the power button and mini HDMI port.

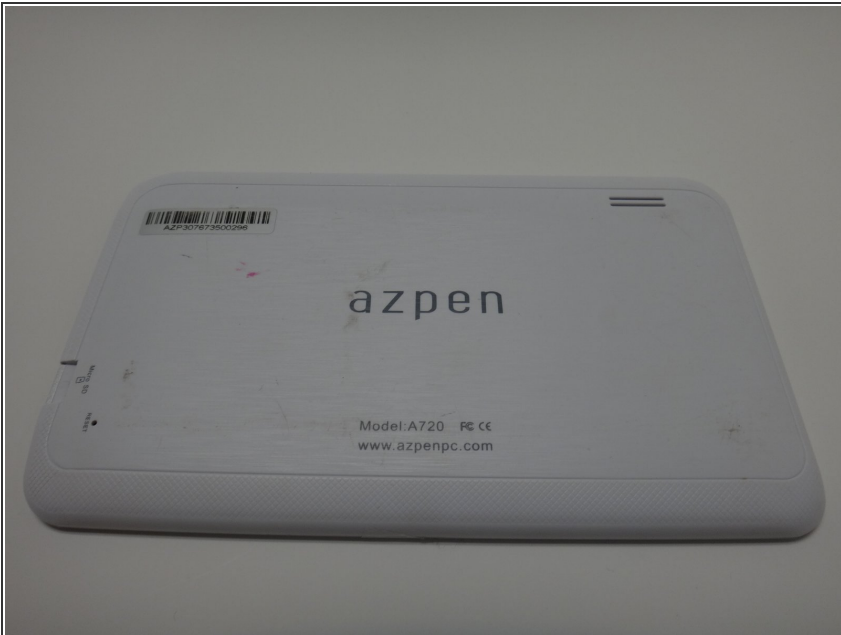
Step 2

- Lay the tablet screen-side down.

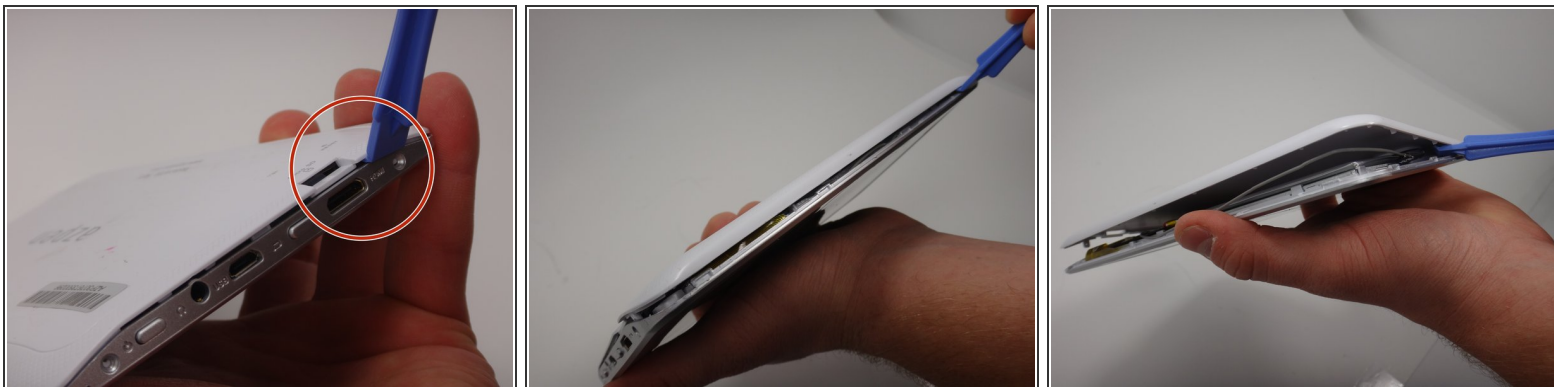
Step 3

- Use the plastic opening tool to pry the white back from the silver frame. Start near the micro SD slot.
- Slide the plastic opening tool around the perimeter of the casing until the back is disconnected.

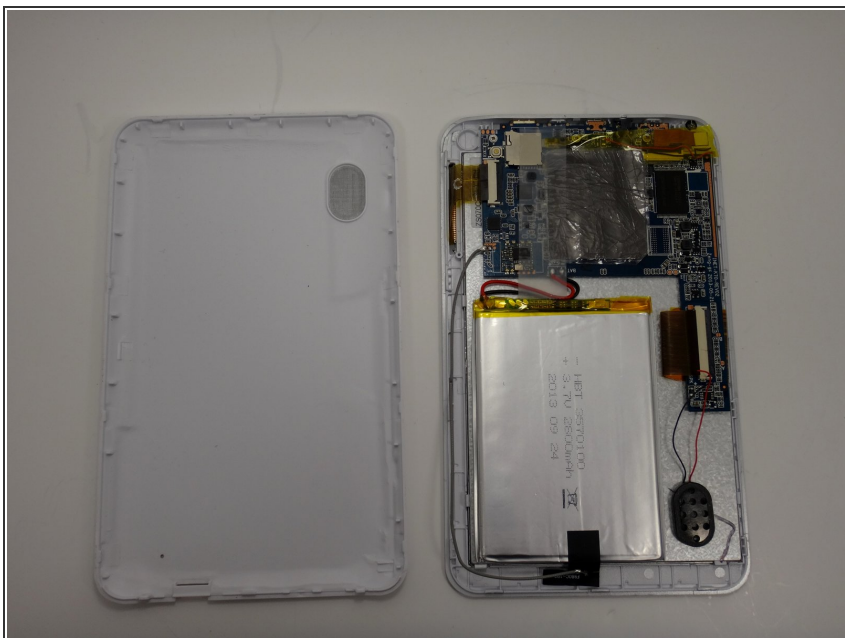
Step 4

- Take the white backing off your tablet.

Now all of the components are accessible for maintenance
