Asus CM1745 CD Drive Replacement

Partial desktop teardown and replacement of faulty CD Drive.

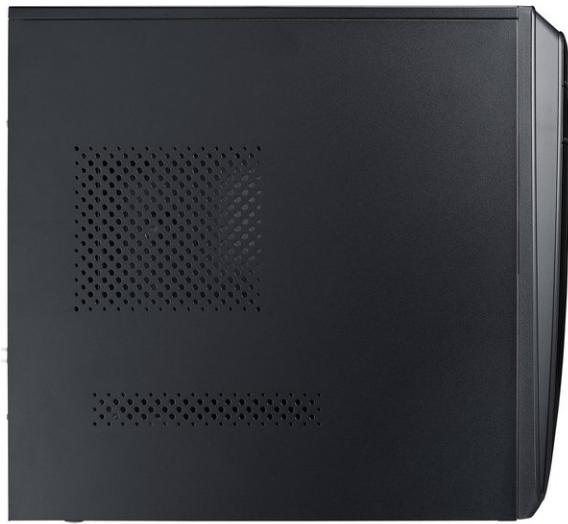
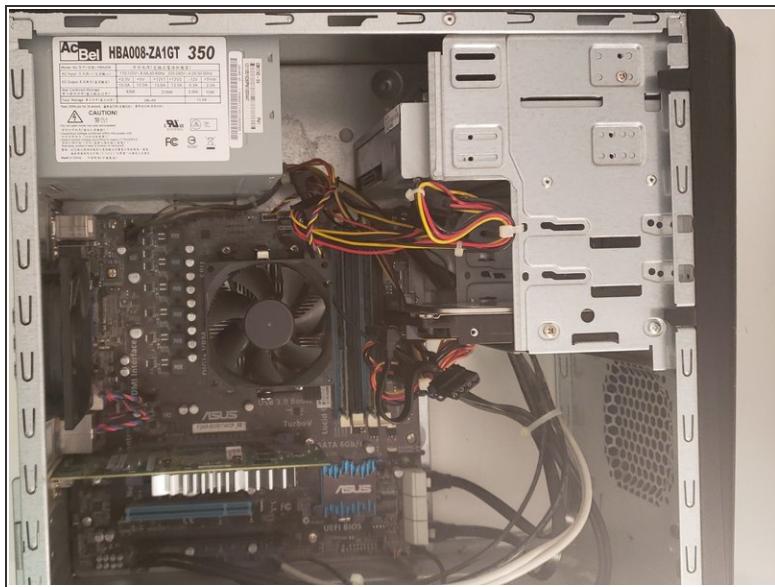
Step 1 — CD Drive

- Remove the sidepanel by unscrewing the two screws fastening the panel on the rear. Once unscrewed, slide the panel towards the rear until it releases then lift away.

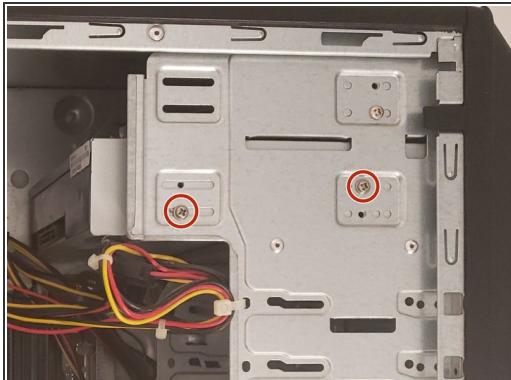
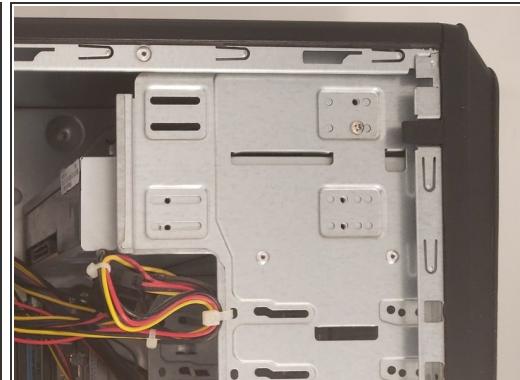
Step 2

- Remove the two cables connected to the CD Tray
- Remove the two screws with a Phillips #0 screwdriver.

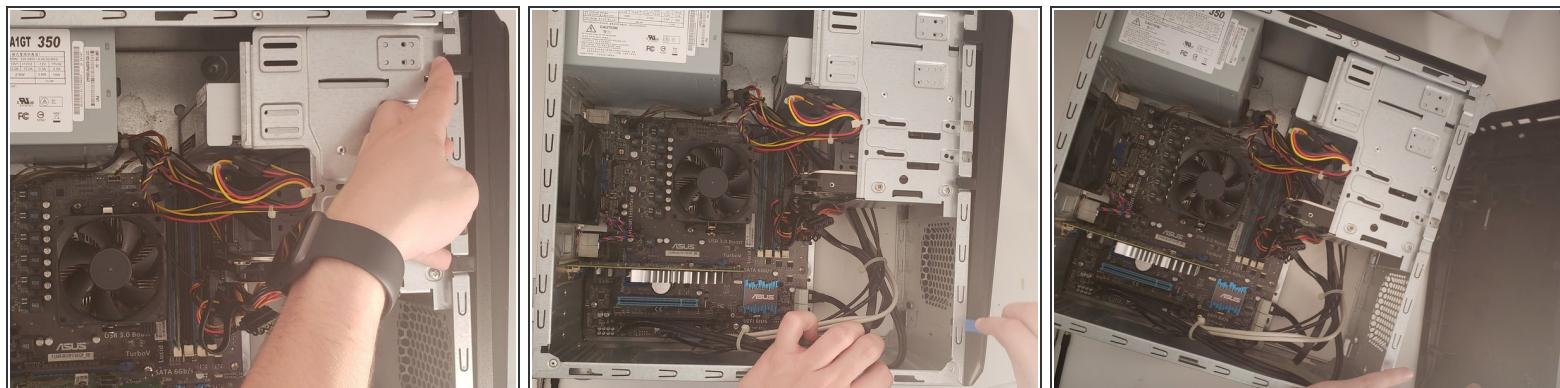
Step 4

- Remove the front panel using the iFixit opening tool.

(i) You will first pull the visible clips off of the chassis as seen in the second photo then use the opening tool to pry the other clips off.

- Once a few of the clips pop open, pull the front panel off with relative ease.

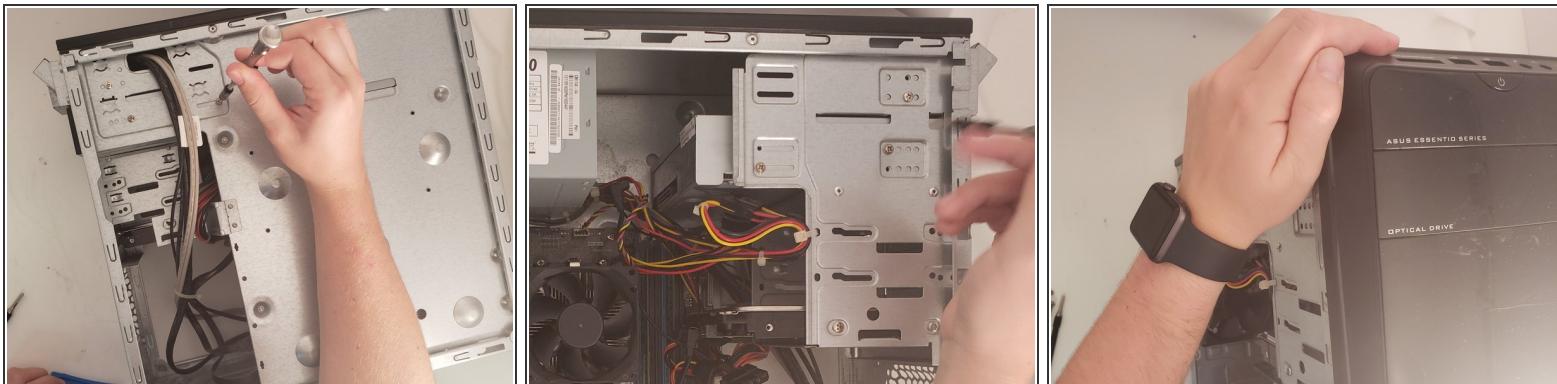
Step 6

- Place the new CD Drive in the place of the old one and secure it by rescrewing the previous screws. Reattach the two connectors for power and data on the back.
- Reattach the front panel after reinstalling the CD Drive by orienting the panel with the chassis and pressing it into place.
- Make sure all clips are re-secured by pushing around the perimeter.

If everything looks correct, boot the computer and check to see if the CD Tray works as intended. If so, reassemble the case.
