Asus Chromebook C523N Back Cover Replacement

How to remove the back cover of the Asus Chromebook C523N.

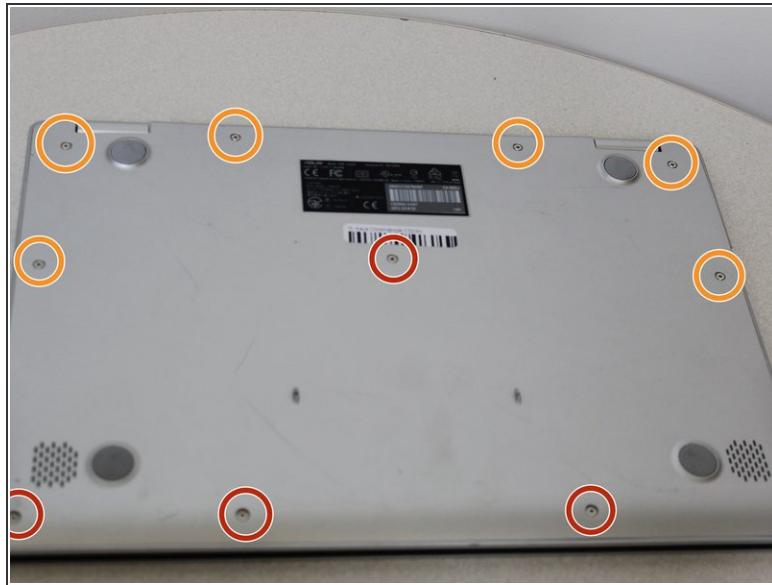
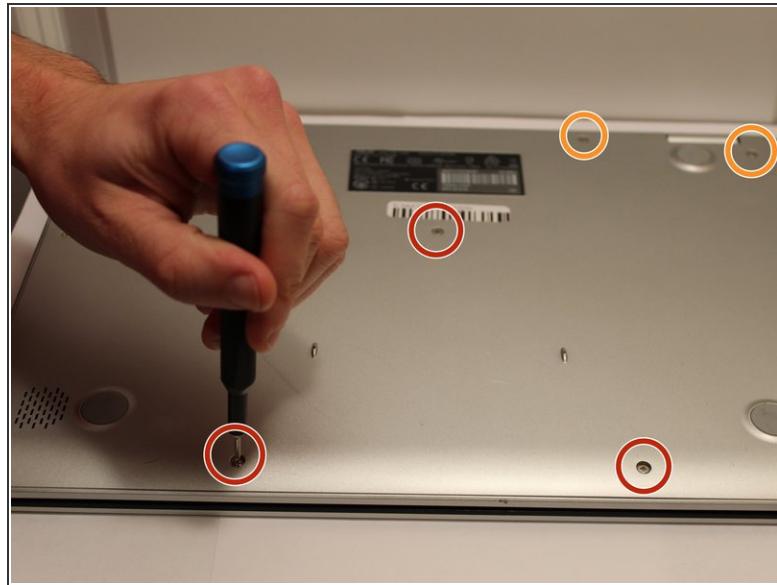
Step 1 — Back Cover

- Remove the four 0.5mm JIS #00 screws from the bottom edge of the Chromebook and one in the center.
- Remove the six 1.7mm JIS #00 screws from the sides and top edge of the Chromebook.

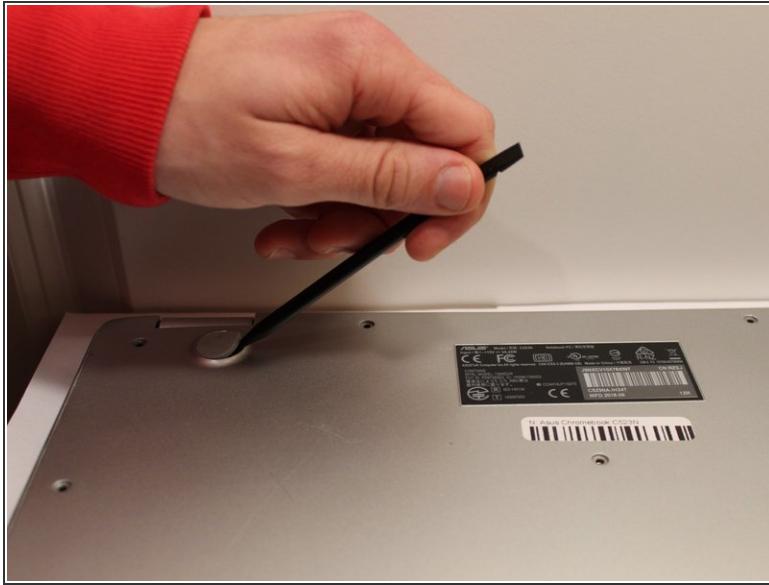
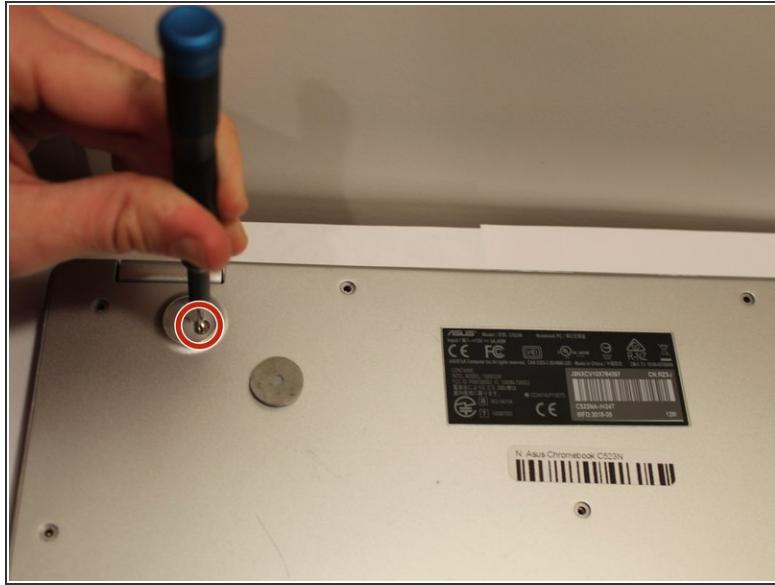
Step 2

- Using a spudger, lift the top left base pad and remove it to reveal a final screw underneath.
- Remove the one 0.5mm JIS #00 screw underneath the base pad.

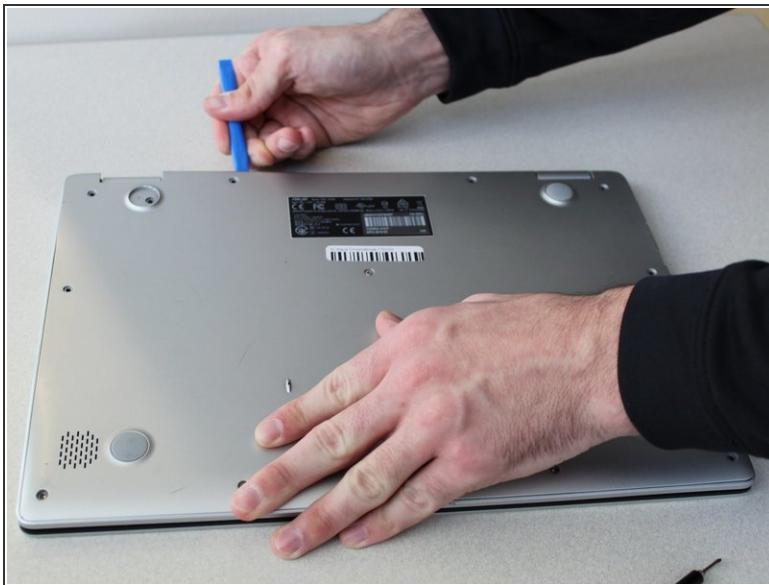
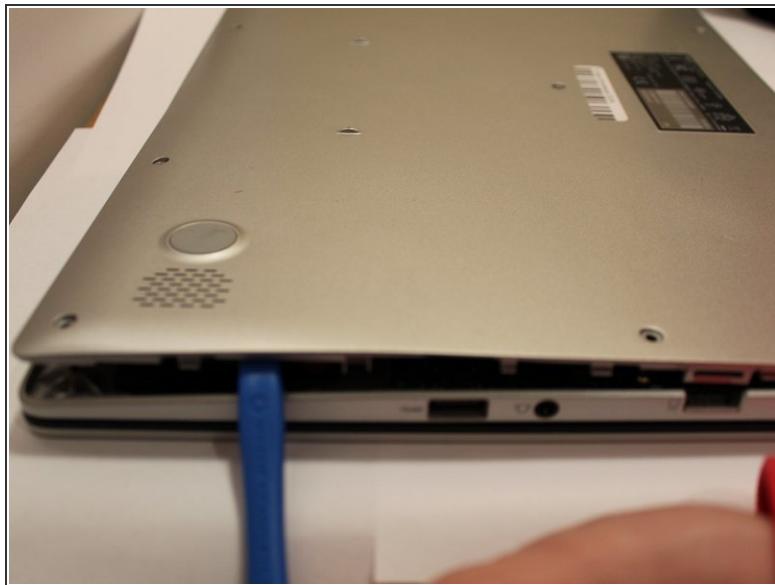
Step 3

- Use an opening tool to gently pry the base enclosure up and remove from the laptop.

To reassemble your device, follow these instructions in reverse order.
